Primary hip replacement stem taper fracture due to corrosion in 3 patients

Michael M Morlock, Dennis Bünthe, Harmen Ettema, Cees C Verheyen, Åke Hamberg & Jeremy Gilbert

To cite this article: Michael M Morlock, Dennis Bünthe, Harmen Ettema, Cees C Verheyen, Åke Hamberg & Jeremy Gilbert (2016) Primary hip replacement stem taper fracture due to corrosion in 3 patients, *Acta Orthopaedica*, 87:2, 189-192, DOI: [10.3109/17453674.2015.1128780](https://doi.org/10.3109/17453674.2015.1128780)

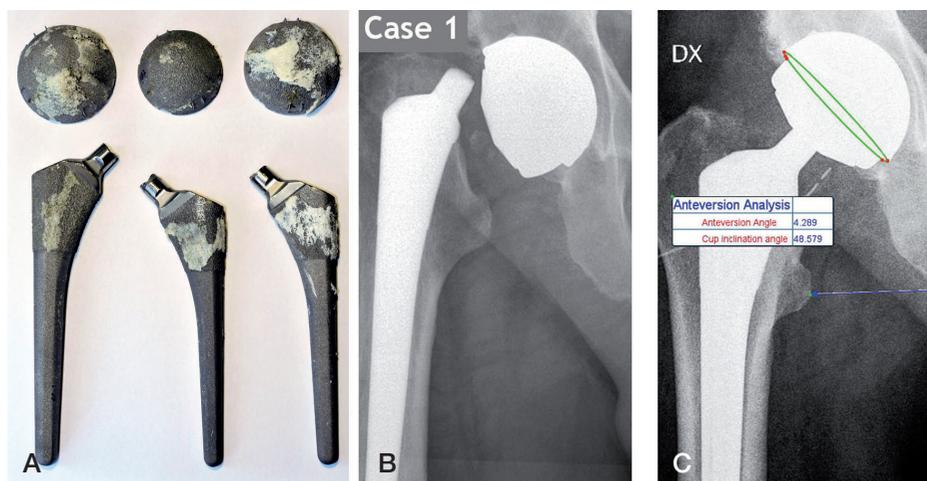
The patient was a 62-year-old physically active man who had had an uneventful primary hip replacement until he felt a sudden snap in the right hip followed by intense pain, 4 years after surgery. Radiographs showed the broken stem taper. The

Figure 1. A. The 3 revised stems (left to right: case 1, case 2, and case 3). The bone attached to the implants is an indication of the ingrowth of the implants and the extent of bone defect caused during revision. B. Post-fracture radiograph of case 1. C. Pre-fracture radiograph of case 1. Cup angles were measured using image analysis software available at www.imatri.com (Joubert 2013).

hip was revised to an uncemented KAR stem and a Pinnacle cup with a ceramic-on-ceramic 36-mm bearing articulation (DePuy, Leeds, UK). The surgery was uneventful. Blood serum metal ion concentrations at revision were as follows: Co, 0.9 µg/L; Cr, 2.0 µg/L; and Ti, 61 µg/L.

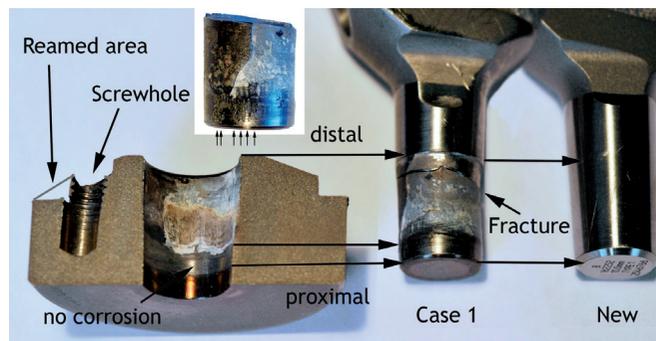
Figure 2. The cut ball head insert and stem taper (with broken-off piece placed in original position) together with a new stem taper. The screw hole was drilled into the ball head insert for removal (which was unsuccessful); reaming of the slope of the insert allowed holding on to the insert and successful removal. The distal edge of the ball head insert is imprinted circumferentially onto the stem taper (arrow). The proximal edge of the contact between male and female taper and also the edge of the corroded area are marked on the taper insert together with the corresponding position on the stem taper. The insert shows the scratches in the non-corroded area originating from entrapped bone pieces (small arrows) in the broken-off stem taper piece.

The taper contact area is divided into a small intact region (proximal) and a large corroded region (distal, Figure 2). Signs of small bone fragments were identified in the intact contact region, suggesting contamination that prevented incomplete seating (“jamming”) during assembly. The male stem tapers showed a circumferential impression of the distal edge of the female insert taper (Figure 2).

Case 1 showed pronounced scratches at the proximal end of the male stem taper interface, probably due to contamination with bone during assembly. This may have prevented the taper from fully seating, resulting in increased micromotion during in vivo loading (Jauch et al. 2011) and thus promoting the observed formation of thick layers of TiO₂ (Grupp et al. 2010). In the other 2 cases, biological material was also found in the taper interface, but not in such a clear form as in case 1. The high fixation strength of the broken-off stem taper tip in the ball head insert was due to the thick layers of TiO₂ (Figure 4). Conversion of the Ti alloy to oxide creates high pressure at the taper interface, since the volume of oxide is 70% higher (Ti has a Pilling-Bedworth ratio of 1.7), making it almost impossible to disassemble the components (“cold welding”).

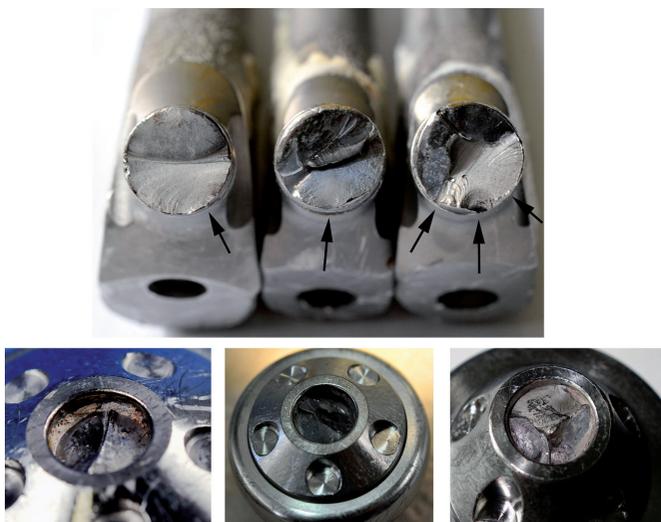
The fracture surfaces revealed fatigue fractures with rest lines radiating out from the origin of the crack (Figure 3). The location of the crack origin was always located on the lateral side, with the highest bending load during activities. All fractures occurred about 1–4 mm inside the taper contact (Figure 3). White deposit identified as titanium oxide (TiO₂) by EDX analysis was always found at the taper interface (Figures 2 and 3).

Figure 3. Upper panel: Stem fracture surface with fatigue cracks radiating out from the origin of the crack (black arrows) as a series of concentric rings (rest lines; left to right: cases 1 to 3). Case 3 had 3 crack origins, which subsequently coalesced into a unified fracture. Lower panel: All the fractures occurred slightly inside the female taper (about 1–4 mm proximally from the open end). The broken-off male stem taper piece remained inside the female ball head insert taper.

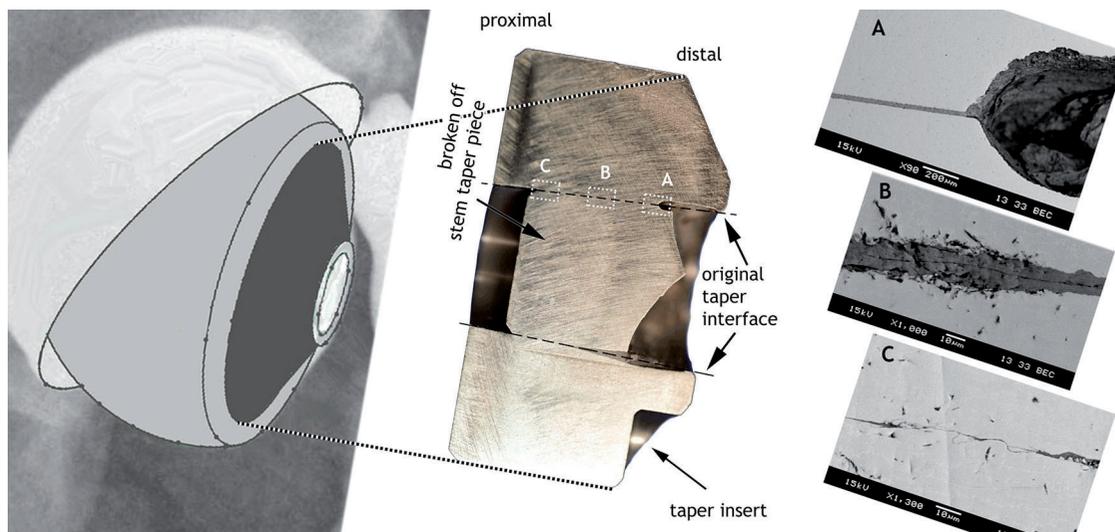
The cut, assembled taper interface from case 2 was analyzed using SEM. The fracture originated in the large corrosion cavities (up to 500 μm wide), which were found close to the distal end of the taper (Figure 4). The gap between the male and female taper surfaces narrowed to about 40 μm in width at the proximal end of these cavities. The thin gap was filled with titanium oxide. Moving proximally at the taper interface, the oxide layer narrowed and became very thin until there was direct contact between asperities at the most proximal intact region (Figure 4C).

Figure 4. Left panel: Orientation of cup and head in case 2. Middle panel: Aligned orientation of the cut ball head insert with the fractured stem taper piece (dashed lines: original taper surface; areas A, B, and C for SEM are highlighted). Right panel: A. SEM of the corrosion cavity at the location of conversion to a smaller gap. B. SEM image of the middle of the taper articulation. The line down the middle of the dark TiO₂ layer marks the location of the original metal interface. The bulk titanium material was converted directly to TiO₂ by corrosion. C. SEM of the proximal end of the articulation. Tight junction between male and female taper surfaces with asperity contact and thin oxide layer.
