The Sinking Sequence of MV Estonia

Dem Promotionsausschuss der
Technischen Universität Hamburg-Harburg
zur Erlangung des akademischen Grades
Doktor-Ingenieur (Dr.-Ing.)
genehmigte Dissertation

This thesis reconstructs the sinking of the RoPax Ferry MV Estonia on September 28th 1994, with a strong focus on describing the chain of events that caused the eventual sinking, and how the ship sank. Once the sinking is understood, this thesis explores possible safety improvements that should be implemented in the design of new vessels of this type. The investigation is based on a combination of testimonies of survivors as well as numerical calculations based on the framework of the testimonies.

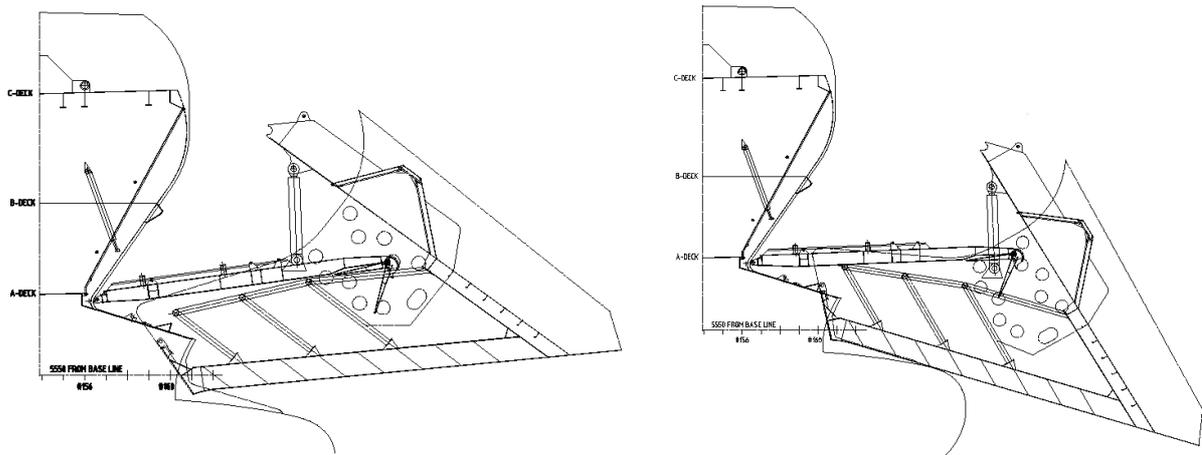
- Deep, sharp indentations in 20mm thick visor shell plating tracks from visor bottom upwards approximately 3.0m parallel to the visor centreline girder. Most likely cause is that damage occurred when the visor contacts the straight part of the stem post following detachment from the vessel. [...]

Figure 3.4 and Figure 3.5: The bow visor forcing the bow ramp open and falling on the bulbous bow [CARLS01]

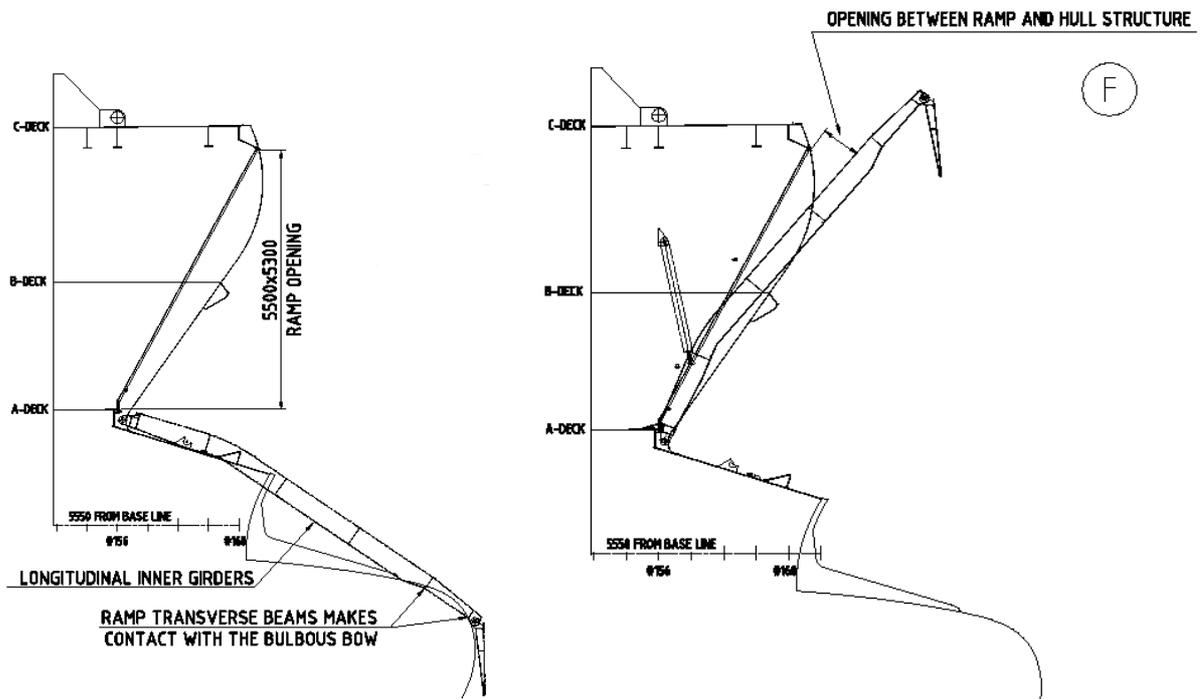
- During the later stage of the sinking sequence, when the vessel’s heel is approximately 90 degrees, and the stern starts to point towards the seabed, the bow ramp begins to close under its own gravity. Broken hinges on port side makes the ramp lean to starboard and the ramp upper starboard console makes contact with the front bulkhead preventing the ramp from closing fully. In this position the gap between upper and part of ramp and forecastle deck is approximately 0.6 – 0.8 meters. This was the ramp final position on the wreck in 1994.”

Figure 3.6 and Figure 3.7: The bow ramp fully pulled open and the condition as found on the seabed [CARLS01]

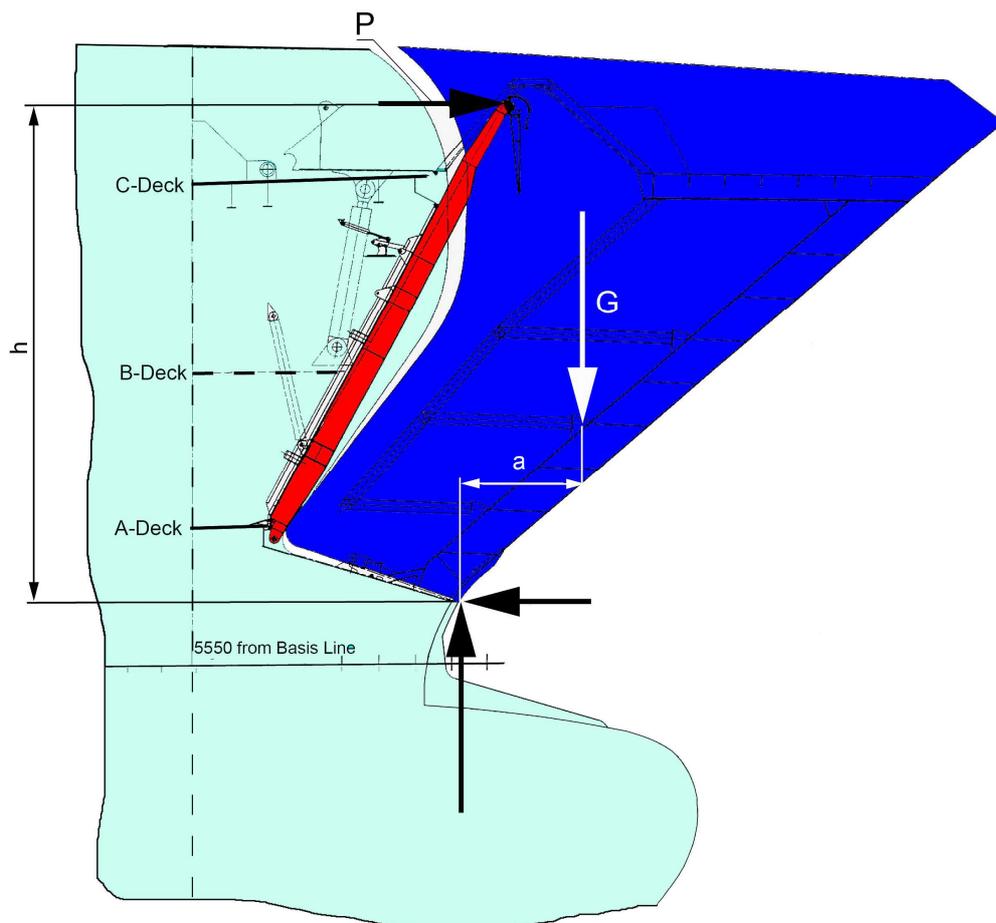
[LEH] distinguishes between two failure modes. The *causa prima* is a fatigue failure of the visor hinges, but all consequential failure of the bow ramp opening sequence had a *causa secunda* of an overload of the visor hinges. [LEH] calculates a bow visor opening moment of 225kN conservatively, disregarding the water most likely in the bow visor as assumed by [CARLS01]. Furthermore [LEH] calculates a ramp opening force of about 200kN with the following conditions: Only the two starboard hinges of the ramp are intact and the hooks were not engaged as can be seen on the video material of [ROCK]. Only one of the four locking bolts are closed. The statement of [LEH] on this calculation is: “This force ‘P’ is less than 225kN, therefore this load explains very clear, that the ramp has been opened by reason of the bad condition of the ramp securing system.”

Figure 3.8: Direction of the forces pulling the bow ramp open [LEH]

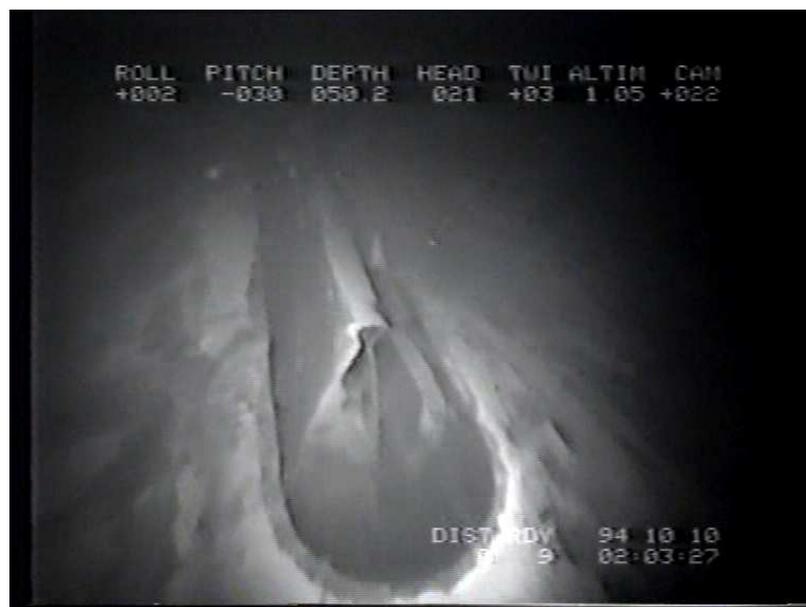
MV Estonia had two stabiliser fins, one on each side of the ship in the area between frames e and r, see *Figure 6.2*. According to the testimonies of crew members, the stabiliser fins were deployed at about 00:30, half an hour before the first heavy heel occurred. On the video-tape of the ROV-inspection of October 10th 1994, at time code 02:03, the port side stabiliser fin can be seen. The stabiliser is in its drawn-in position – into the ship's hull, see *Figure 6.3*. There is no obvious damage observed.

Figure 6.3: The drawn in-position of stabiliser fins of MV Estonia [ROCK]

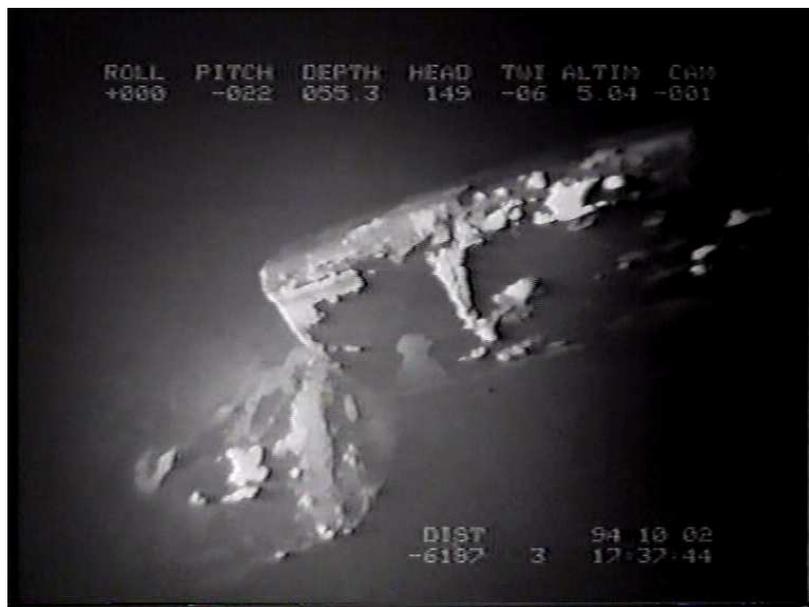
Each rudder angle is kept the same by a connecting bar in the steering gear room. On the videotape the rudders have no obvious damage and the angle of about 35° can be confirmed on the videotape of ROV-inspection - October 2nd 1994 at a time of 17:37 on the tape, see *Figure 6.4*. This is position the rudders would be in due to the action of gravity in the case of a loss of system pressure, so it cannot definitely deduced what position of the rudder is as last controlled by the bridge.

Figure 6.4: The position of rudder

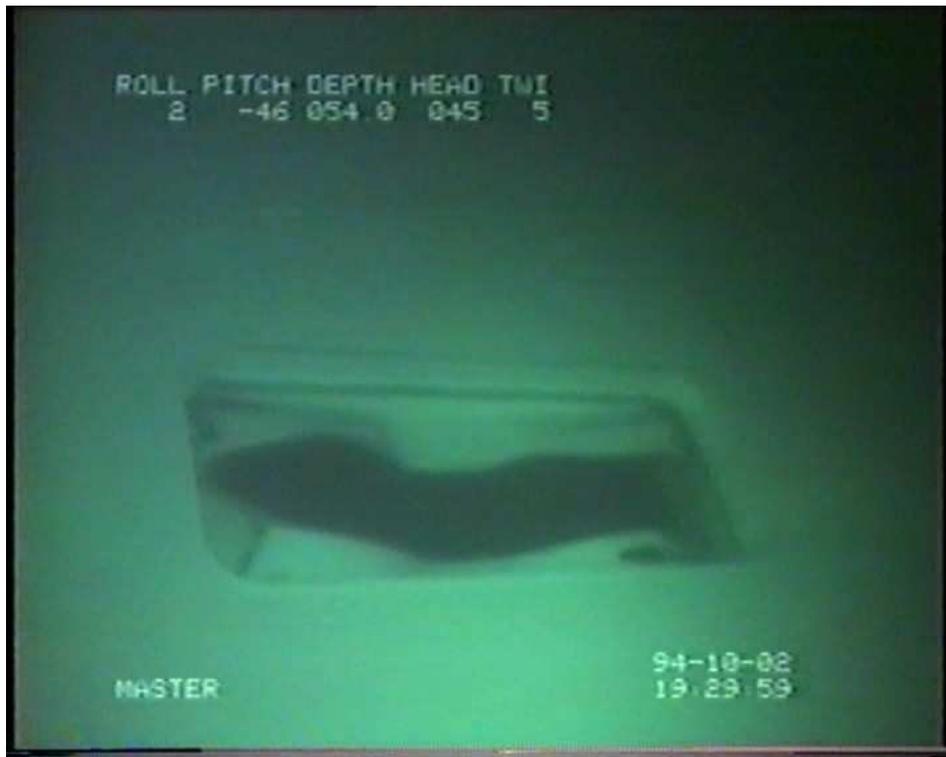
Figure 6.5 shows a broken window on Deck 4, the curtains can be seen clearly. Also on Deck 4, *Figure 6.6* shows a broken window with a mattress hanging out.

Figure 6.5: Broken window on Deck 4

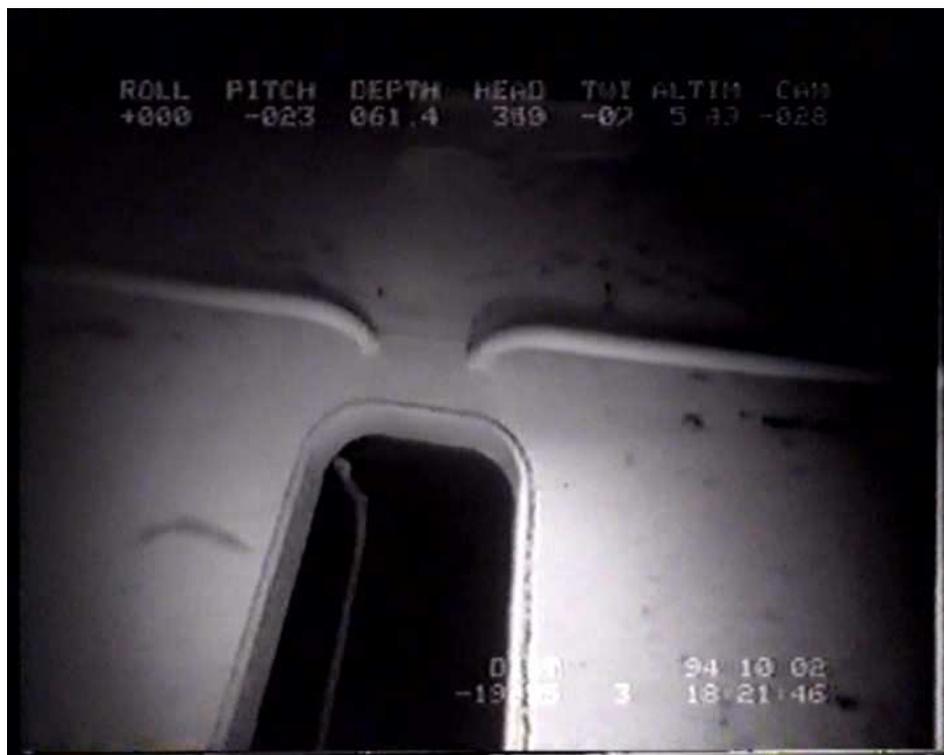
Figure 6.7: One of the openable type windows of Deck 7/8 in an opened state

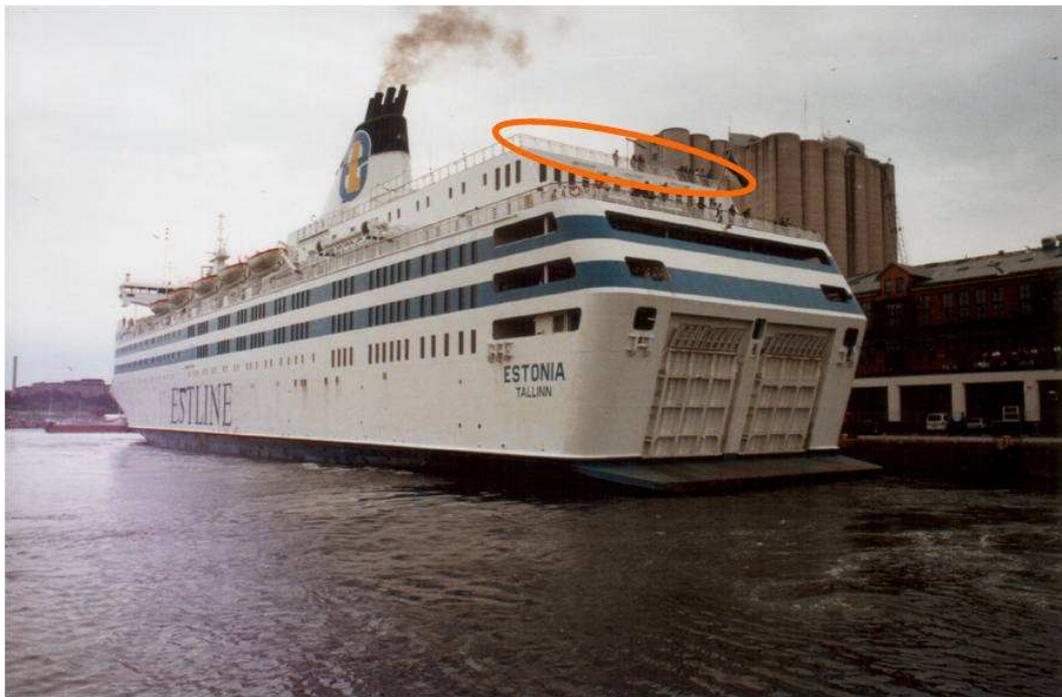
There is unfortunately no video available that shows the stern railing on Deck 9, see *Figure 6.19*, but [ROCK] records that there are “some minor buckles in the superstructure at the stern near deck 8”. This indicates MV Estonia hit the seabed stern-first with a list of significantly more than 90°, but not in an upside-down condition. A list of 120°-140° at time of collision seems to be likely, looking at the damage to the vessel’s stern.

Figure 6.19: Stern view of MV Estonia, unfortunately no underwater video material available

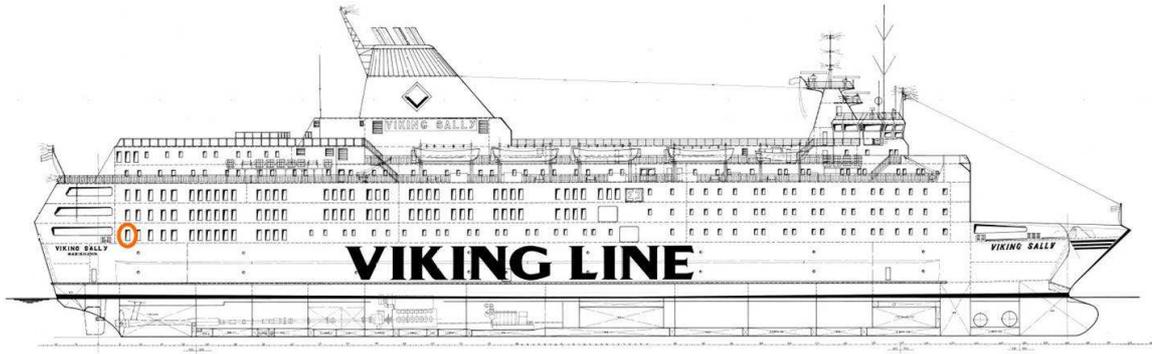
In Step 23, the first window collapses - due to a hydrostatic load of a column of over 3.55m. It is the last window on Deck 4 on the starboard side and the compartment behind the window is Main Fire Zone 3 (MFZ). Over subsequent steps, as the water level in this compartment rises, the water pours down to Deck 3, Deck 2 and finally in the Store Room between frames 33 and 43 on Deck 1. This last compartment floods in calculation Step 34.

Figure 12.21: Graphic of collapsed window on Deck 4 which fails in step 23, 01:22:00

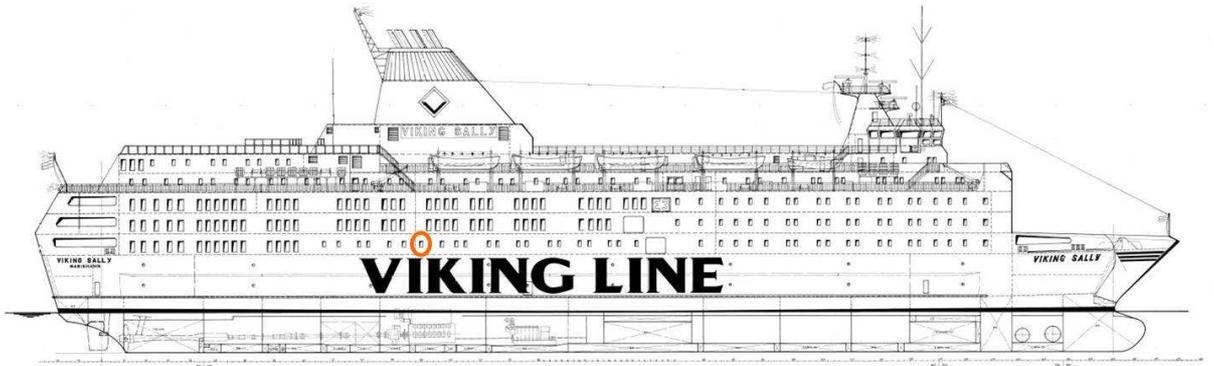
A third window, the first small window with a size of 400mm x 800mm, collapses due to a hydrostatic pressure equivalent to a water column of more than 4.15m. This window is part of the Main Fire Zone 2 on Deck 4.

Figure 12.26: Graphic of collapsed window on Deck 4, Main Fire Zone 2 which failed in Step 27, 01:24:00
