# Taper corrosion: a complication of total hip arthroplasty

Cite this article: *EFORT Open Rev* 2020;5:776-784.

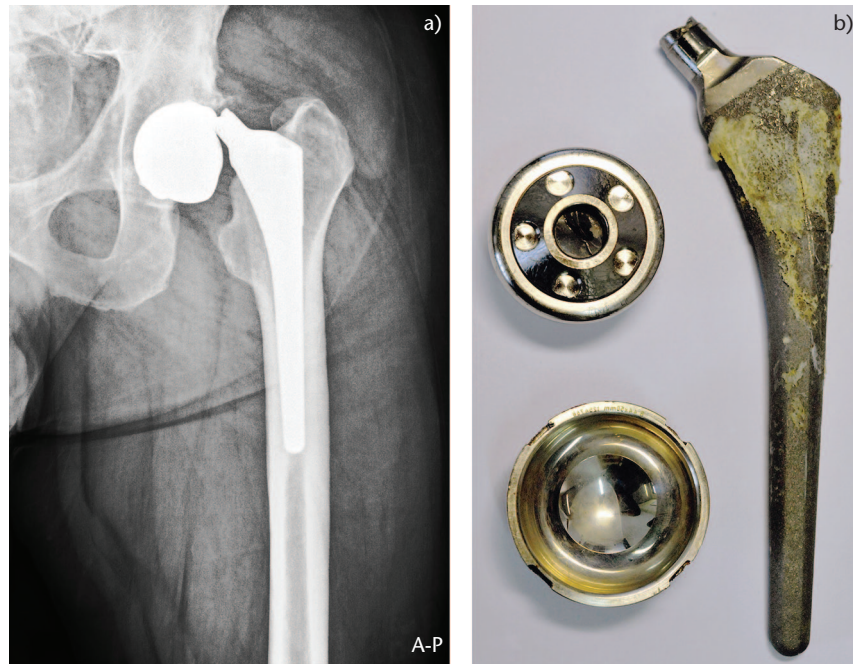
Stem taper fracture as the worst clinical endpoint of taper corrosion has been observed in only one particular MoM design using a Ti-alloy adapter sleeve connector with a Ti-alloy stem (Fig. 3). In this design a high frequency of cold welding between stem and adapter was also observed.<sup>20</sup>

**Fig. 3** (a) X-ray of a stem taper fracture in a Ti-alloy primary stem with a large MoM bearing after four years in situ. This design utilizes a Ti-alloy adapter sleeve to assemble the CoCr-bearing surface to the stem. (b) The explanted components with the broken stem taper inside the adapter sleeve inside the head (courtesy H. Ettema, Isala).

Corrosion at Ti-alloy–Ti-alloy taper junctions is typically not recognized until catastrophic failure occurs as a result of the absence of a biological response to the Ti debris in most cases (i.e. fracture, Fig. 3, Fig. 5). In contrast, clinical failure of taper junctions between CoCr heads and Ti-alloy stems typically does not involve mechanical failure but is caused by the biological response to the Co and Cr debris, which is created in the corrosion process (Fig. 4).<sup>34</sup> It is important to realize that the male stem taper is usually not damaged in such a situation, even so it might look corroded due to the Co and Cr debris from the inside head taper. After careful cleaning it is possible in most cases to maintain the stem and put on a ceramic head with a Ti-alloy adapter sleeve.<sup>54</sup> Both CoCr heads and ceramic heads on CoCr stems show a very low material release.<sup>60</sup> The results for oxidized zirconium heads in comparison to CoCr heads are favourable but inconsistent.<sup>51,61</sup>

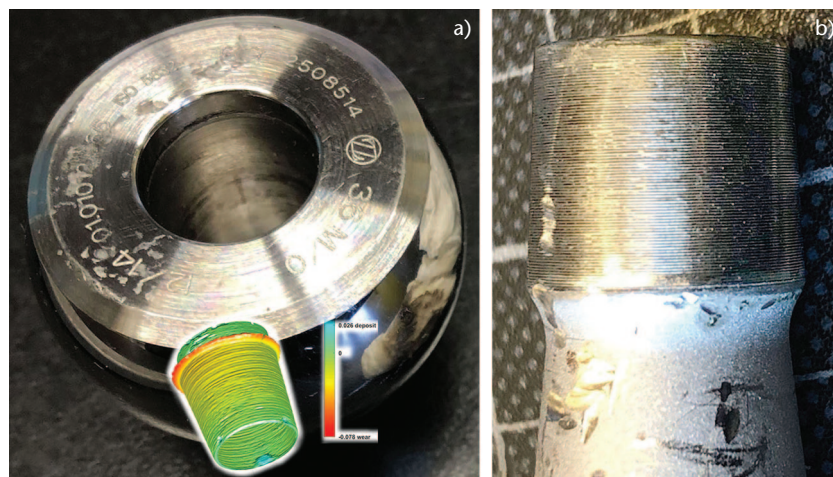
**Fig. 4** (a) Female head taper corrosion after seven years in situ. The overlay shows the depth of the female head taper wear (material loss 6.7 mm<sup>3</sup>). (b) The male stem taper did not show signs of corrosion but slight marks from the revision surgery.

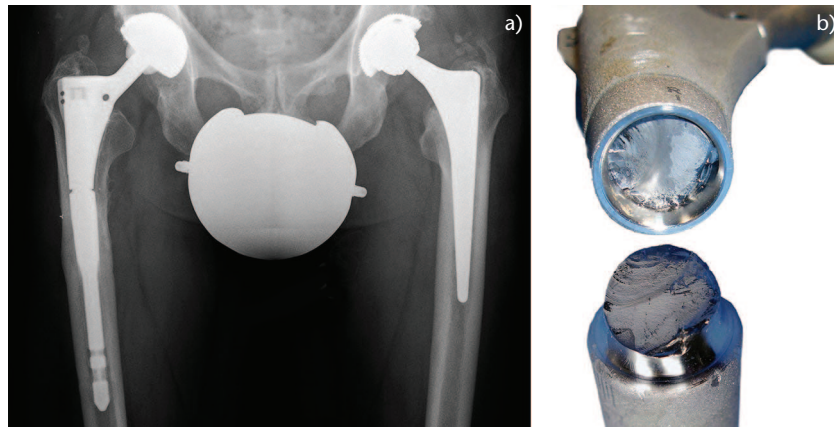
Long and large heads, varus stems and higher offset stems apply higher load to the taper interface and as such exhibit more fretting and corrosion.<sup>40–47</sup> Fracture of hip revision stems are a ‘good’ example to illustrate this (Fig. 5): Due to the long lever arm of the joint load to the

stem–neck piece taper connection, the risk of micro-movement with consecutive corrosion is clearly elevated, especially under unfavourable loading conditions, ultimately resulting in an elevated rate of taper fracture at the neck piece stem taper.<sup>48</sup> Similar arguments can explain the higher corrosion problems for dual taper hips.<sup>49,50</sup>

**Fig. 5** (a) X-ray after fracture of a Ti-Ti Revision stem after seven years in situ (courtesy M. Rudert, Würzburg). (b) Fracture surfaces of the broken taper showing the typical split lines of a fatigue fracture.

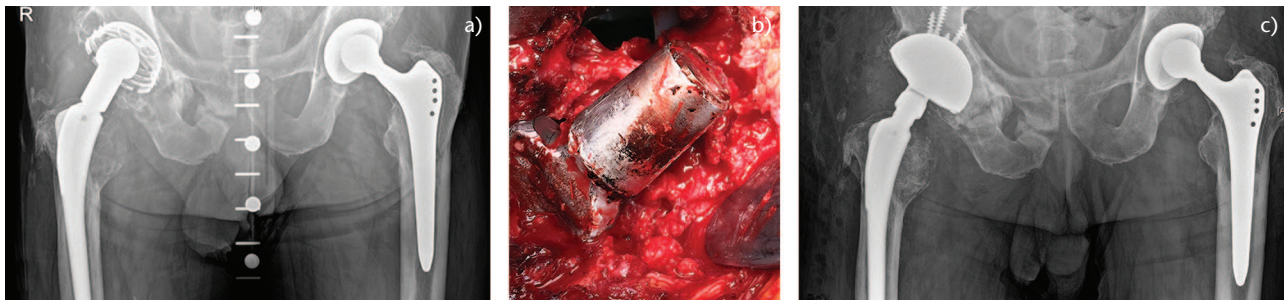
**Fig. 6** (a) X-ray of a male patient (76 years) prior the 4th isolated right cup revision in 2019 after original stem implantation with a 32 mm metal XXXL head in 1984. (b) The stem taper showed only light corrosion and minor damage from the multiple revision surgeries. (c) X-ray after the revision with a 36 mm ceramic option XXXL head on the original stem.

even in adverse loading conditions if assembled properly (Fig. 6), but the diameter of the heads should not exceed 32 mm.
