**Head Taper Corrosion Causing Head Bottoming Out and Consecutive Gross Stem Taper Failure in Total Hip Arthroplasty**

Michael M Morlock<sup>1</sup>, Emilie C Dickinson<sup>1</sup>, Klaus-Peter Günther<sup>2</sup>, Dennis Bunte<sup>3</sup>, Valerie Polster<sup>1</sup>

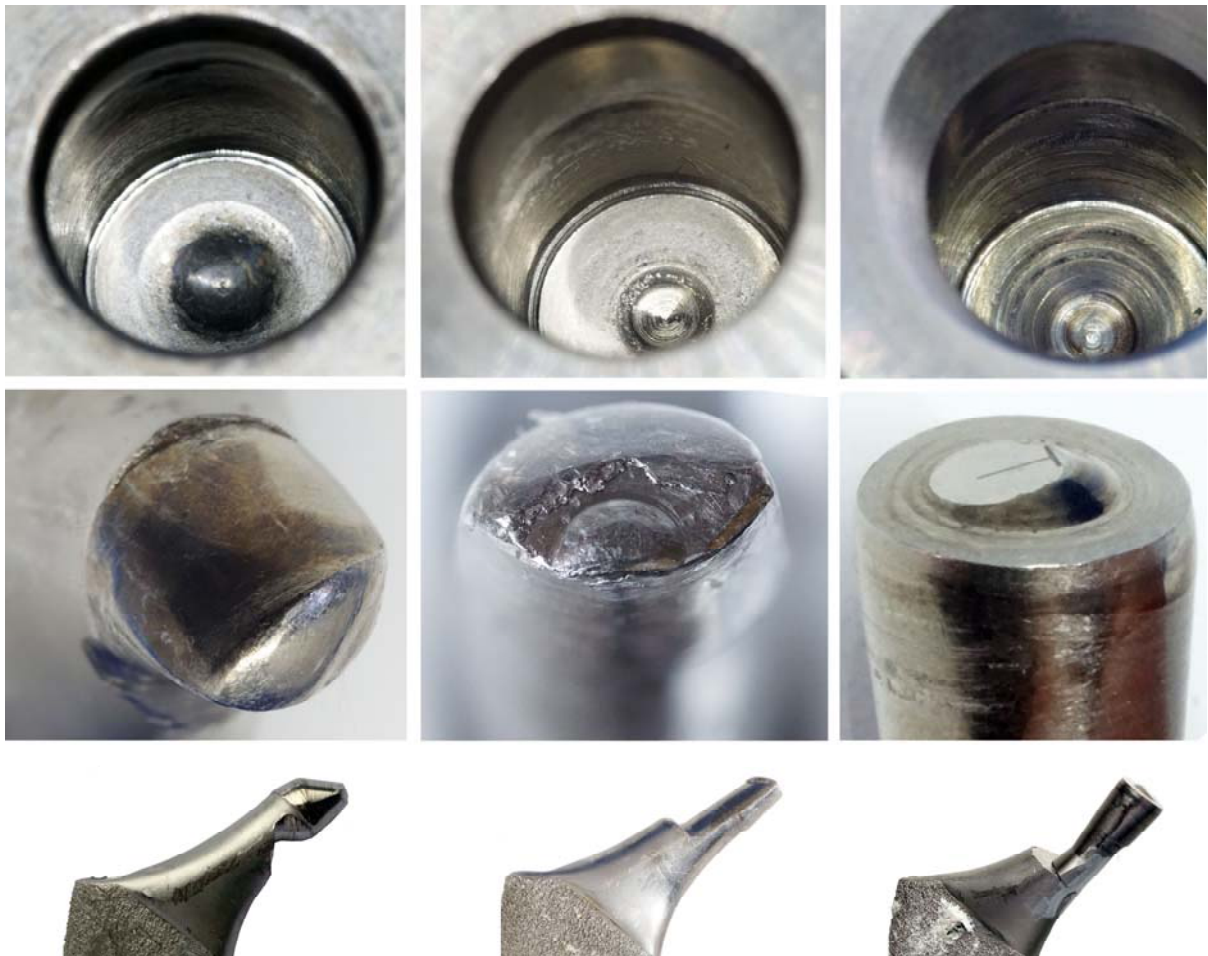
Figure 8

- Figure 8: The three observed Gross Taper Failure patterns of the stem (bottom row) were all associated with bottoming out of the male stem taper in the female head taper. Associated with each failure pattern was a specific wear pattern of the tip of the male stem taper (middle row) and the bottom of the female head (top row): "Bird Beak" (left column), "Toothpick" (middle column), "Trumpet" (right column).
