SCHRIFTENREIHE SCHIFFBAU

Comparison of Proposed Stability Criteria with the Results of Model Tests

Seakeeping Tests with the Model of a 30 m Cutter
carried out in the Hamburgische Schiffbau-Versuchs-
anstalt GmbH. (Hamburg Ship Model Basin Ltd.)

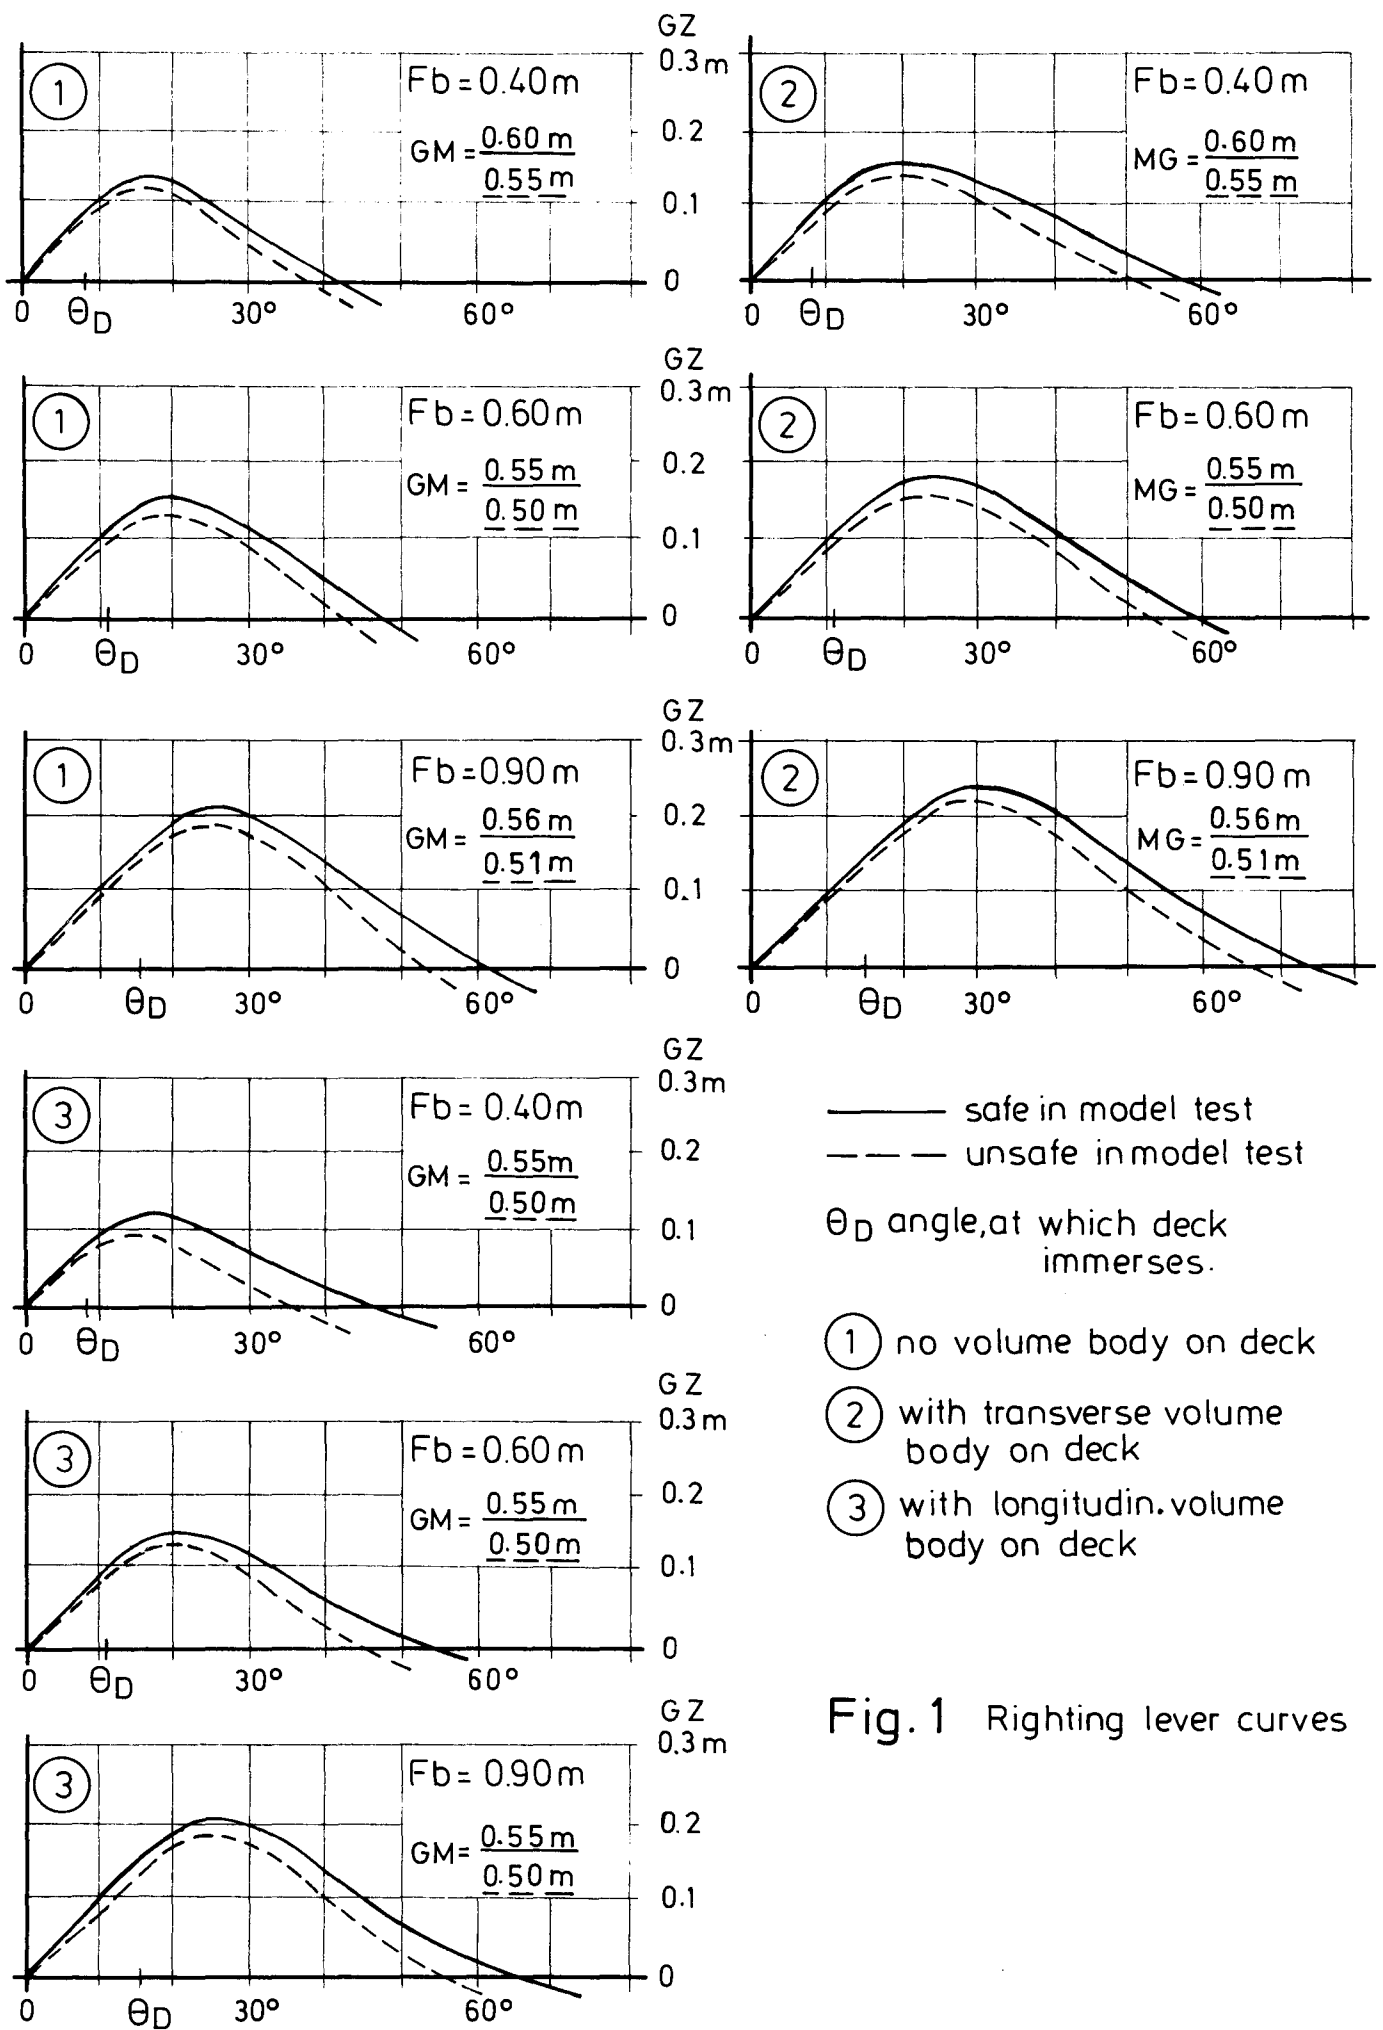
Fig.1 Righting lever curves

In Fig. 1 the lowest righting arm curves of "safe" cases and the highest righting arm curves of "unsafe" cases are shown. In the following the curves of the "safe" cases are taken as capsize limits. This choice has been made because righting levers derived by interpolation between those of unsafe and safe cases would not have differed much from the chosen levers. It should also be kept in mind, that the tests did not include heeling moments from wind or gusts. Therefore actual stability

It can be seen from Fig. 1 that the righting arms which are necessary to prevent capsizing increase with increasing freeboard (or decreasing draft). This holds for the ship with free deck area behind the forecastle as well as for the ship with volume bodies on the deck. The ship where the volume body on deck extends from side to side needs higher righting levers in order to be safe than the ship without or with a longitudinal volume body. There is no significant difference in the righting levers of the ship with free decks and of the ship with the longitudinally arranged volume body on deck.

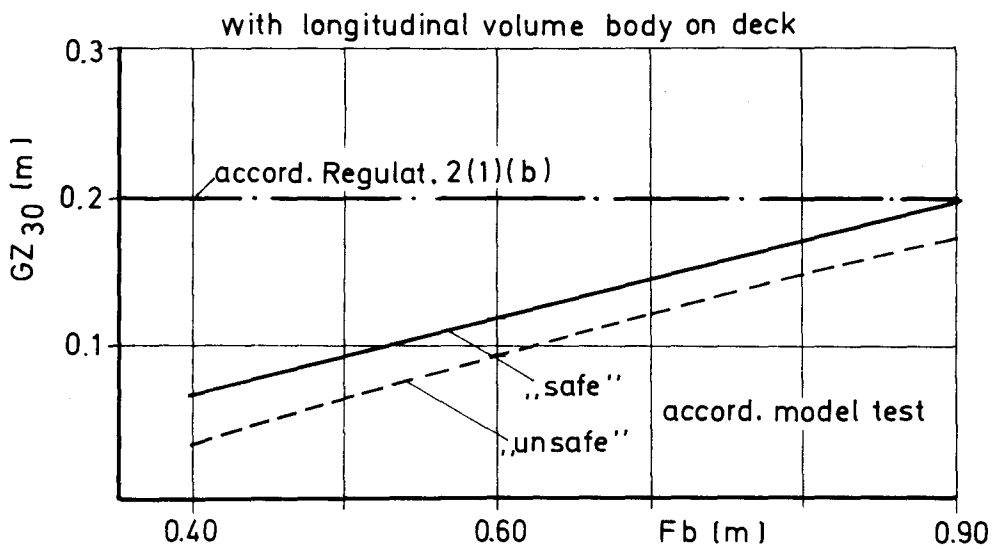
Fig. 4 Required GZ at $\theta = 30^\circ$

A comparison of the required righting lever at an angle of heel of 30° according to the model tests on the one hand and according to Regulation 2 (1) (b) on the other hand is shown in Fig. 4. For small freeboards the righting lever required by the Regulation seems to provide a sufficient safety margin; but this margin decreases with increasing freeboard.

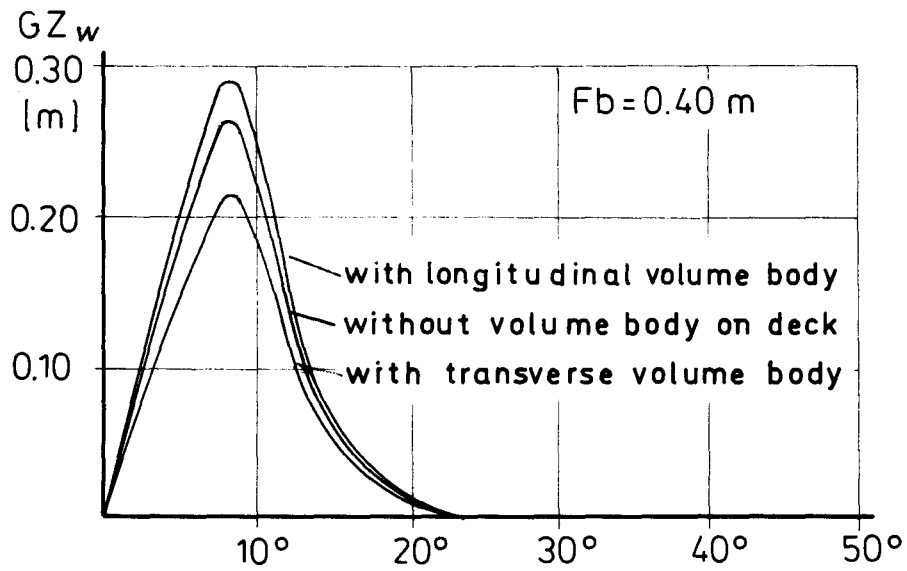
Fig. 5 Heeling lever curves due to water on deck (accord. IMCO-proposal)

Regulation 4 requires that every vessel shall be able to withstand the effect of water on deck to the satisfaction of the Administration. As guidance for the investigation of this effect the method described in PFV XVI/8, Annex II p. 47/50 has been used. The levers GZ_w of the heeling moment due to water on deck determined according to this method are shown in Fig. 5. There is not much difference between the heeling levers GZ_w for the case without and with a longitudinal volume body on deck. As to be expected the minimum righting levers necessary to prevent capsizing are about the same for both these cases. The heeling levers GZ_w for the case with the transverse volume body on deck are significantly lower than those for the other two cases. The corresponding minimum righting levers however are higher than those for the other two cases. This unlogical result can only be explained by the fact that the method for the determination of the heeling moment due to water on deck is not realistic enough. The same conclusion is reached if the difference between the area under the righting lever curve up to 40° angle of heel and the area under the heeling lever curve is considered (this difference is equal to the area under the righting lever curve between the dynamic heeling angle due to water on deck and 40° angle of heel). Fig. 6 shows that the excess area under the righting lever curve which is necessary to prevent capsizing is much higher in the case with the transverse volume body on deck than in the cases without or with the longitudinal volume body on deck. Therefore, the proposed method is - at least for the investigated capsizing situation - not suited to take account of the effect of water on deck.

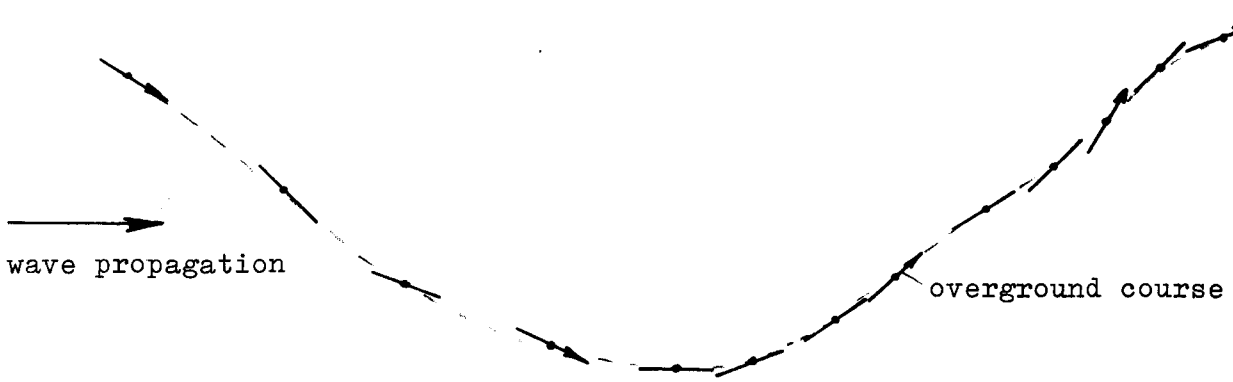
Fig. A 4

Run No. 19

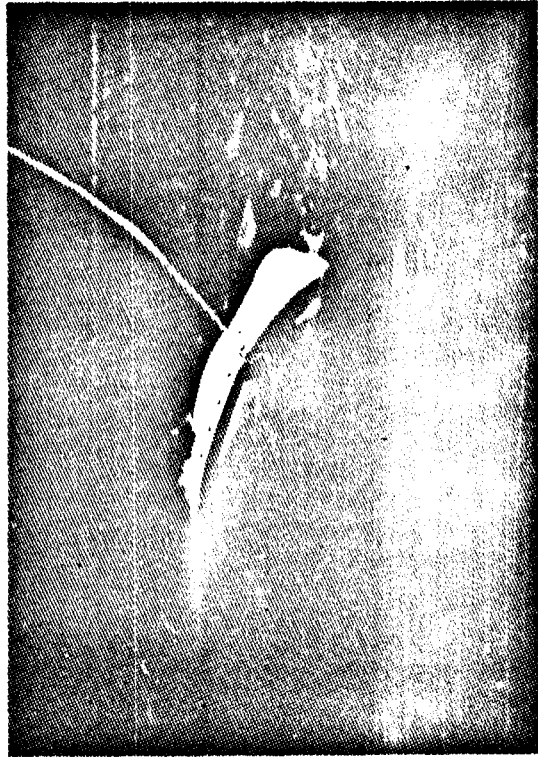
Ship running in abt. 30° stern sea
Freeboard 0,90 m; Volume of displacement 200 m³; GM₀ = 0,45 m
with longitudinal volume body on deck

Fig. P 1 to P 7a show some photographs of the model in stern sea.

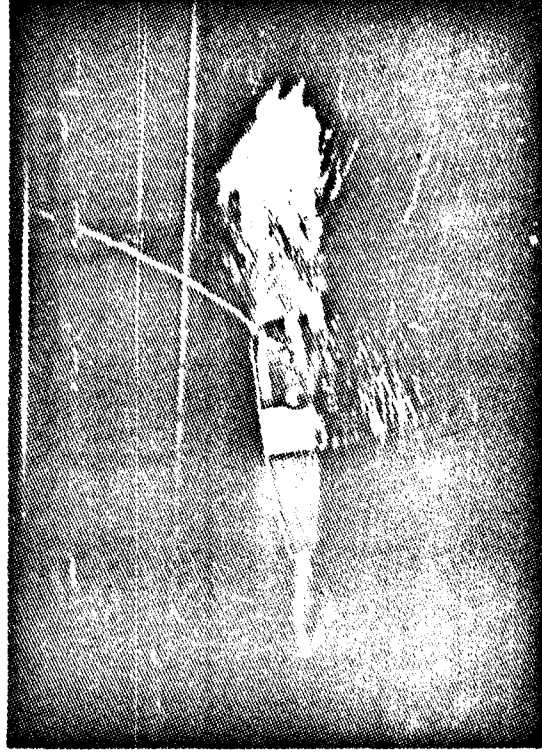
Ship running in abt. 30° stern sea
Freeboard 0,60 m; Volume of displacement 242 m³; GM₀ = 0,50 m
with transverse volume on deck.
