The Sinking Sequence of MV Estonia

Dem Promotionsausschuss der
Technischen Universität Hamburg-Harburg
zur Erlangung des akademischen Grades
Doktor-Ingenieur (Dr.-Ing.)
genehmigte Dissertation

This thesis reconstructs the sinking of the RoPax Ferry MV Estonia on September 28th 1994, with a strong focus on describing the chain of events that caused the eventual sinking, and how the ship sank. Once the sinking is understood, this thesis explores possible safety improvements that should be implemented in the design of new vessels of this type. The investigation is based on a combination of testimonies of survivors as well as numerical calculations based on the framework of the testimonies.

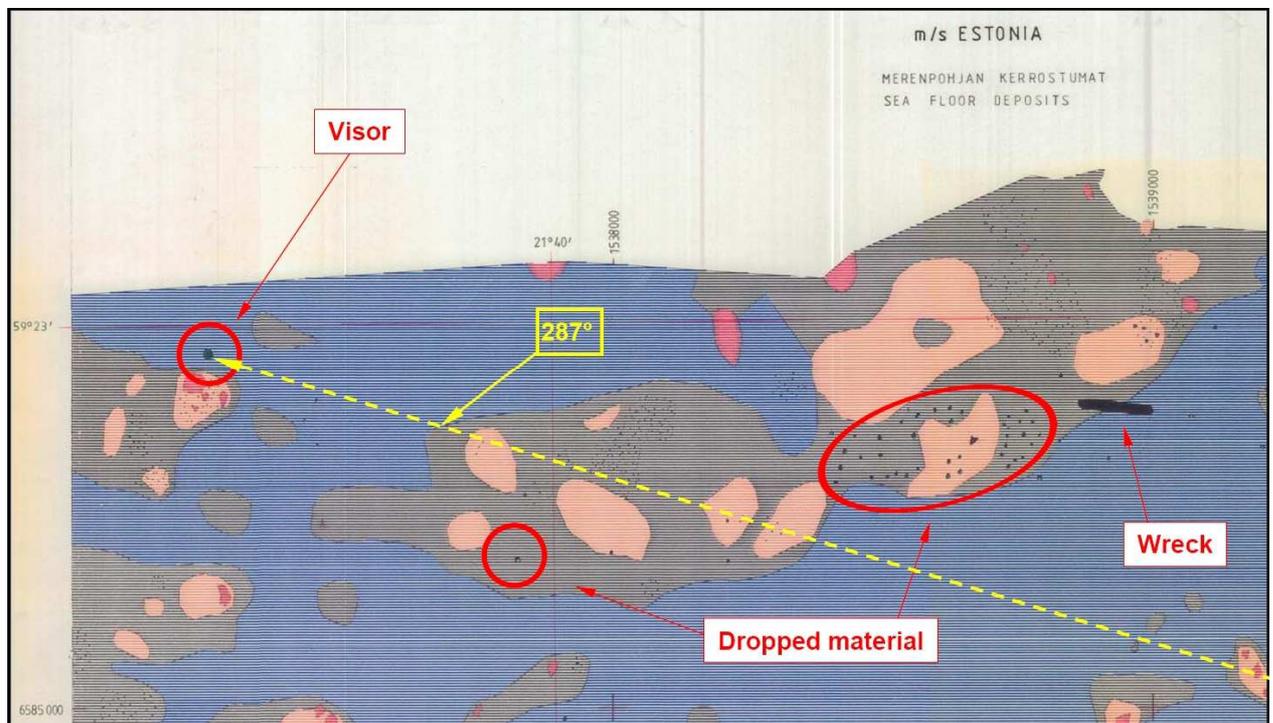
Figure 3.1: Map of the sea floor deposits based on sonar measurements in October 1994

A sonar scan and evaluation of Dr. Nuorteva of October 1994 shows the most probable sailing direction of MV Estonia was 287° , from the direction of (?) the visor about one nautical mile westerly of the wreck. See *Figure 3.1* with explanations of Dr. Valanto [HSVA02]. In between these two points, but significantly away of the most probable course, several remnants of the vessel were detected. The JAIC concluded a turn to starboard side after the loss of the visor, a reduction of velocity till finally the ferry was drifting due to wind and wave action [JAIC05].

The HSVA-consortium [HSVA02] and the SSPA-consortium [SSPA05] reconstructed the last turn of MV Estonia and both outcomes are very similar, but differs with the JAIC with a different time sequence. The basis of this reconstruction was the map of dropped material, *Figure 3.1*.

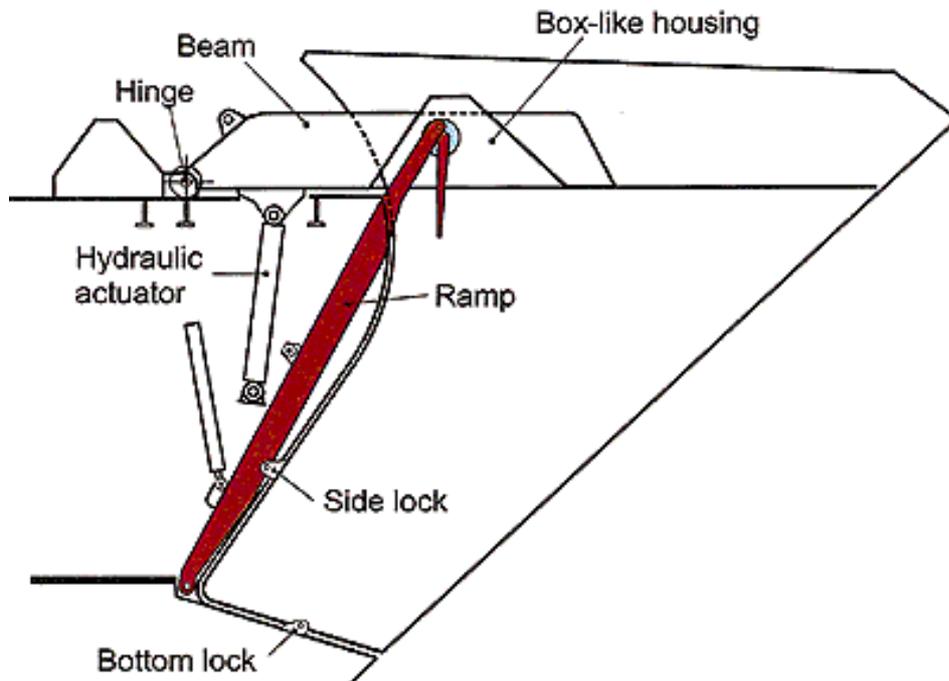
through three lugs. The arrangement of bow ramp and bow visor can be seen in Figure 3.2.

Figure 3.2: Arrangement of bow visor and bow ramp [JAIC03]

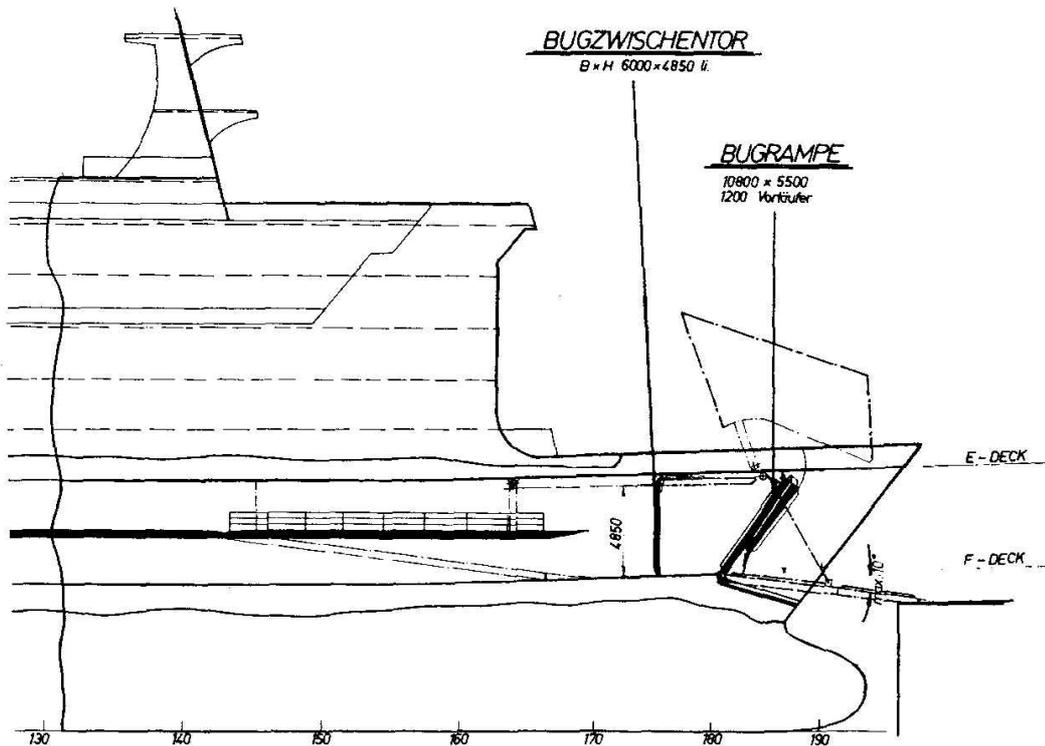
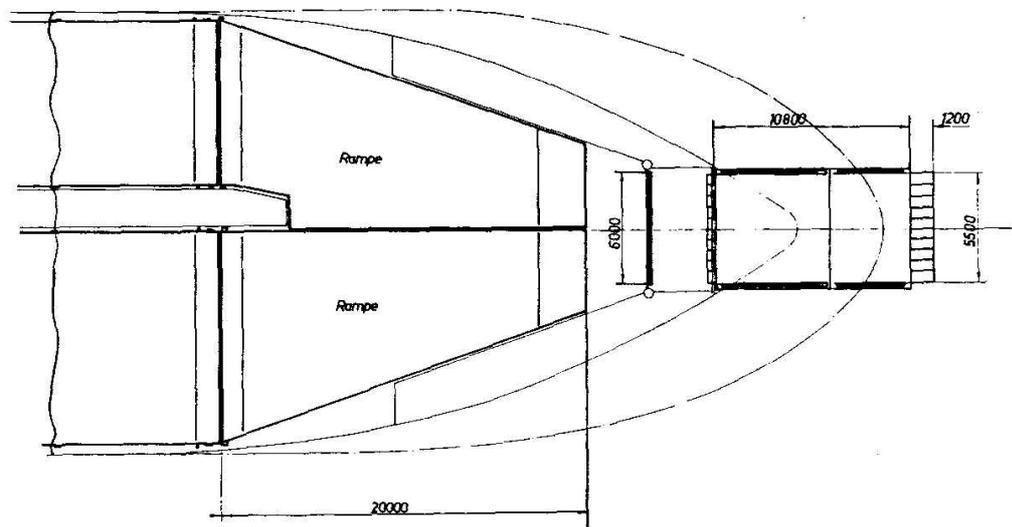
MV Olau Hollandia had a different bow visor and bow ramp arrangement: Her bow ramp was foldable and because of this, the 12m long bow ramp - including flaps - did not need a box-like housing [Hansa01]. This arrangement is shown in *Figure 3.9*. This means in case of a loss of the bow visor, it would be much less likely that the bow visor pulls open the bow ramp with it, as [CARLS01] explained for MV Estonia.

The collision bulkhead of MV Olau Hollandia has an upper extension from her Main Car Deck to the lowest deck of the superstructure. This can also be seen in *Figure 3.9*.³

Figure 3.9: Arrangement of bow visor and bow ramp on MV Olau Hollandia [HANSA01]

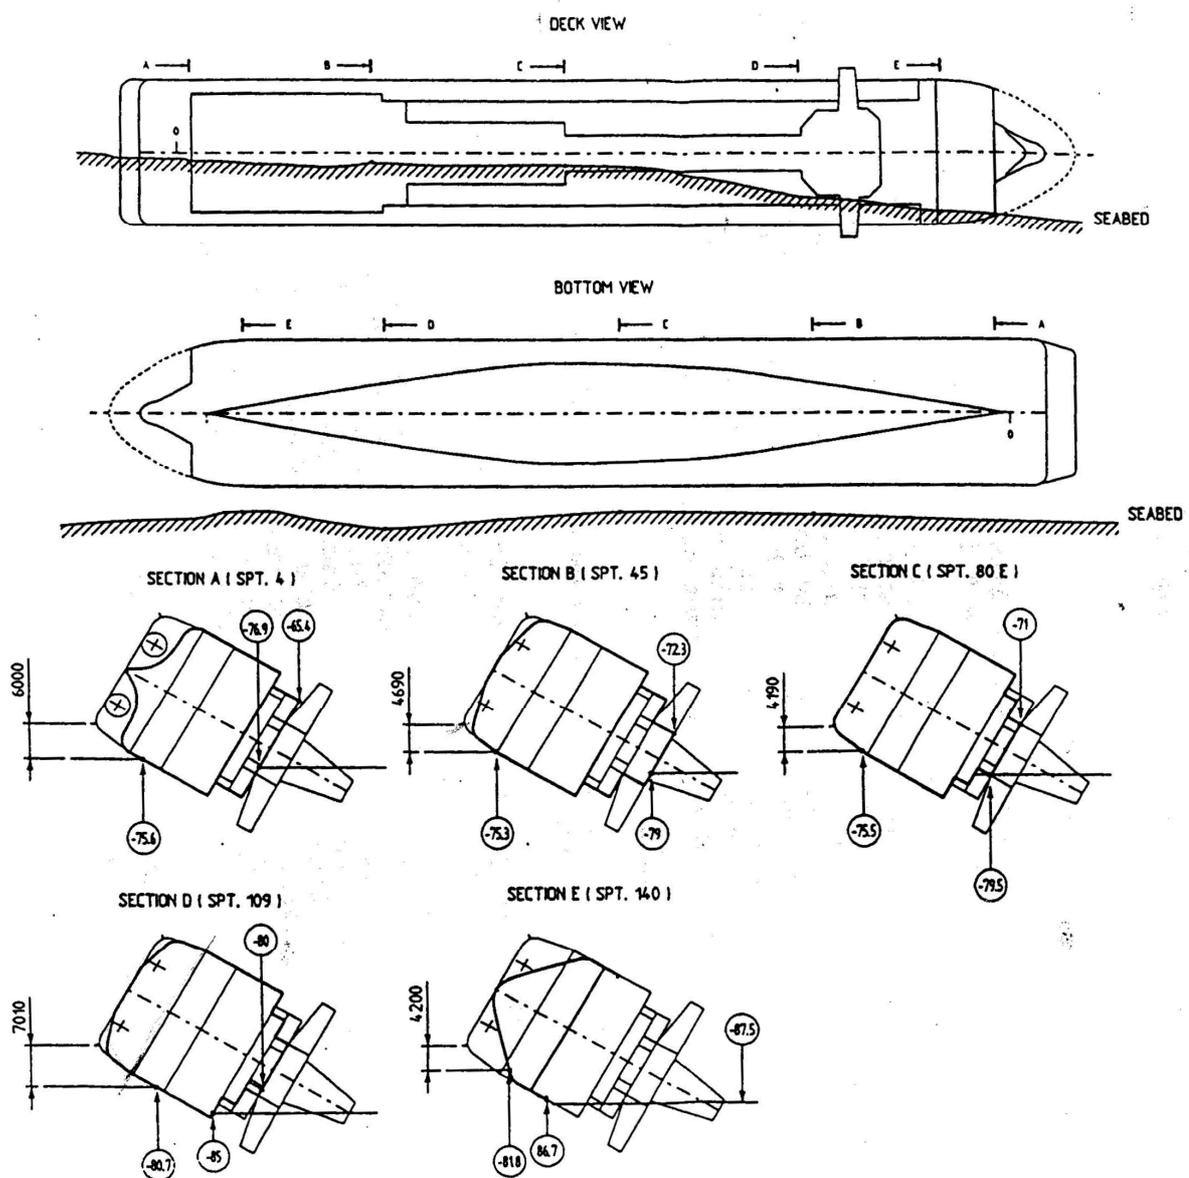
Figure 6.1: The position of MV Estonia on the seabed by [ROCK]

Figure 6.1 shows the position of MV Estonia on the seabed. It is noteworthy that the stern of MV Estonia is dug in the seabed nearly to centre line, but the bow is not. The bow area seems to be laid down on the seabed. The numbers in circles are the water depth in meters.

To answer the question of how MV Estonia hit the sea floor, different scenarios were developed. By the information provided by *Figure 6.1*, it is most likely that MV Estonia sank stern first and that the ferry hit the sea bottom with her starboard side. To exclude scenarios in which MV Estonia hits the sea bed portside or upside down, the available video tapes were analysed, looking for damage to the stern area of the vessel.

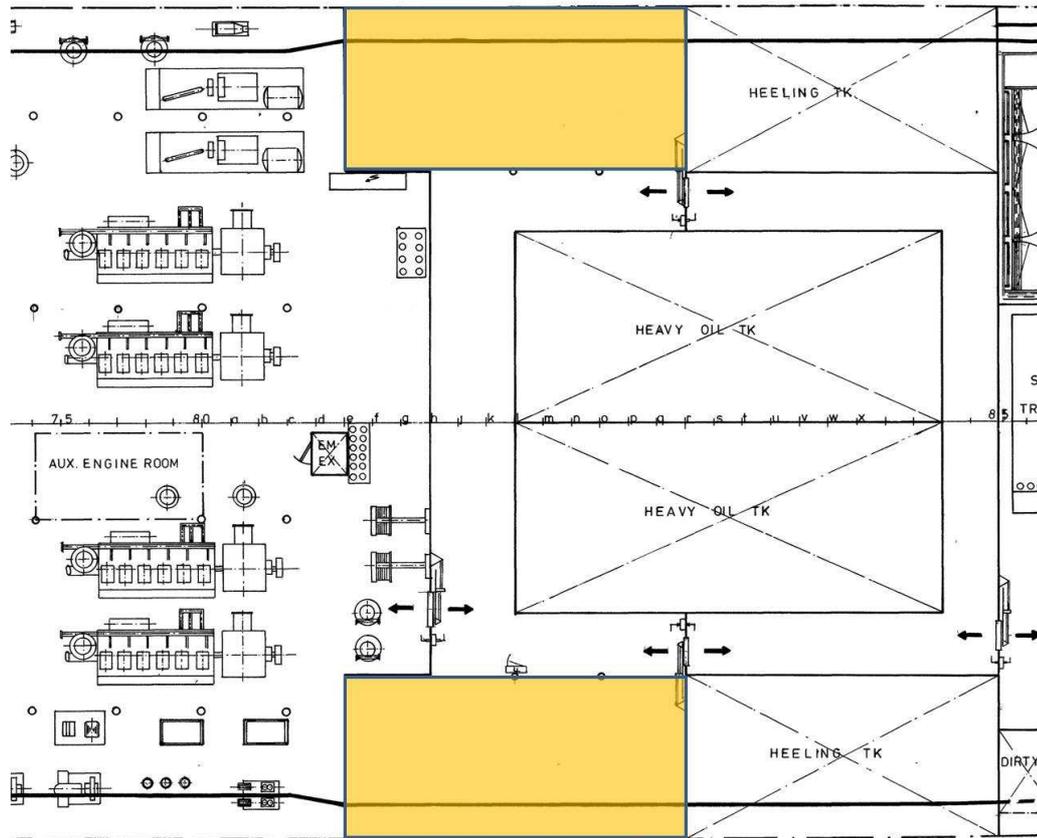
MV Estonia had two stabiliser fins, one on each side of the ship in the area between frames e and r, see *Figure 6.2*. According to the testimonies of crew members, the stabiliser fins were deployed at about 00:30, half an hour before the first heavy heel occurred. On the video-tape of the ROV-inspection of October 10th 1994, at time code 02:03, the port side stabiliser fin can be seen. The stabiliser is in its drawn-in position – into the ship's hull, see *Figure 6.3*. There is no obvious damage observed.

Figure 6.2: The position stabiliser fins of MV Estonia, frame e to r

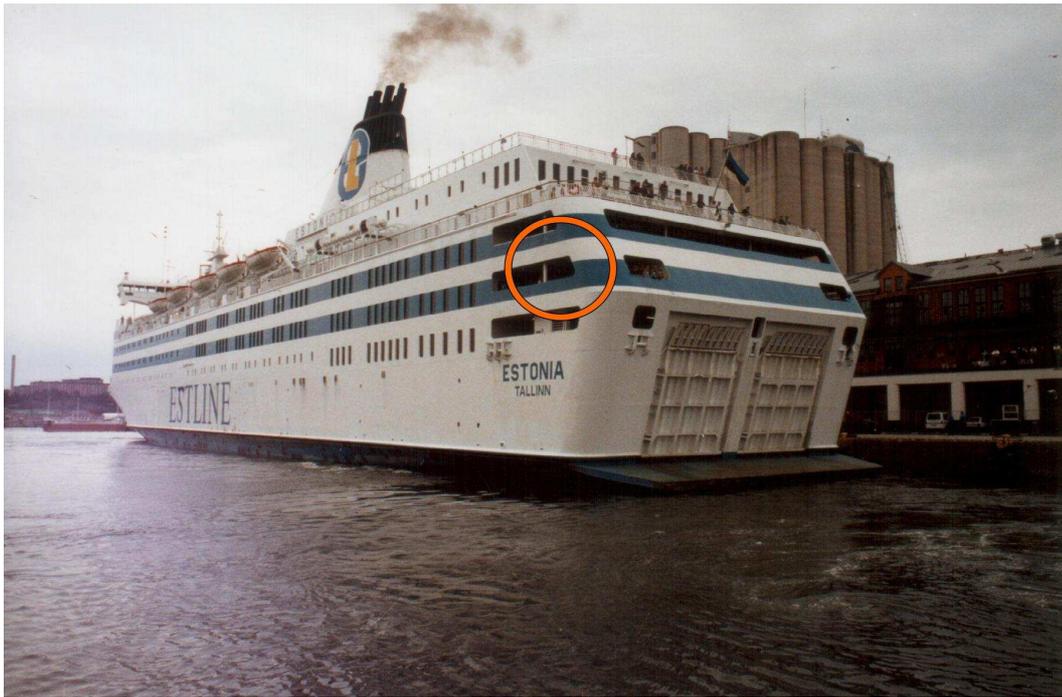
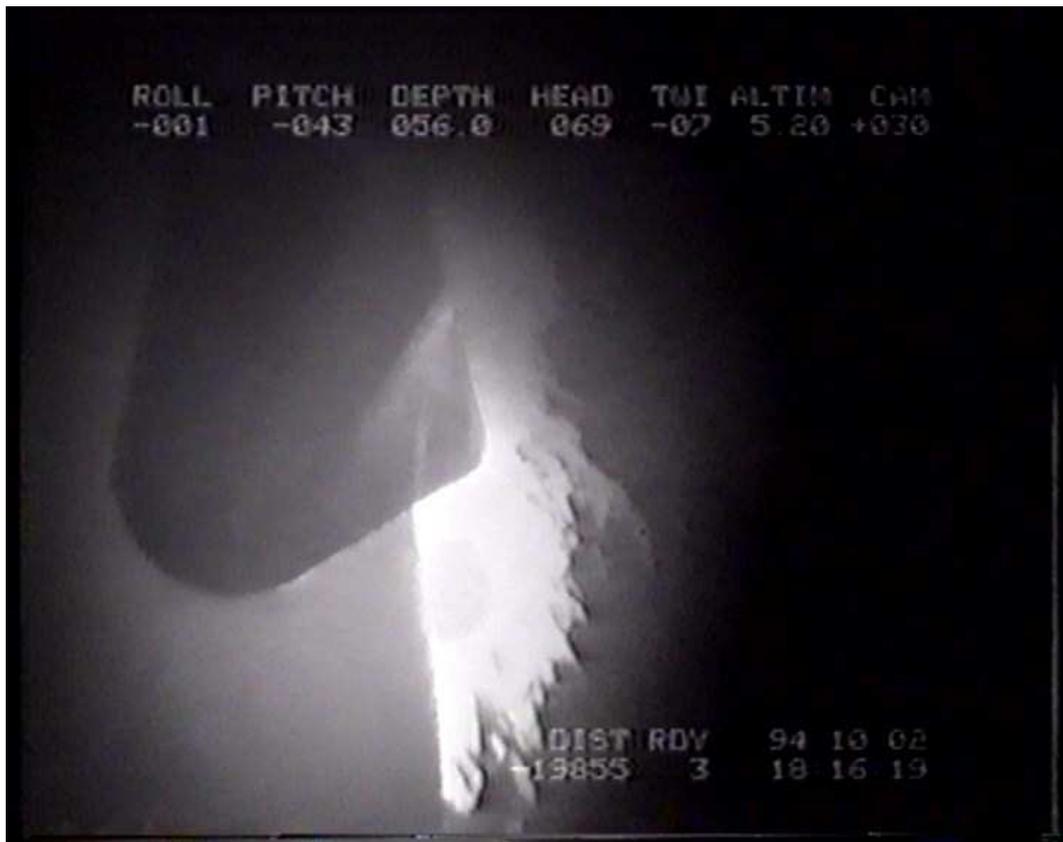
The following figures *Figure 6.9* to *Figure 6.19* show the stern area first on the port side, Deck 5 upwards to Deck 7 and on Deck 7 along the railing to the Centre Line and the stern lights. No obvious damage, no contorted stiffeners, no buckling in the shell plating nor even scratches in the coating are noted. Due to these observations, it is very unlikely that MV Estonia hit the sea floor with the stern part of her port side or in an upside-down position.

Figure 6.9: Stern view of MV Estonia, see Figure 6.10

Figure 6.10: Deck 5, stern from portside, for comparison, see Figure 6.9

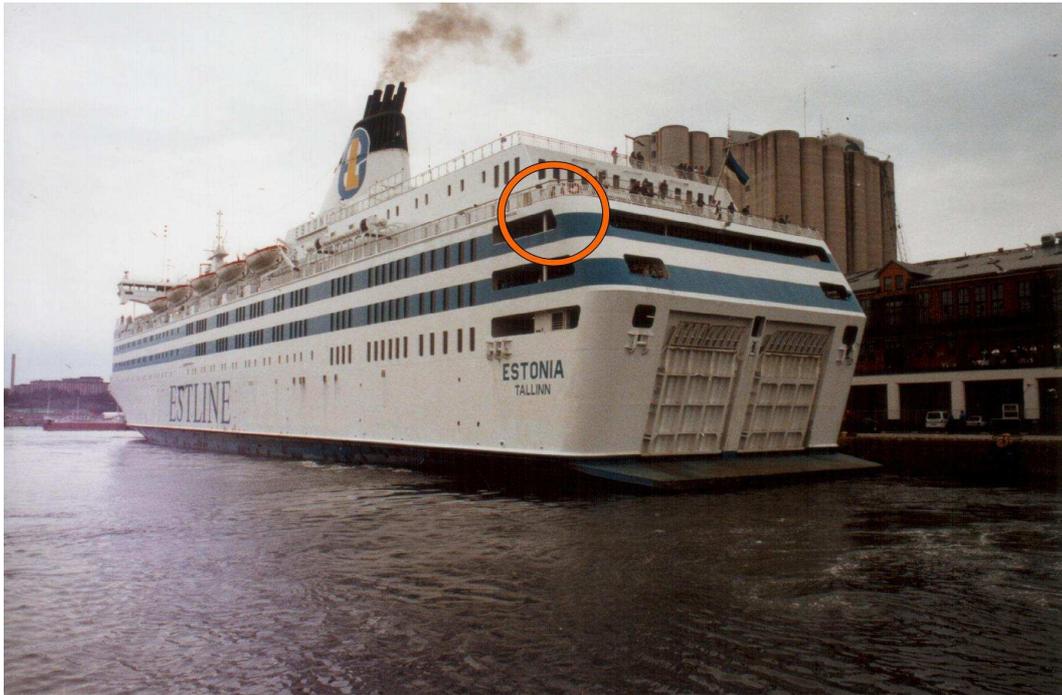
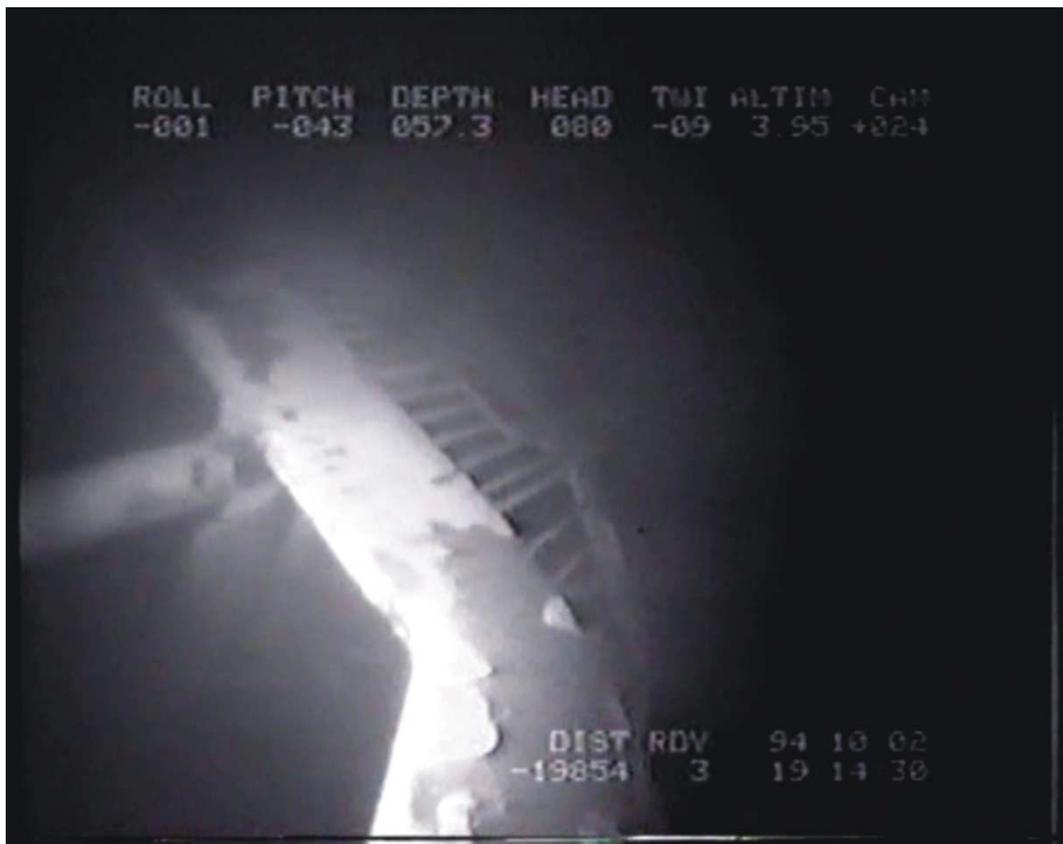
Figure 6.11: Stern view of MV Estonia, see Figure 6.12

Figure 6.12: Deck 6, Stern, Portside, compare Figure 6.11

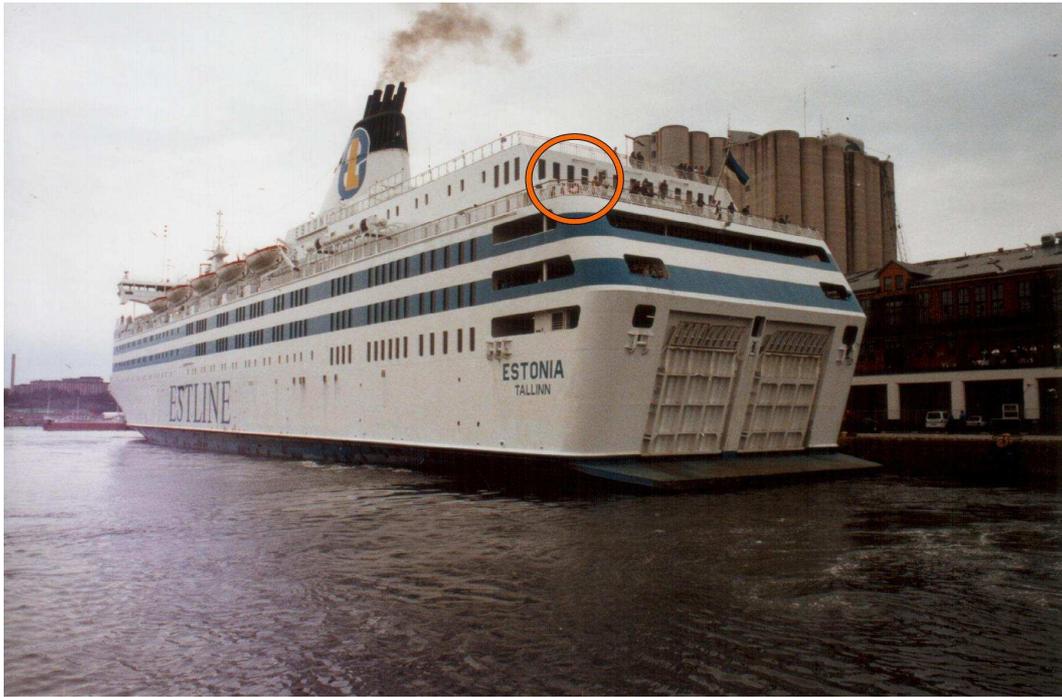
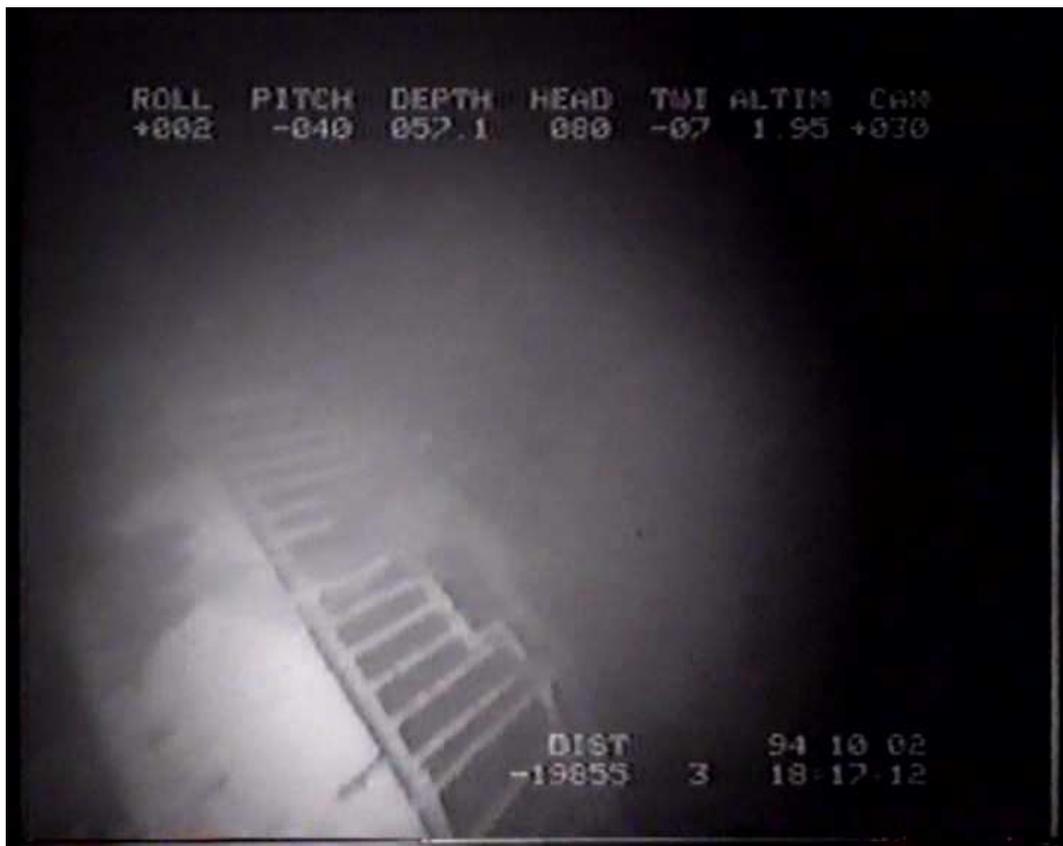
Figure 6.13: Stern View of MV Estonia, see Figure 6.14

Figure 6.14: Railing Deck 7 stern on portside, for comparison, see Figure 6.13

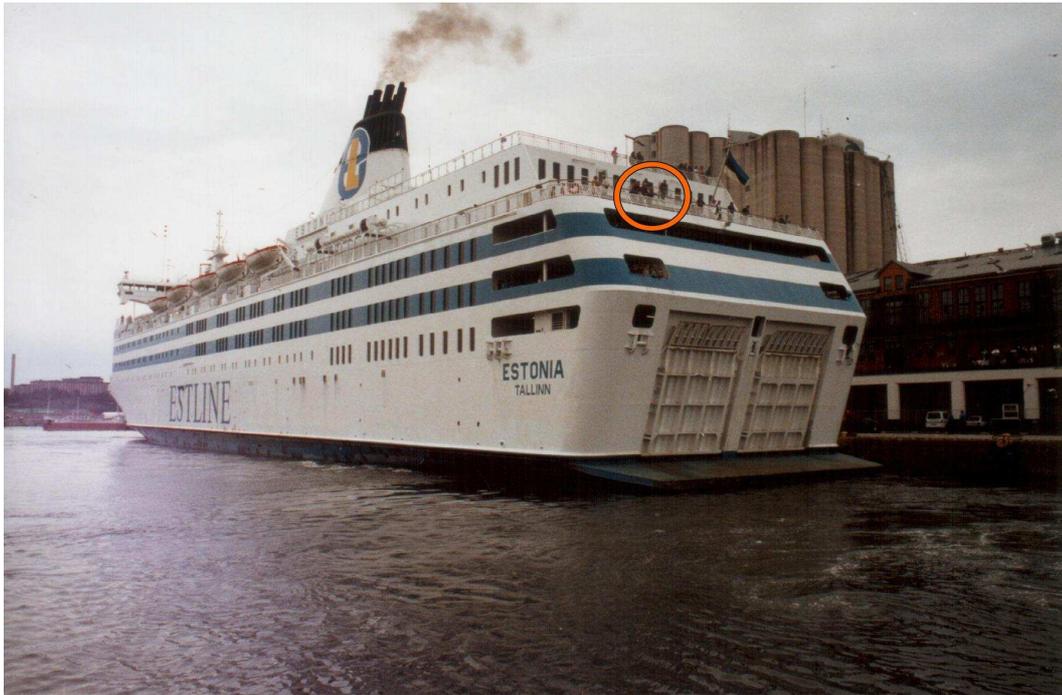
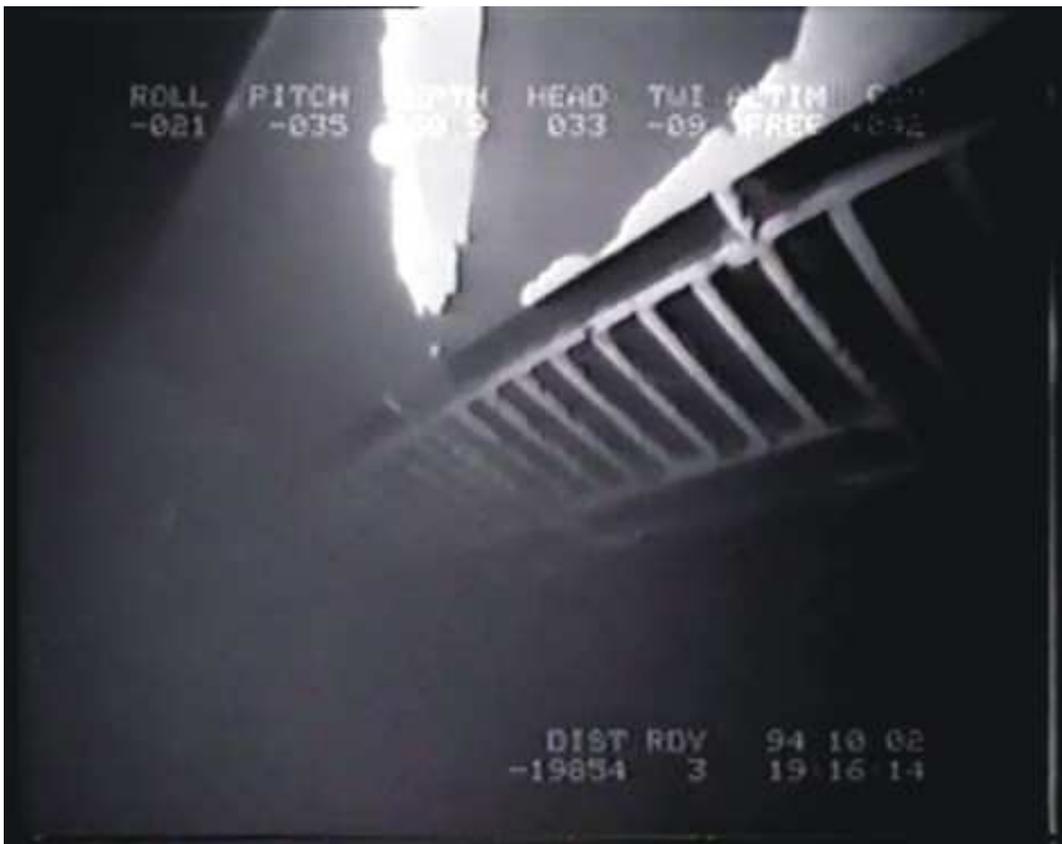
Figure 6.15: Stern view of MV Estonia, see Figure 6.16

Figure 6.16: Railing Deck 7, stern, compare with Figure 6.15

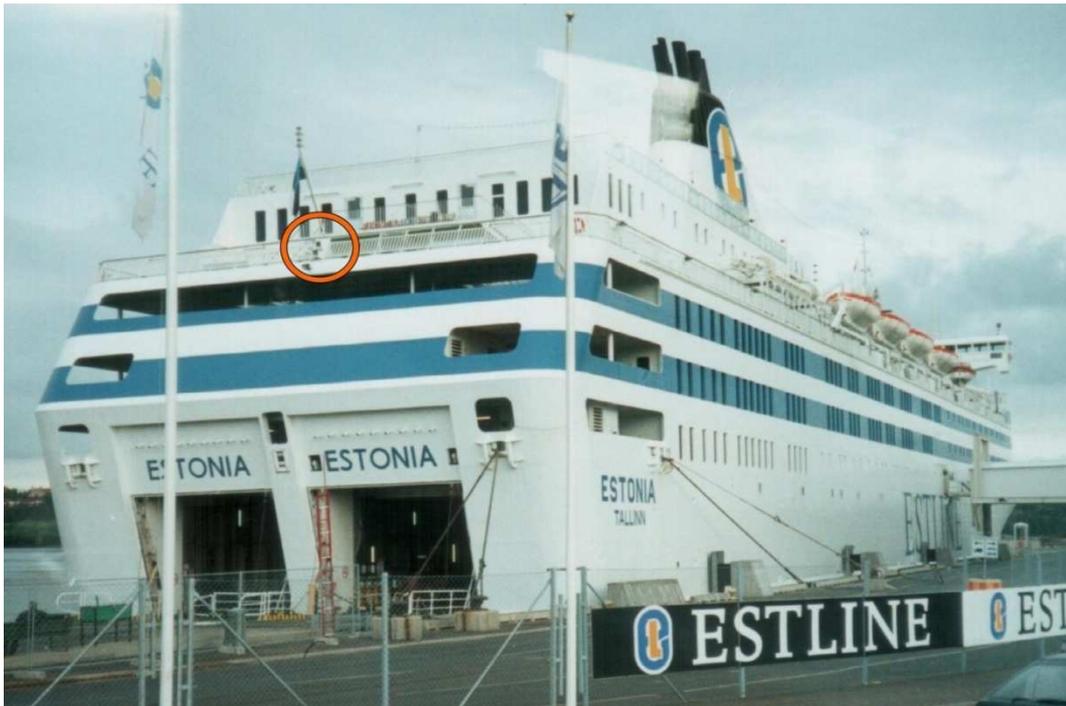
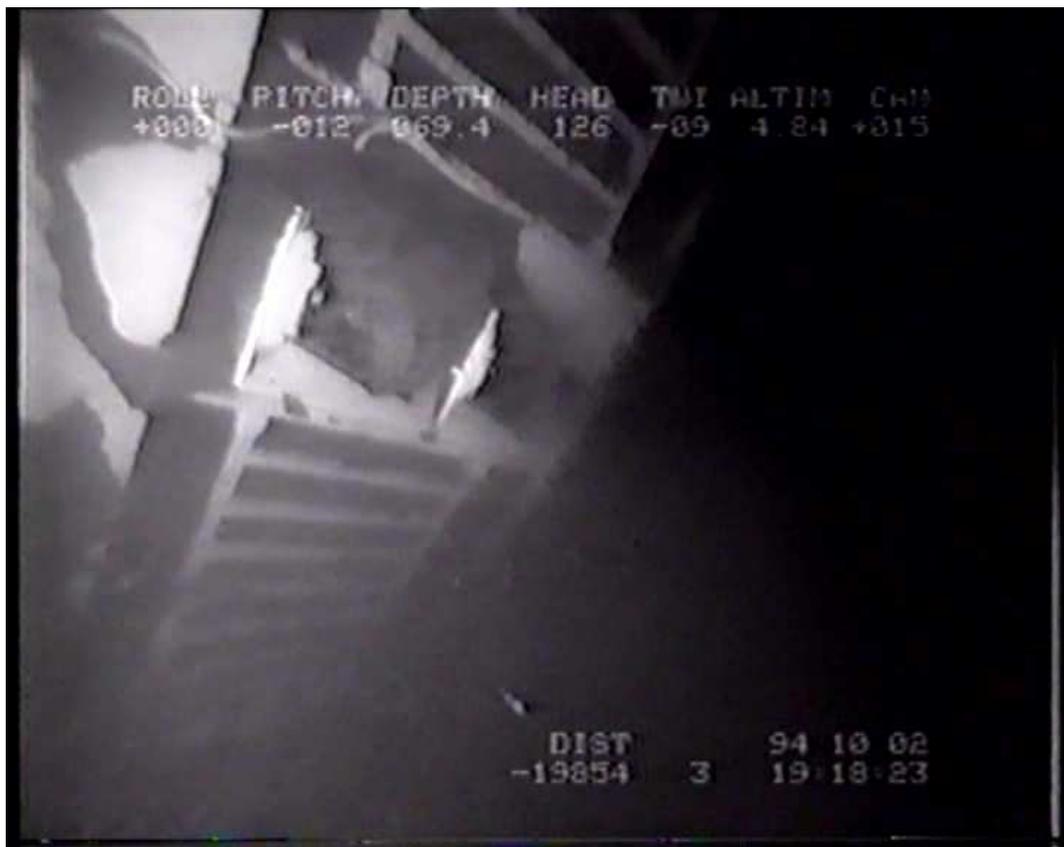
Figure 6.17: Stern view of MV Estonia, see Figure 6.18

Figure 6.18: Stern Light, Deck 7, compare with Figure 6.17

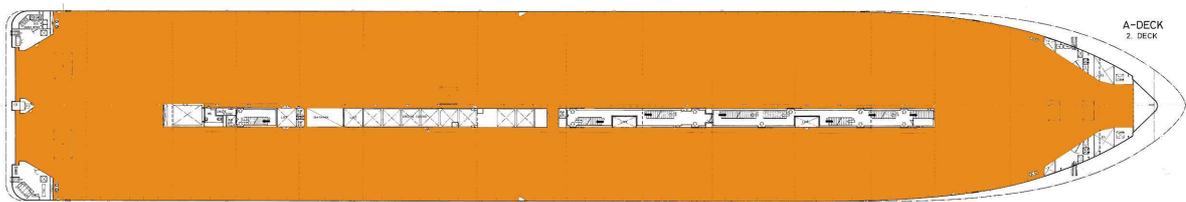
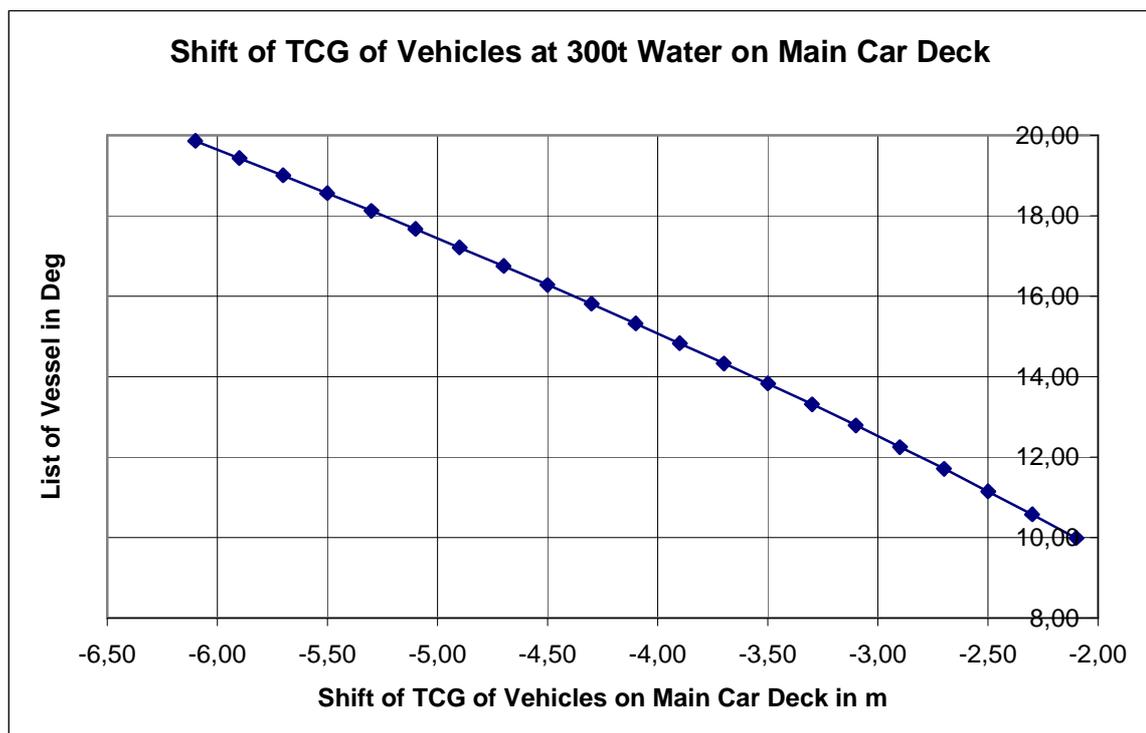
In scenario No.2, the amount of water on the Main Car Deck is set to 300t and kept constant during the whole calculation. The amount of 300t is chosen because 300t corresponds to a list of about 10° . At a list of 10° , a layman might feel uncomfortable or even concerned - with some objects with a low friction coefficient, like glasses on a smooth surface, starting to slide, as reported.

The transversal centre of gravity of the vehicles on Main Car Deck is moved in 0.2m steps from -2.1m from the centre line to starboard, up to -6.1m.

Figure 9.12: Scenario 2 – compartment under consideration

Figure 9.13: Shift of the TCG of vehicles, 300t water on Main Car Deck, shift over list

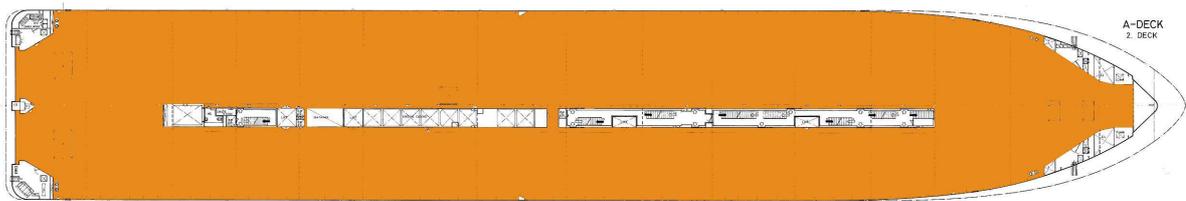
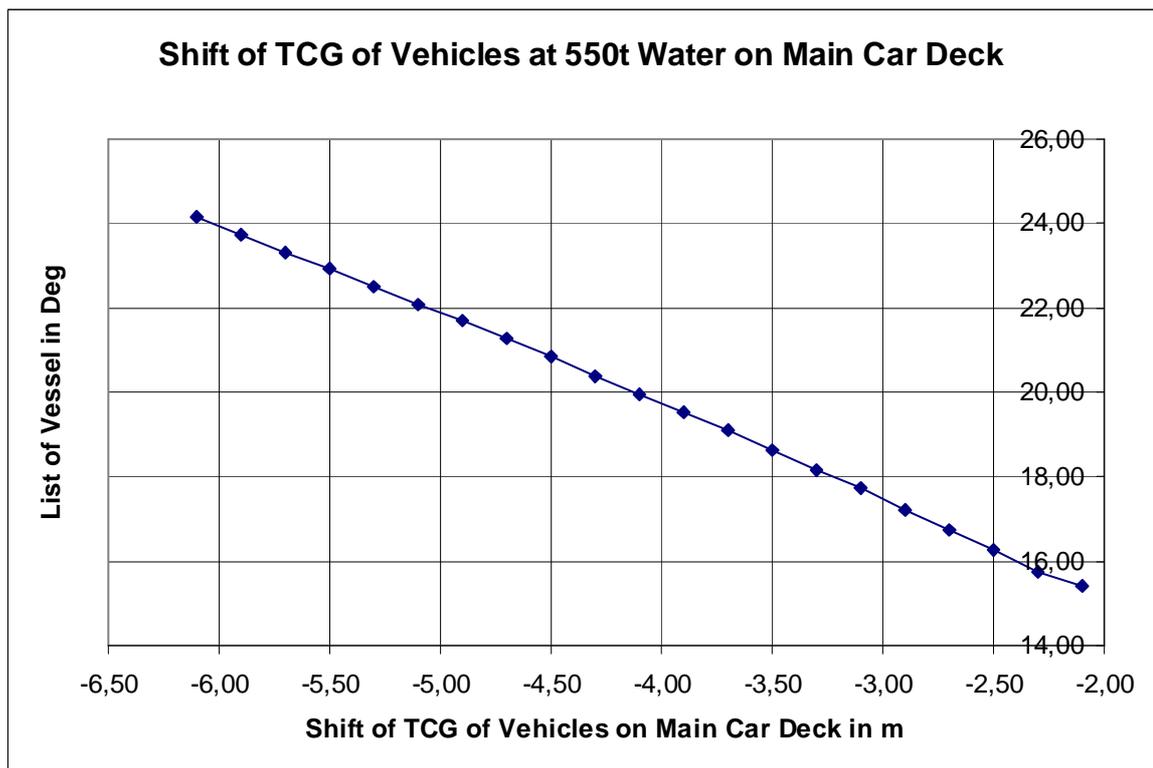
Scenario 3 is identical to 2 except for the fact that 550t of water are modelled to be on the Main Car Deck, which are also kept constant throughout this calculation. The amount of 550t on the Main Car Deck corresponds to a list of about 15°.

Figure 9.14: Scenario 3 – compartment under consideration

Figure 9.15: Shift of the TCG of vehicles, 550t water on Main Car Deck, shift over list

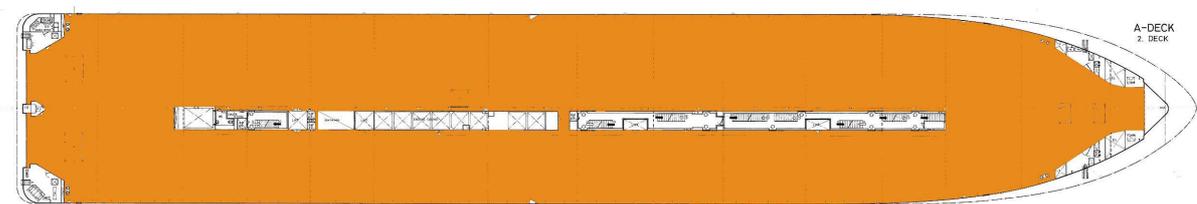
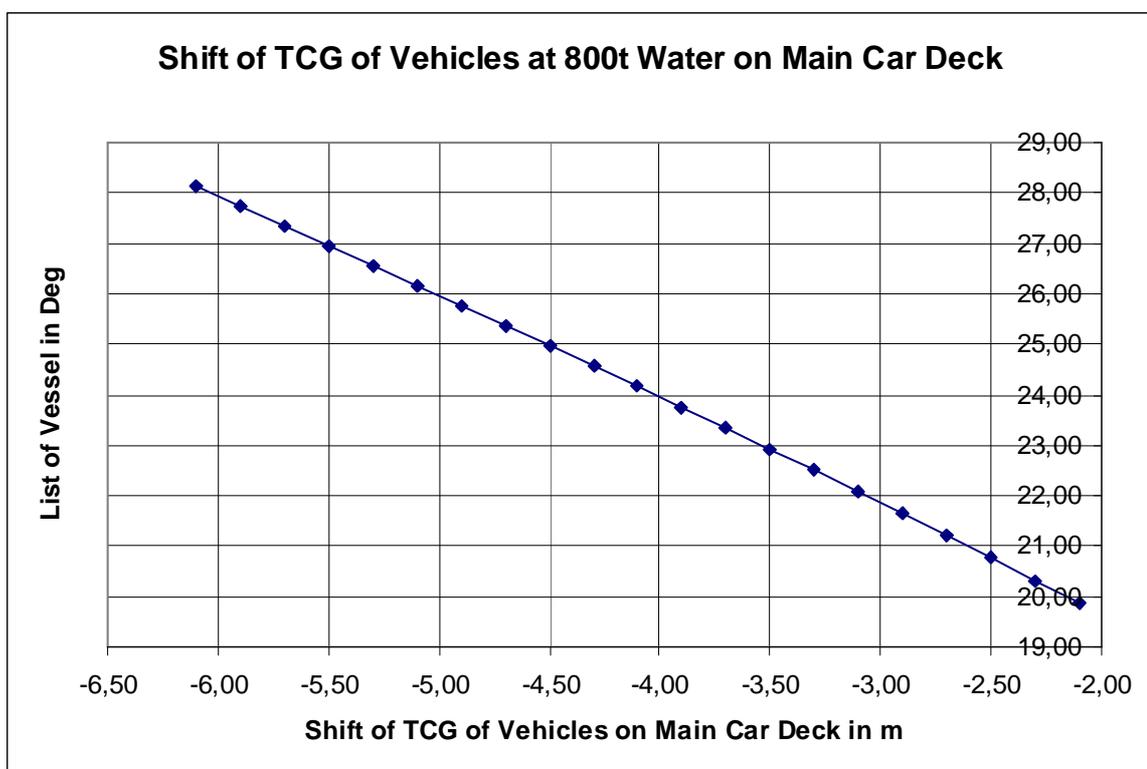
Scenario 4 is again identical to 2 except for the fact that 800t of water are modelled to be on the Main Car Deck, kept constant throughout this calculation. The amount of 800t water on the Main Car Deck corresponds to a list of about 20°.

Figure 9.16: Scenario 4 – compartment under consideration

Figure 9.17: Shift of the TCG of Vehicles, 800t water on Main Car Deck, shift over list

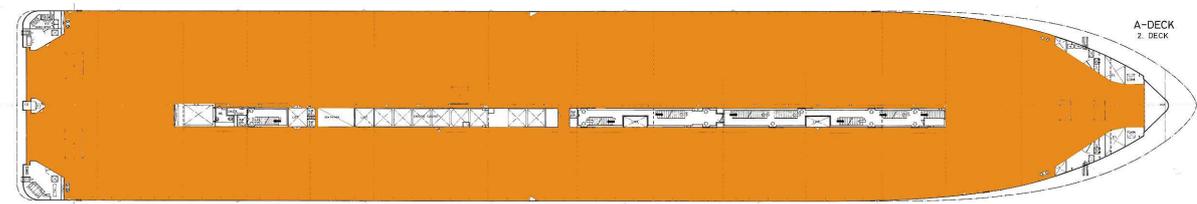
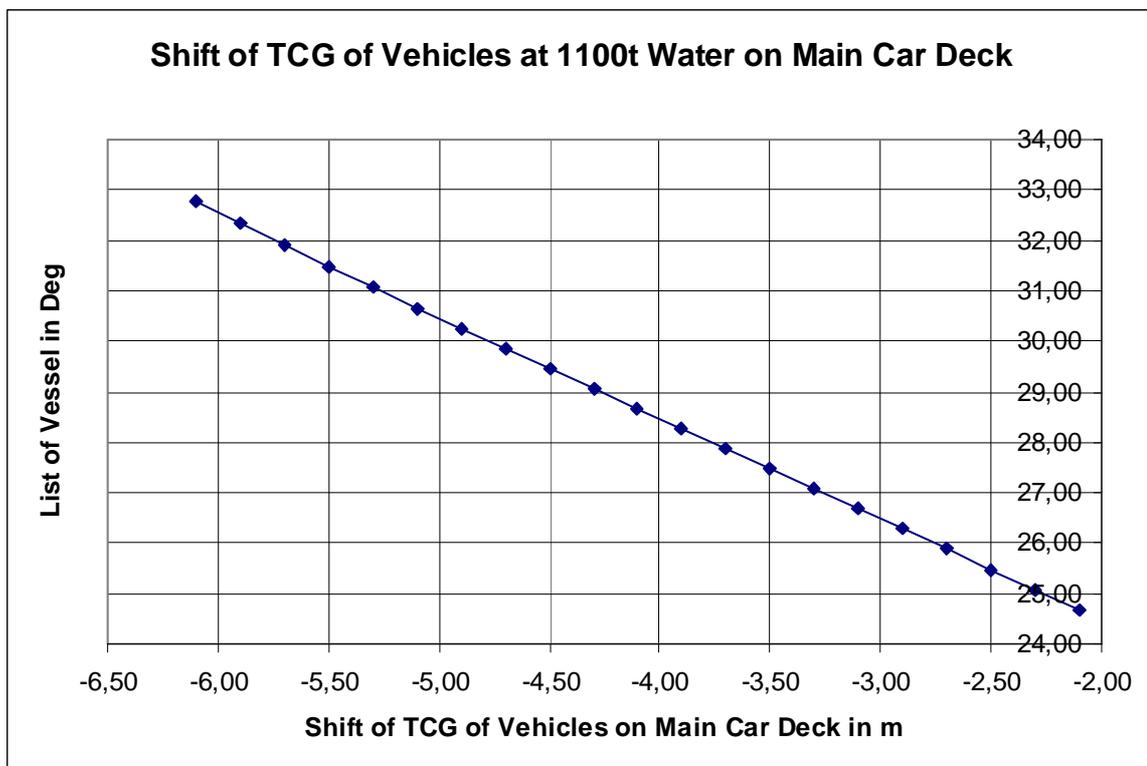
Scenario 5 is identical to 2 except for the fact that 1100t of water is modelled to be on the Main Car Deck, which are kept constant throughout this calculation. The amount of 1100t water on the Main Car Deck corresponds to a list of about 25°.

Figure 9.18: Scenario 5 – compartment under consideration

Figure 9.19: Shift of the TCG of Vehicles, 1100t water on Main Car Deck, shift over list

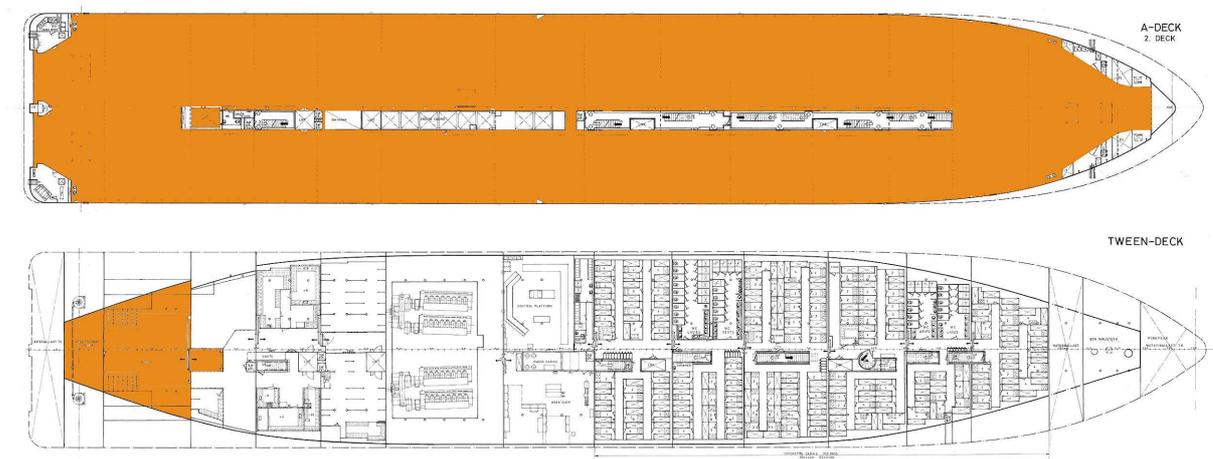
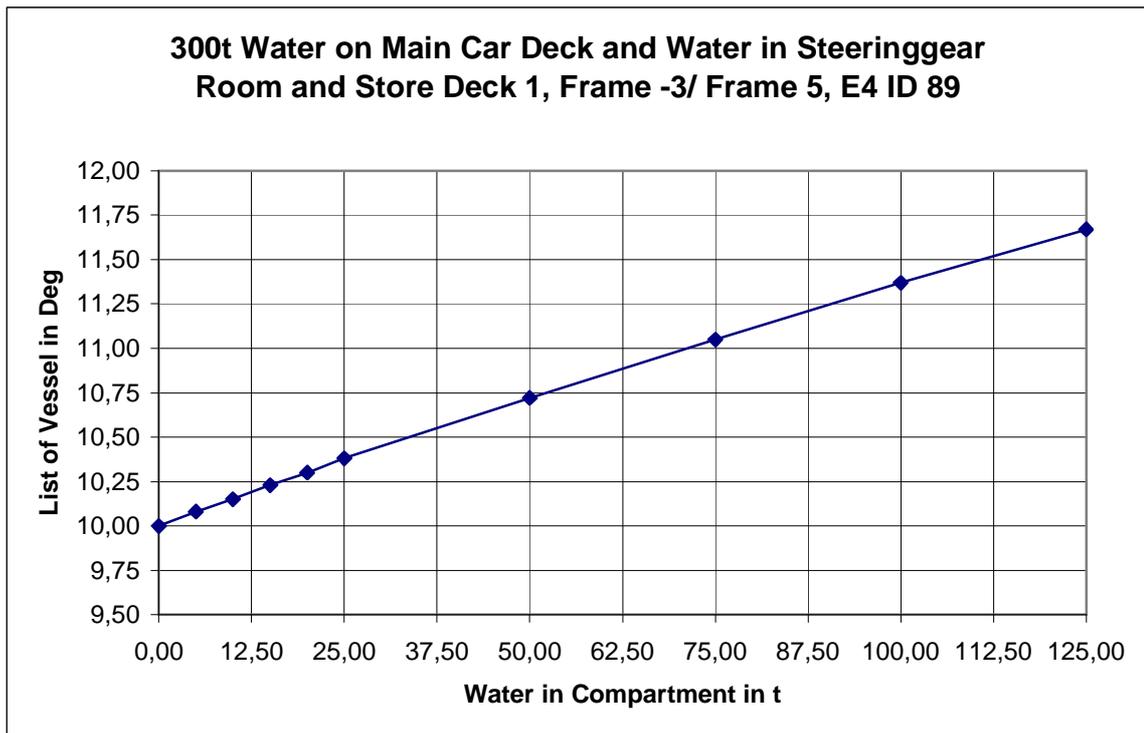
In Scenario 6 a mass of 300t of water on the Main Car Deck is modelled and this mass is kept constant. In addition to the water on the Main Car Deck water is modelled also to be in a lower compartment, the Steering Gear Room, which starts in frame –3, and the store of Tween Deck, beginning at frame 5. The calculation is carried out with the mass of water in these compartments increasing in 5t steps up to 25t and then in 25t steps to 125t.

In order for this scenario to take place, the water may enter the considered compartment by the cargo lift, beginning at frame 23. The TCG of vehicles on Main Car Deck is kept fixed at –2.1m.

Figure 9.20: Scenario 6 – compartments under consideration

Figure 9.21: Water in compartment 89 and 300t water on Main Car Deck, mass over list

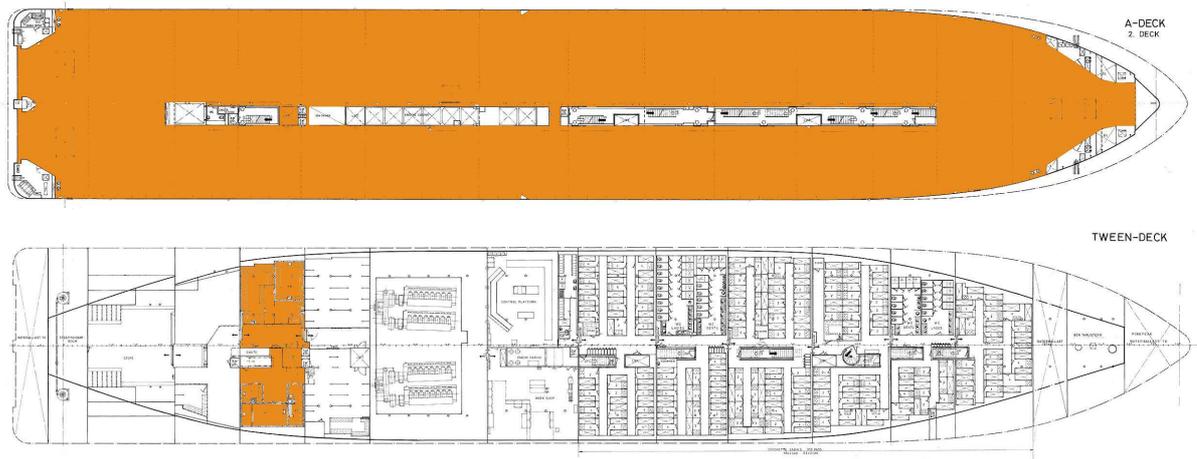
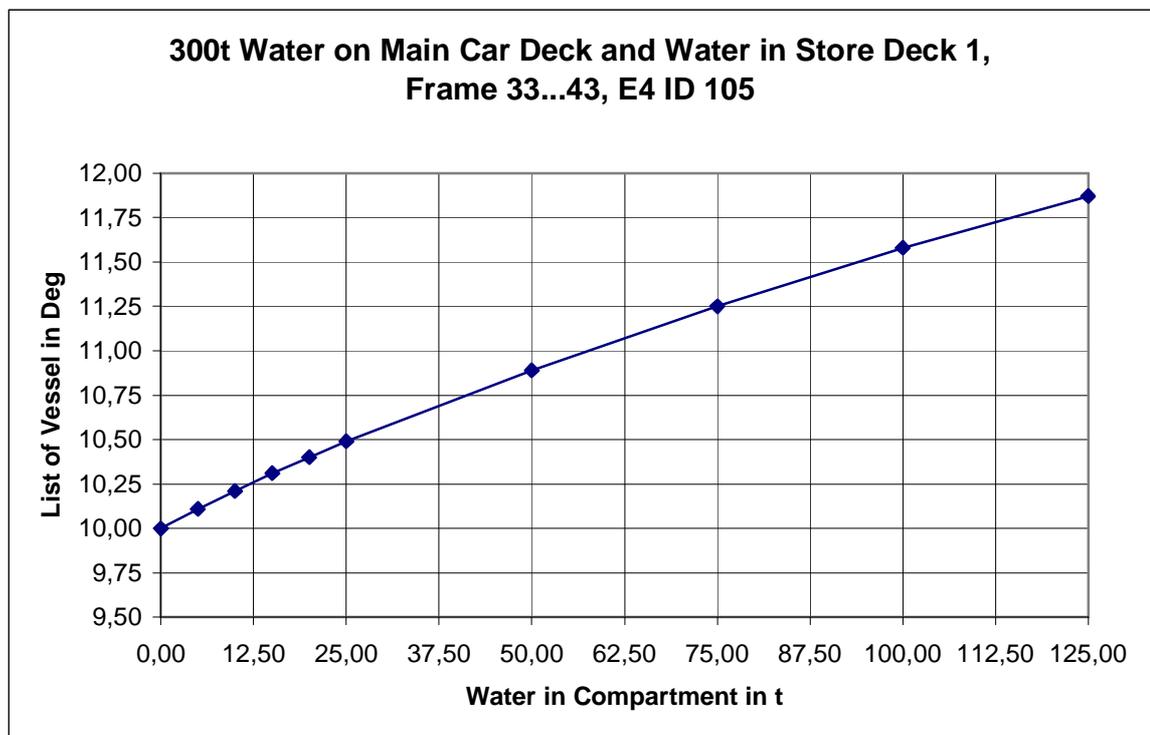
In order for this scenario to take place, water may enter the compartment by the lift beginning at frame 39.5. The TCG of vehicles on Main Car Deck is kept fixed at – 2.1m.

Figure 9.22: Scenario 7 – compartments under consideration

Figure 9.23: Water in compartment 105 and 300t water on Main Car Deck, mass over list
