The Sinking Sequence of MV Estonia

Dem Promotionsausschuss der
Technischen Universität Hamburg-Harburg
zur Erlangung des akademischen Grades
Doktor-Ingenieur (Dr.-Ing.)
genehmigte Dissertation

This thesis reconstructs the sinking of the RoPax Ferry MV Estonia on September 28th 1994, with a strong focus on describing the chain of events that caused the eventual sinking, and how the ship sank. Once the sinking is understood, this thesis explores possible safety improvements that should be implemented in the design of new vessels of this type. The investigation is based on a combination of testimonies of survivors as well as numerical calculations based on the framework of the testimonies.

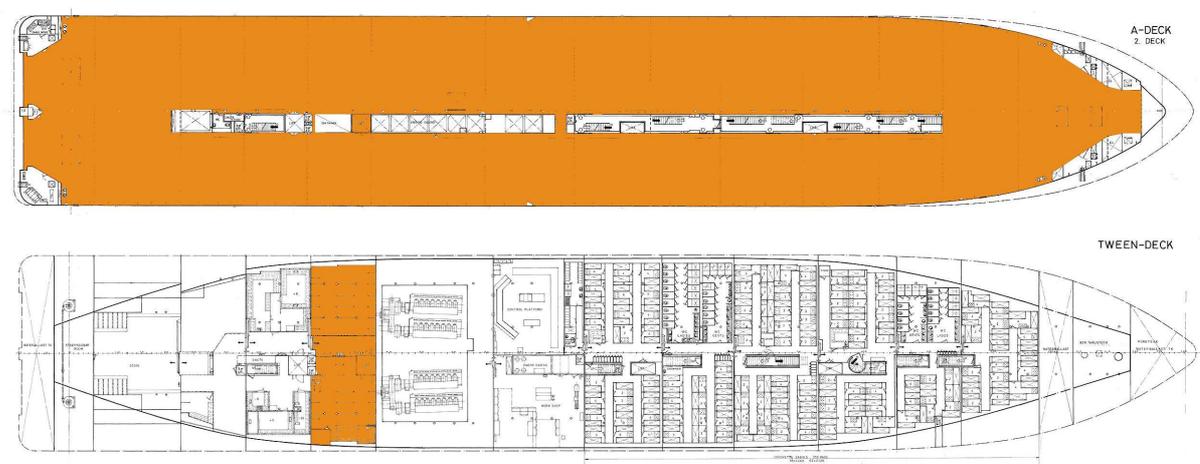
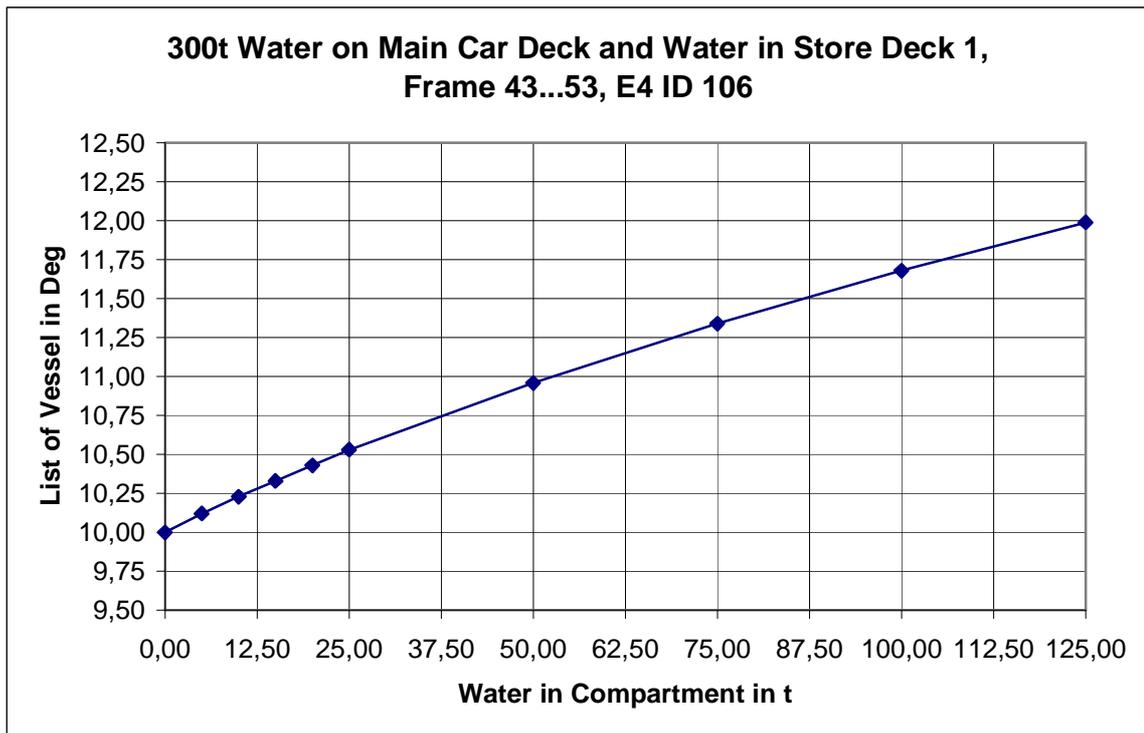
Scenario 8 is again similar to scenario 6 – a mass of 300t of water on Main Car Deck is assumed and this mass is kept constant.. The compartment under consideration is the store, beginning in frame 43, ending at frame 53 with the amount of water in the store increasing in 5t steps up to 25t and then in 25t steps to 125t of water, as in scenario 6. In order for this scenario to take place, water may enter the compartment by the lift beginning at frame 50. The TCG of vehicles on Main Car Deck is kept fixed at -2.1m .

Figure 9.24: Scenario 8 – compartments under consideration

Figure 9.25: Water in compartment 106 and 300t water on Main Car Deck, mass over list

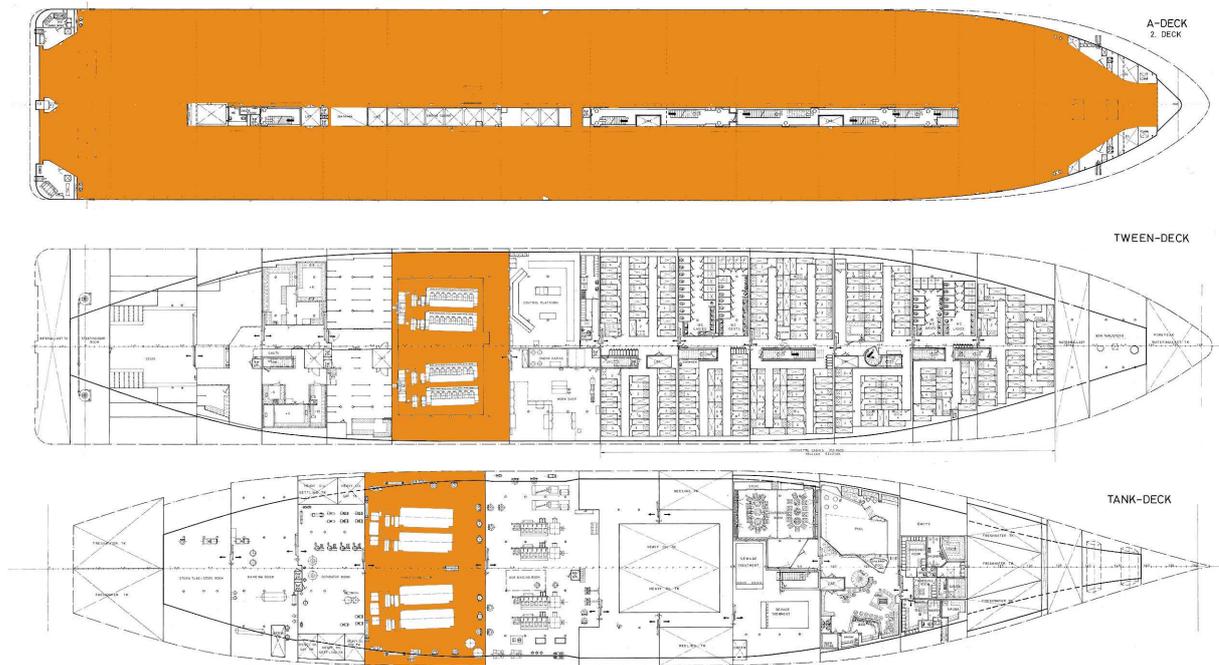
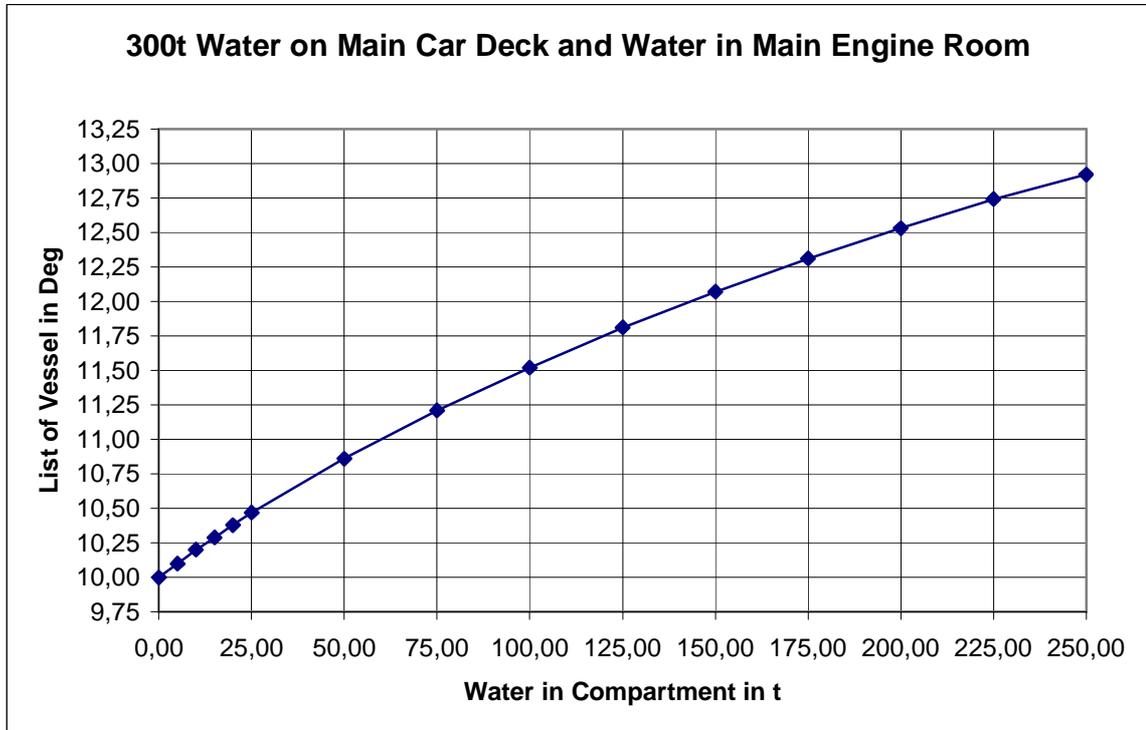
In this scenario, water enters the Main Engine Room through the air ducts. The TCG of vehicles on Main Car Deck is kept fixed at -2.1m .

Figure 9.26: Scenario 9 – compartments under consideration

Figure 9.27: Water in Main Engine Room, 300t water on Main Car Deck, mass over list

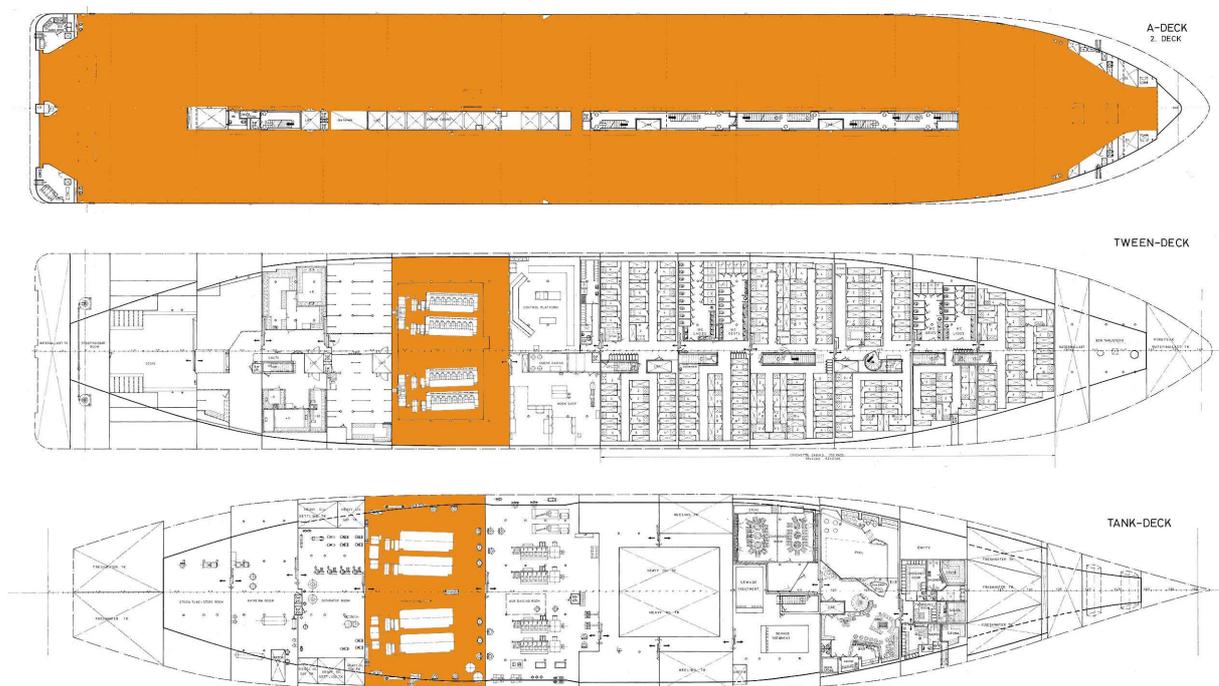
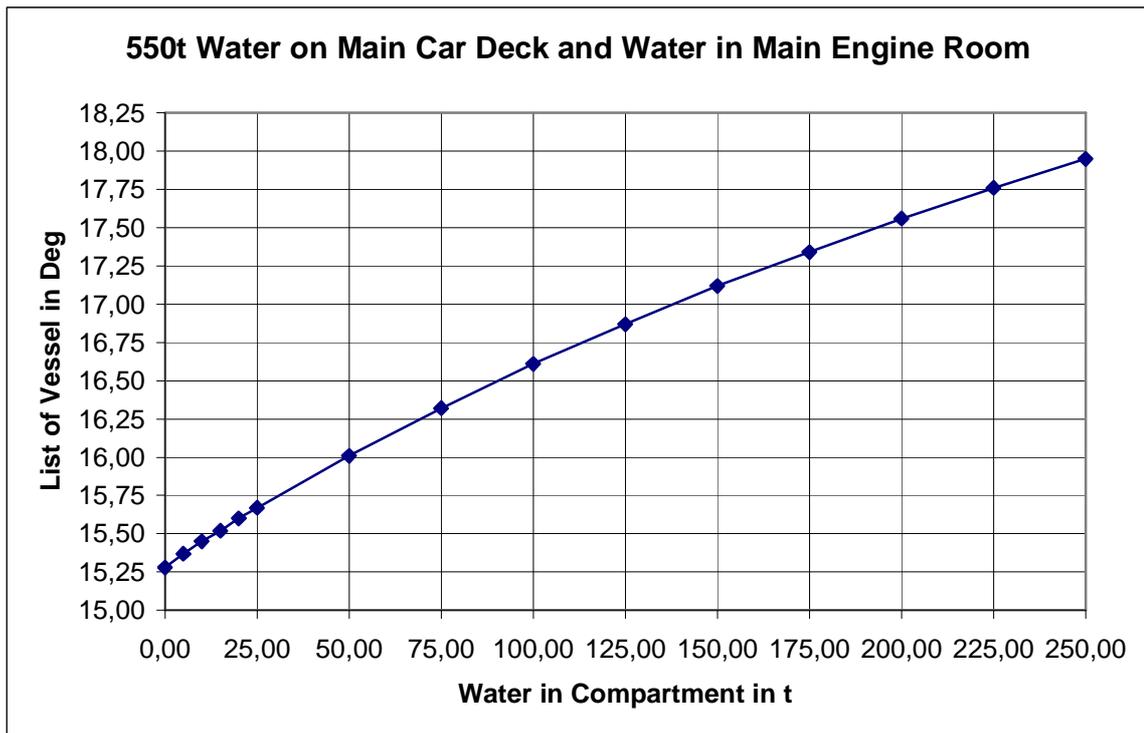
Scenario 10 is completely identical to scenario 9, except the amount of water on the Main Car Deck is 550t, and this mass is kept constant. In addition to the water on Main Car Deck, the flooding of the Main Engine Room is considered. The calculation is carried out with the water in the Main Engine Room increasing in 5t steps up to 25t and then in 25t steps to 250t of water.

In this scenario, water enters the Main Engine Room through the air ducts. The TCG of vehicles on Main Car Deck is kept fixed at -2.1m

Figure 9.28: Scenario 10 – Compartments under consideration

Figure 9.29: Water in Main Engine Room, 550t water on Main Car Deck, mass over list

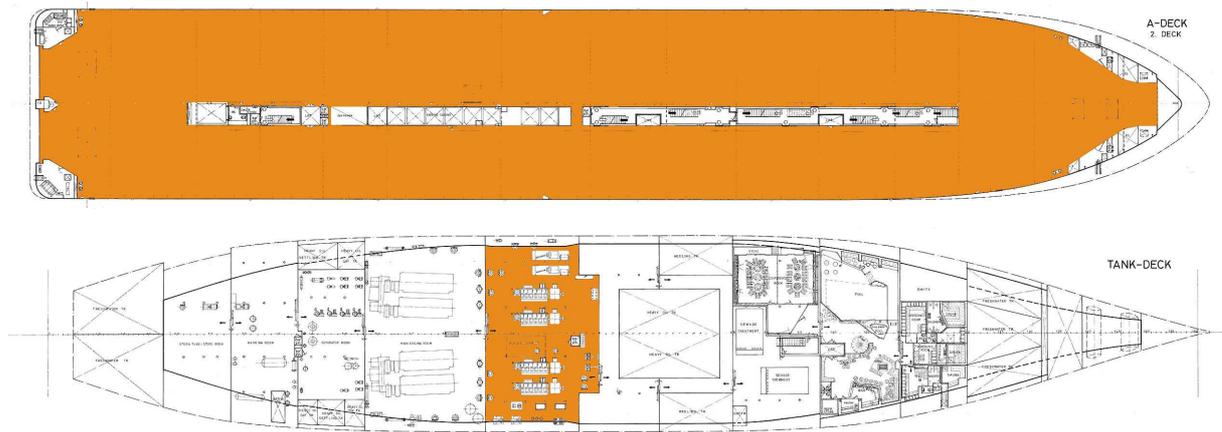
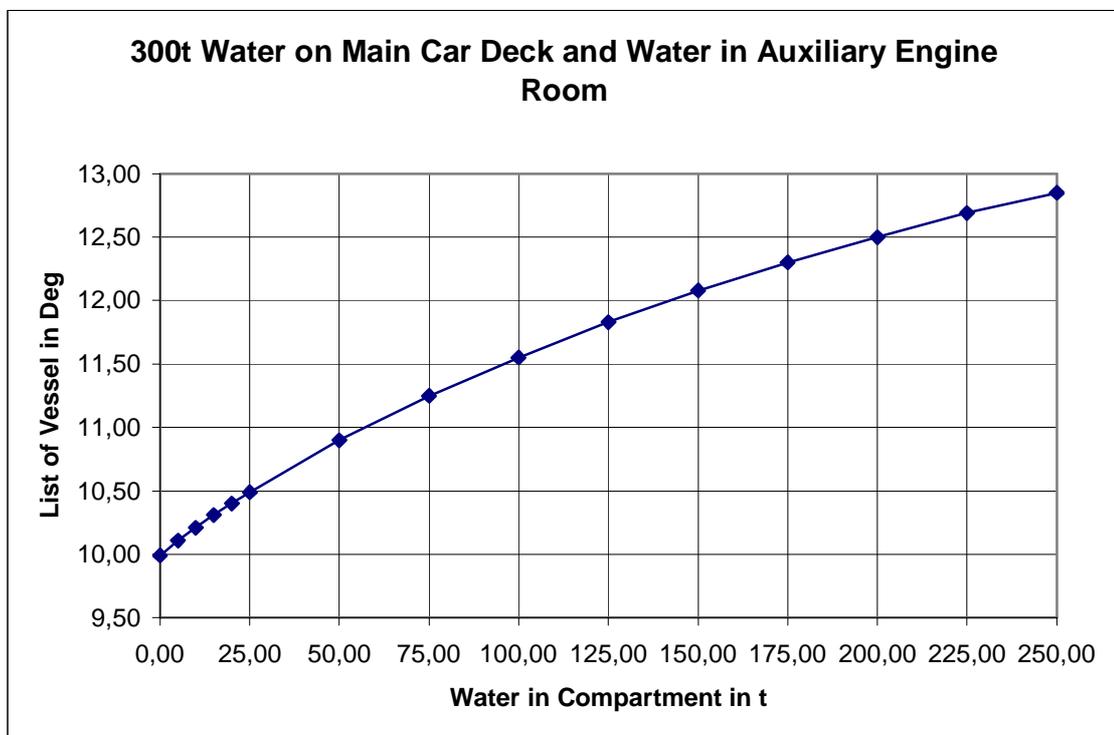
In this scenario, the water enters the Auxiliary Engine Room through the air ducts. The TCG of vehicles on Main Car Deck is kept fixed at -2.1m .

Figure 9.30: Scenario 11 – Compartments under consideration

Figure 9.31: Water in Auxiliary Engine Room, 300t water on Main Car Deck, mass over list

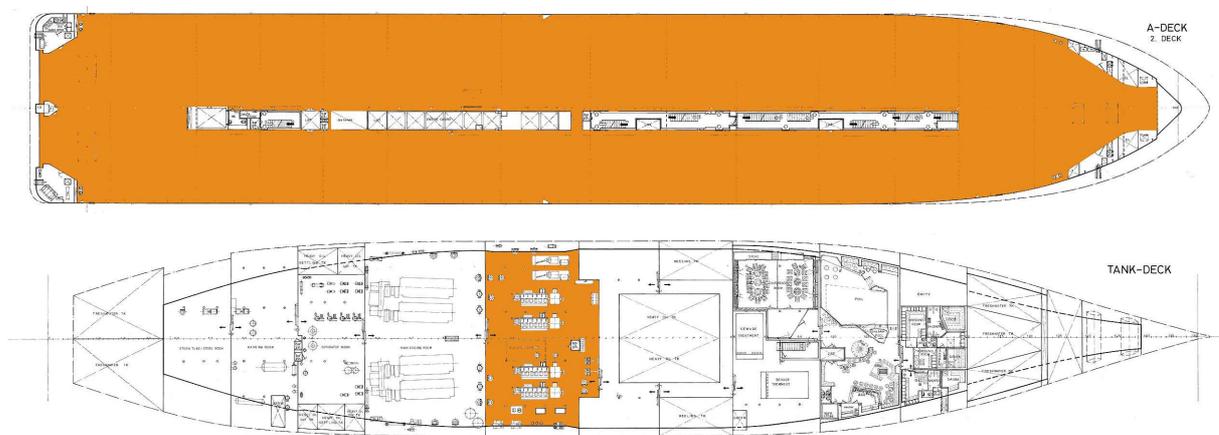
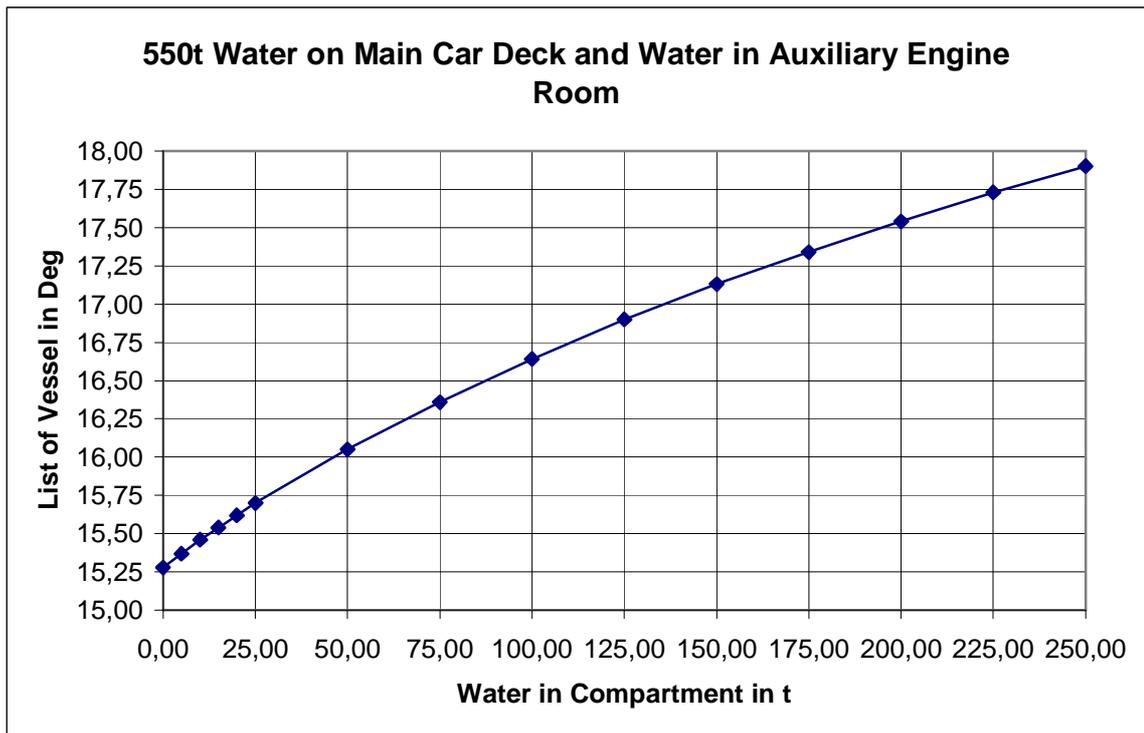
Scenario 12 is exactly the same as scenario 11, except the mass of water on the Main Car Deck is now 550t and this mass is kept constant. In addition to the water on Main Car Deck, the flooding of the Auxiliary Engine Room is considered. The calculation is carried with the water in the Auxiliary Engine Room increasing in 5t steps up to 25t and then in 25t steps to 250t of water.

In this scenario, the water enters the Auxiliary Engine Room through the air ducts. The TCG of vehicles on Main Car Deck is kept fixed at -2.1m .

Figure 9.32: Scenario 12 – Compartments under consideration

Figure 9.33: Water in Auxiliary Engine Room, 550t water on Main Car Deck, mass over list

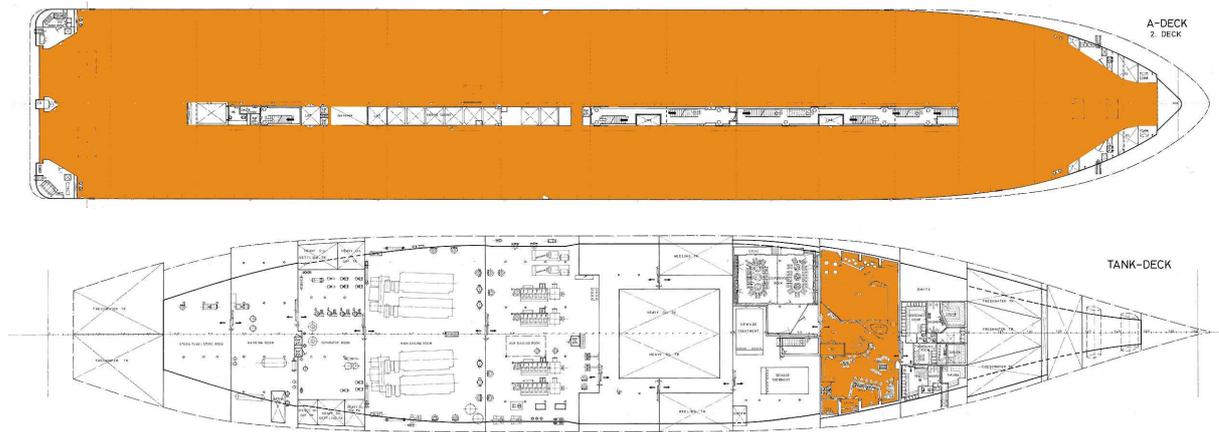
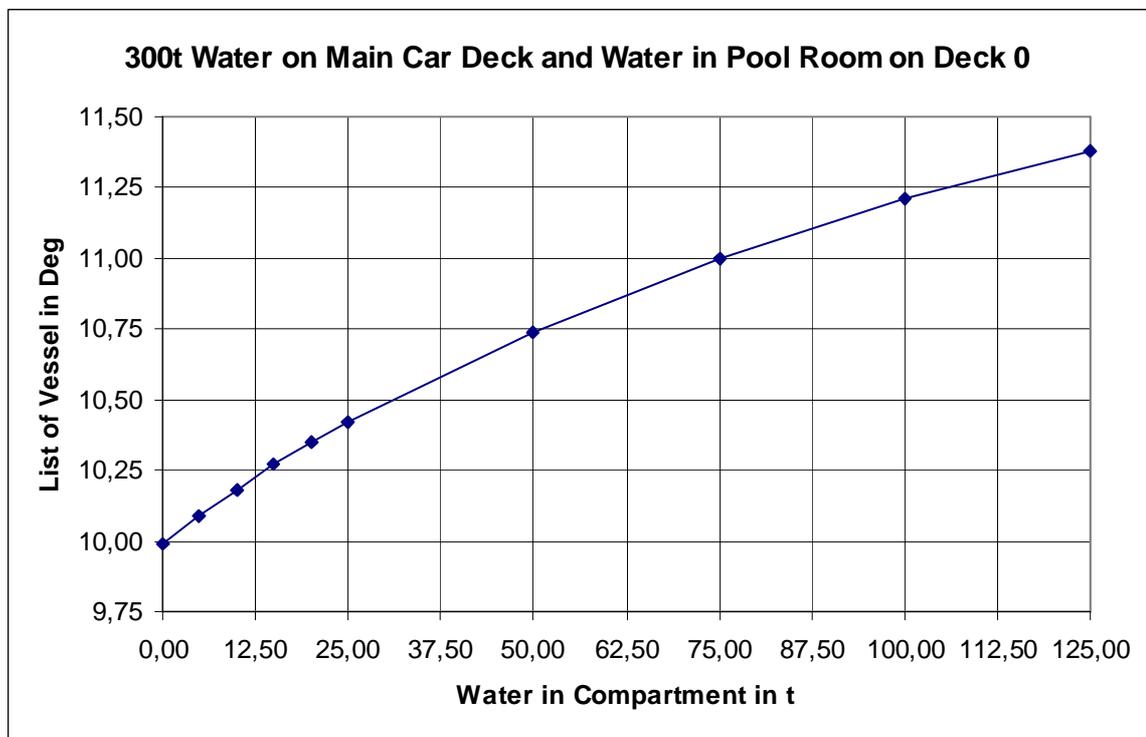
In Scenario 13, a mass of 300t of water on Main Car Deck is assumed and this mass is kept constant. In addition to the water on Main Car Deck, the flooding of the Pool Room is considered. The calculation is carried out with the amount of water in the Pool Room increasing in 5t steps up to 25t and then in 25t steps to 250t . Note that this water in the Pool Room is in addition to the pool water, which is dealt with by the final load case. The TCG of vehicles on Main Car Deck is kept fixed at -2.1m .

Figure 9.34: Scenario 13 – Compartments under consideration

Figure 9.35: Water in Pool Room, 300t water on Main Car Deck, mass over list

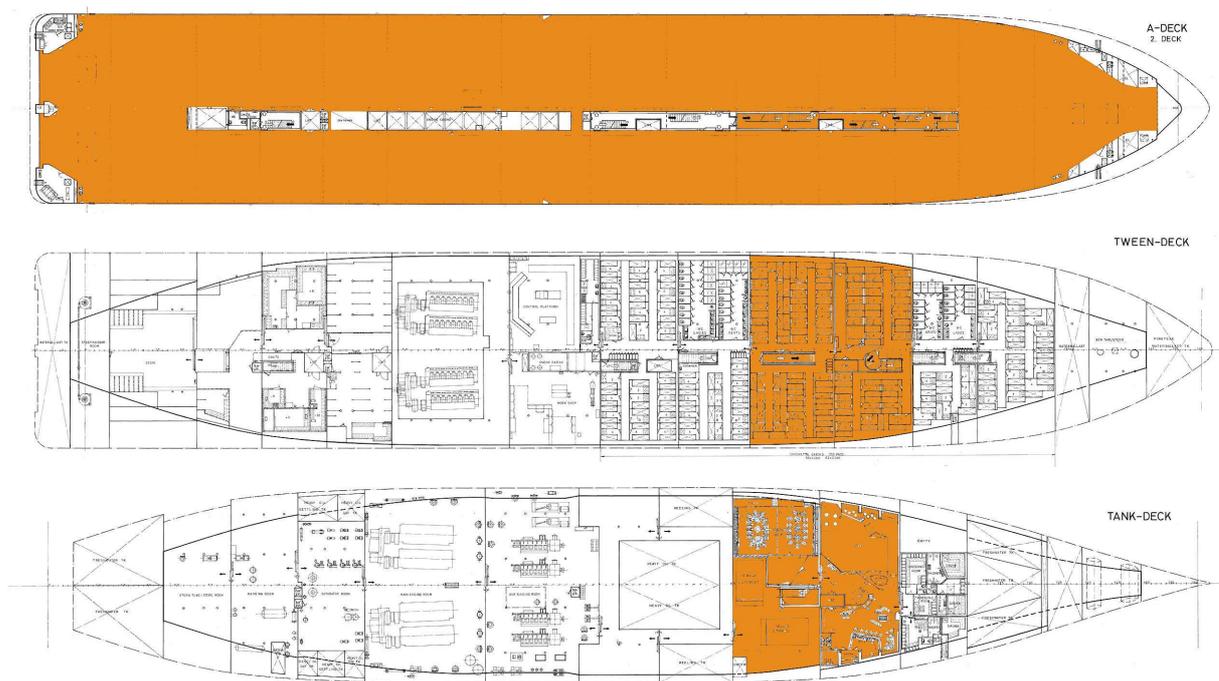
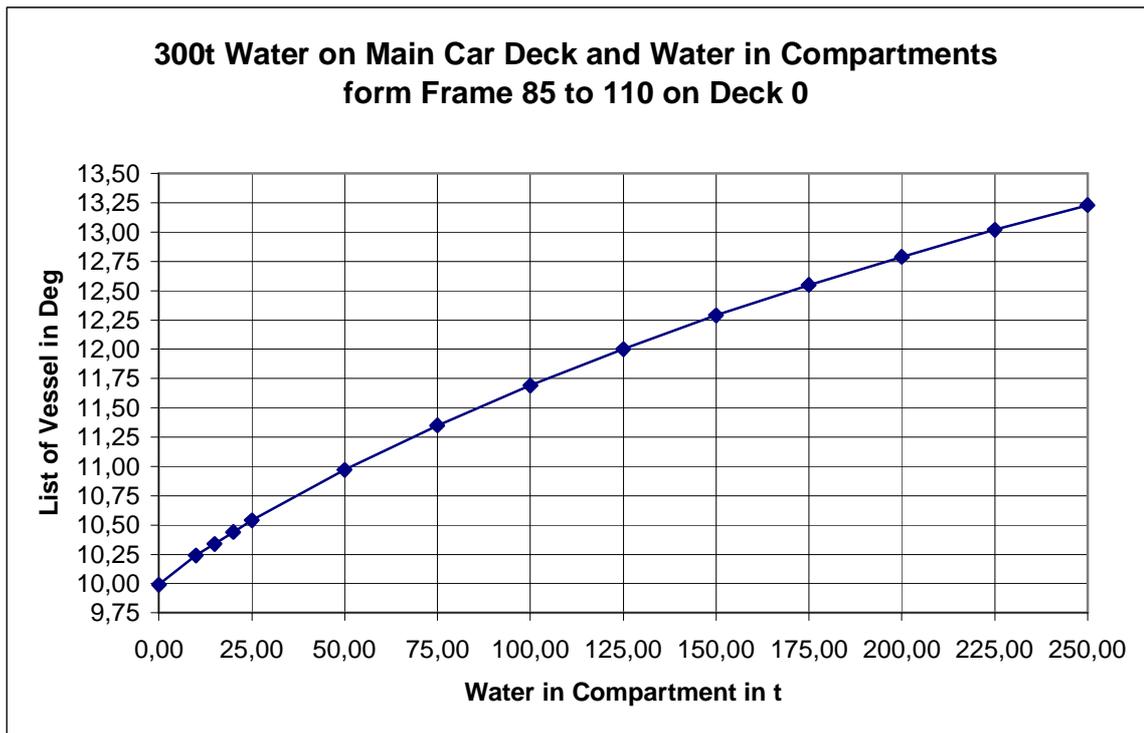
In Scenario 14, a mass of 300t of water on Main Car Deck is assumed and this mass is kept constant. In addition to the water on Main Car Deck, flooding of the Pool Room is considered, along with additional compartments connected by a non-watertight staircase. The calculation is carried out with the amount of water in the Pool Room increasing in 5t steps up to 25t and then in 25t steps to 250t. Note that this water in the Pool Room is in addition to the pool water, which is dealt with by the final load case.

Water enters in this area by the door at frame 105 on Main Car Deck; the first door of the Centre Casing on the port side. From there it enters the stairs at frame 90, 95 and 105, as well as the lift at frame 100 and flowed in the compartments under consideration. The TCG of vehicles on Main Car Deck is kept fixed at -2.1m .

Figure 9.36: Scenario 14 Compartments under consideration

Figure 9.37: Water in compartments Fr. 85 to 110, 300t water on Main Car Deck, mass over list

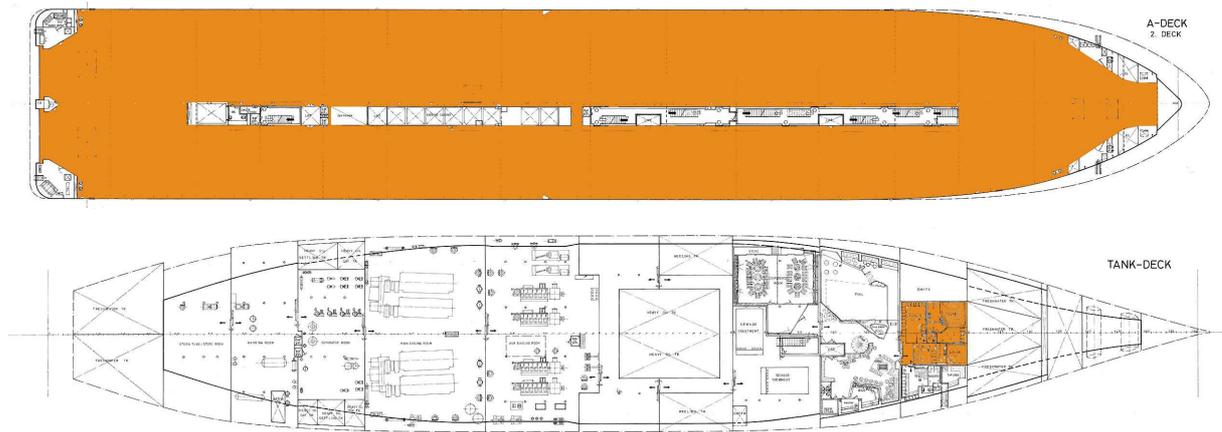
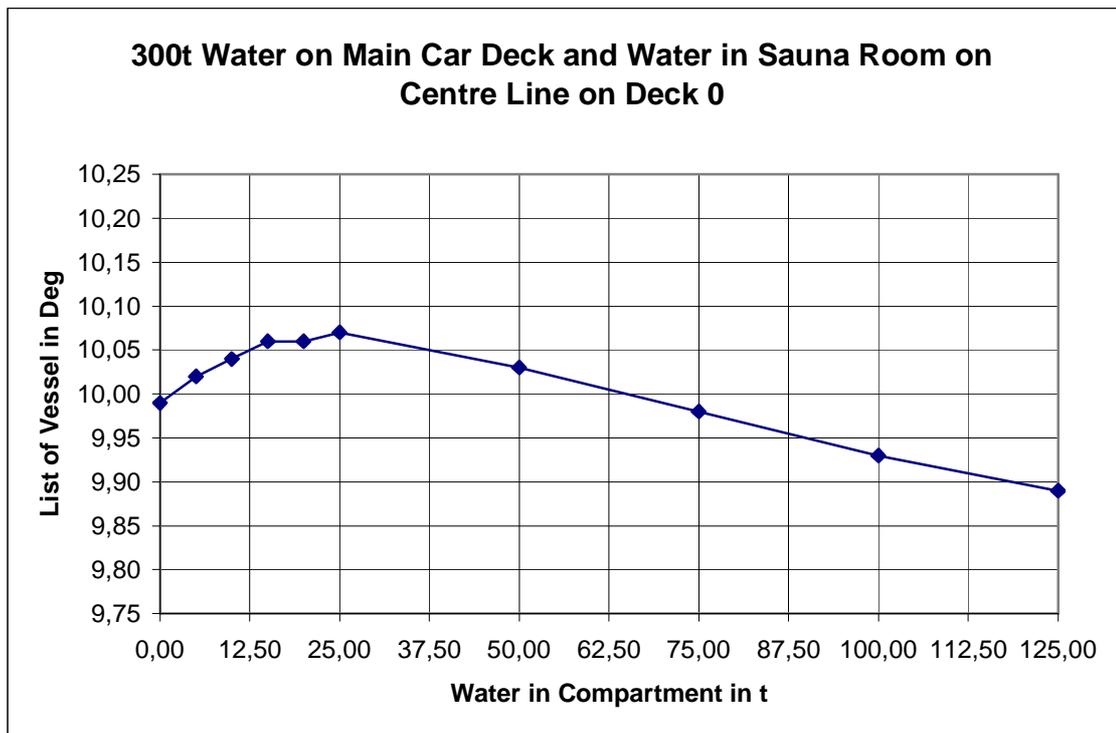
In Scenario 15, a mass of 300t of water on Main Car Deck is assumed and this mass is kept constant. In addition to the water on Main Car Deck, flooding of the Sauna Room at the Centre Line is considered between frames 110 and 120. The calculation is carried out with the amount of water in the Sauna Room increasing in 5t steps up to 25t and then in 25t steps to 125t. The TCG of vehicles on Main Car Deck is kept fixed at -2.1m .

Figure 9.38: Scenario 15 Compartments under consideration

Figure 9.39: Water in Sauna Room with 300t Water on Main Car Deck, mass over list

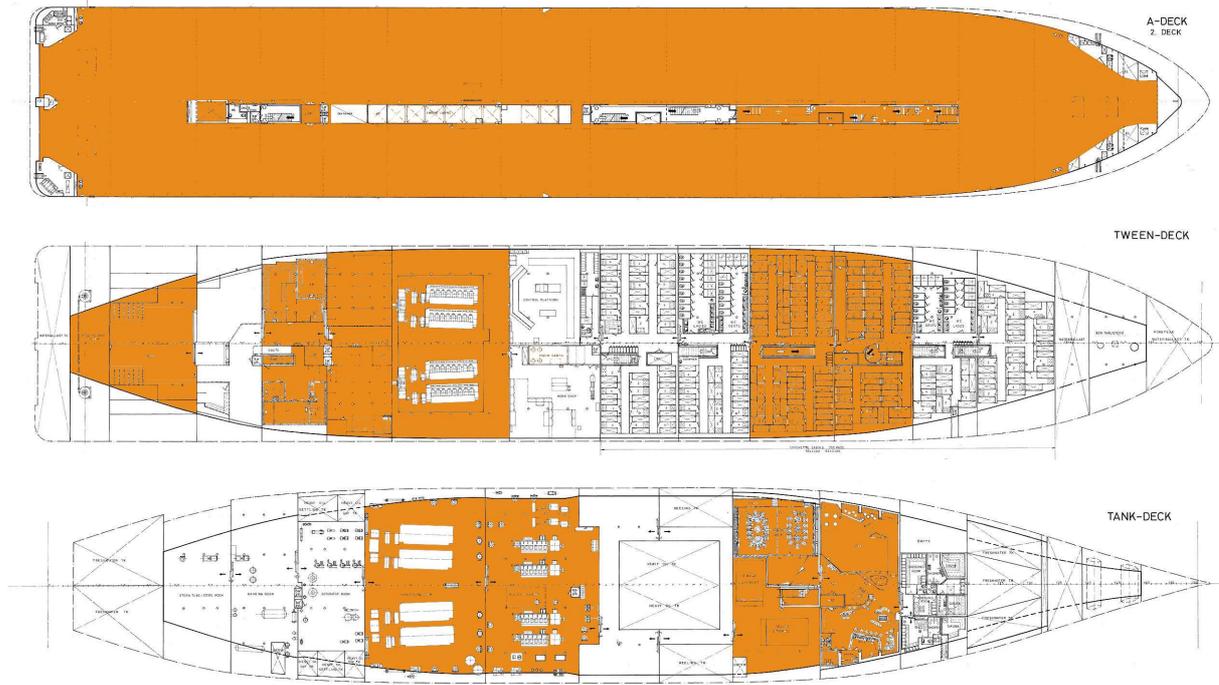
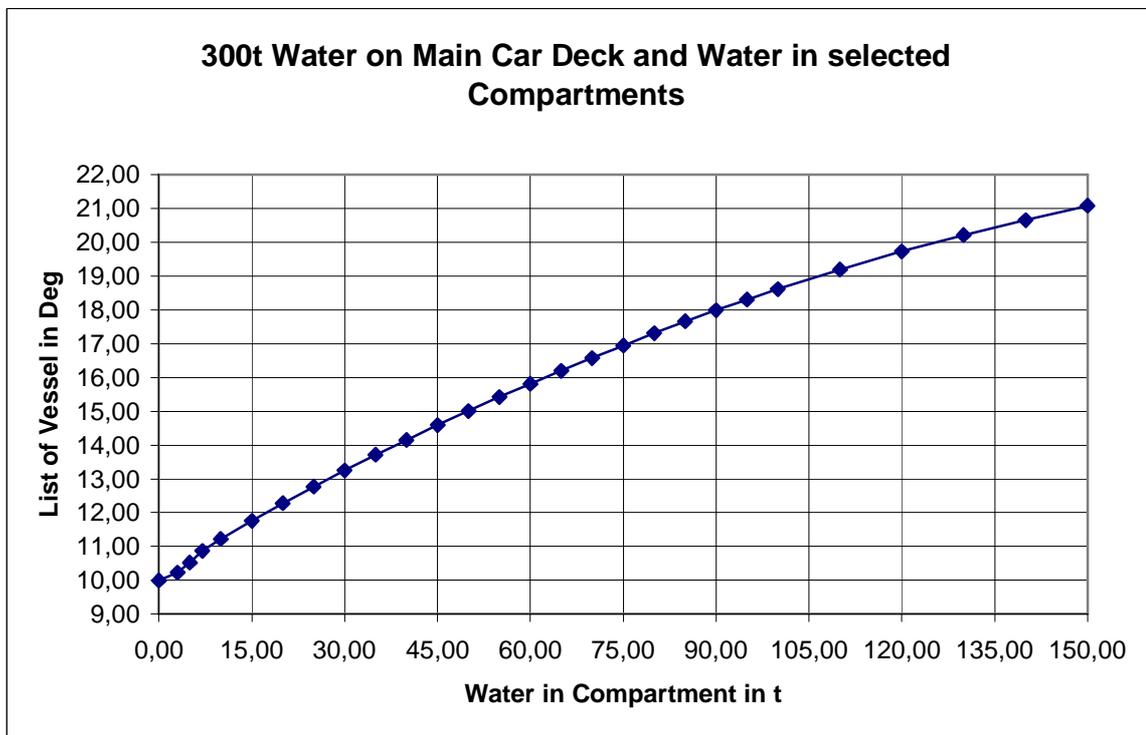
The two cabin compartments on Deck 1, from frame 110 to 120 and 120 to 132 are connected by the central stair case. The TCG of vehicles on Main Car Deck is kept fixed at –2.1m.

Figure 9.40: Scenario 16 – Compartments under consideration

Figure 9.41: Water in selected Compartments with 300t water on Main Car Deck, mass over list

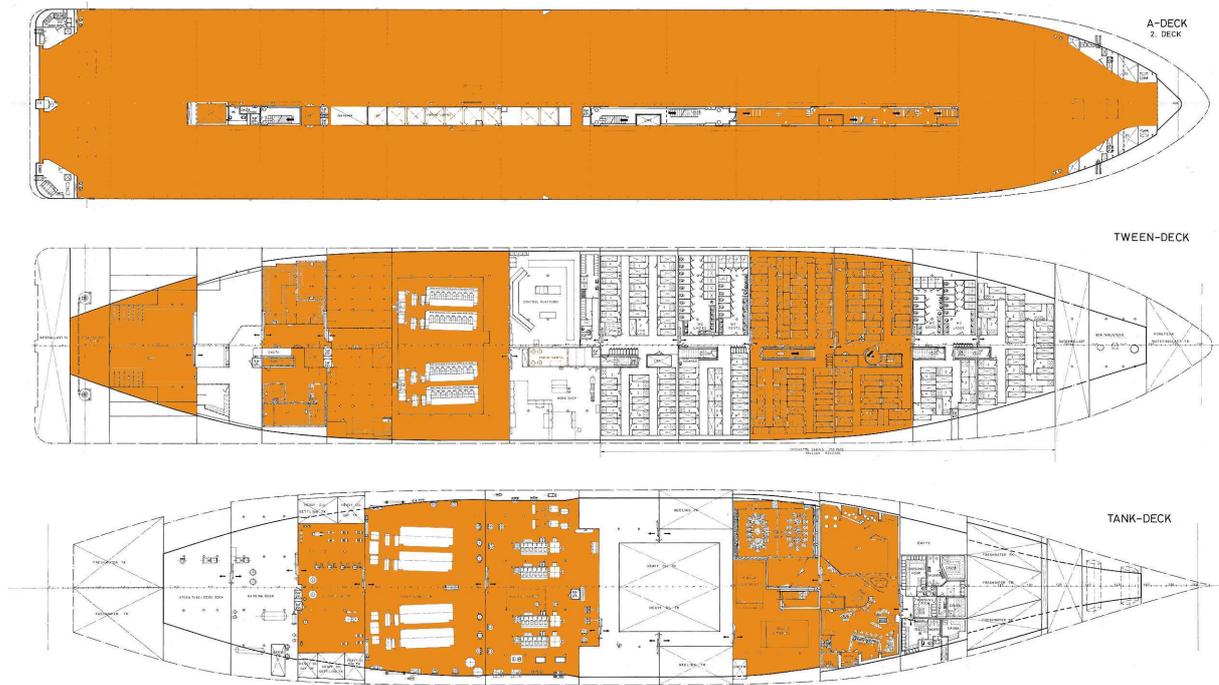
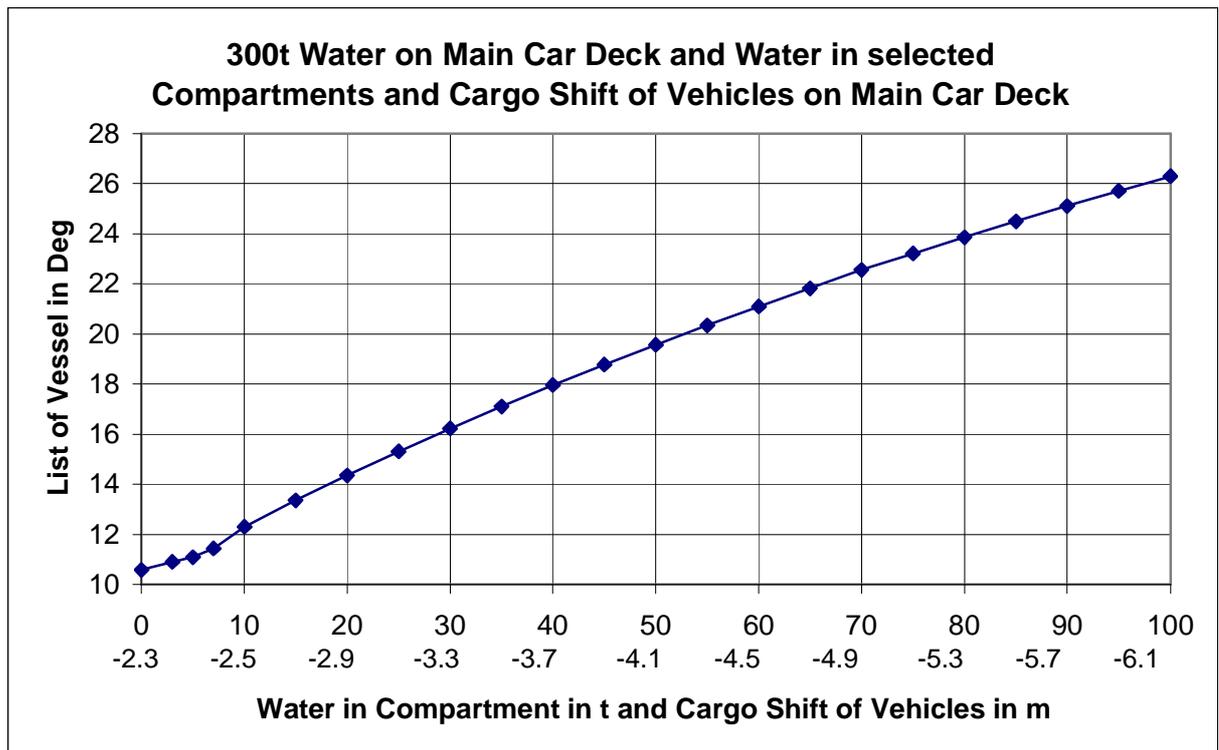
Figure 9.42: Scenario 17 – compartments under consideration

Figure 9.43: 300t water on Main Car Deck with additional water in selected compartments, mass and cargo shift over list

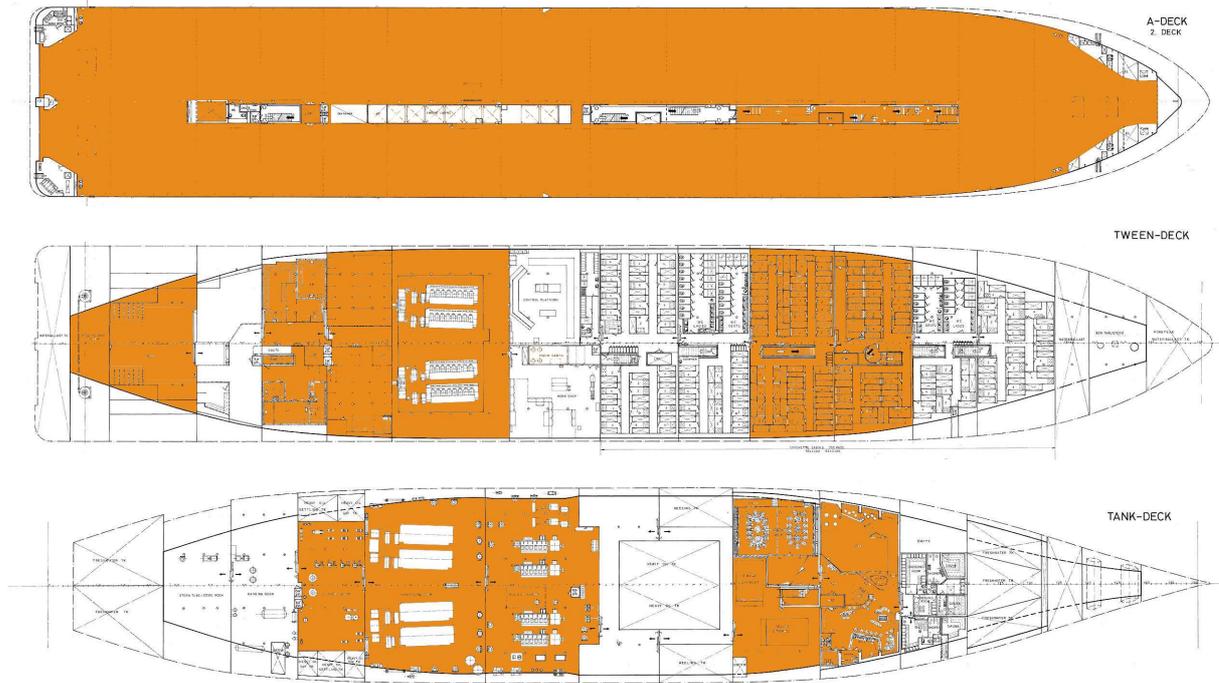
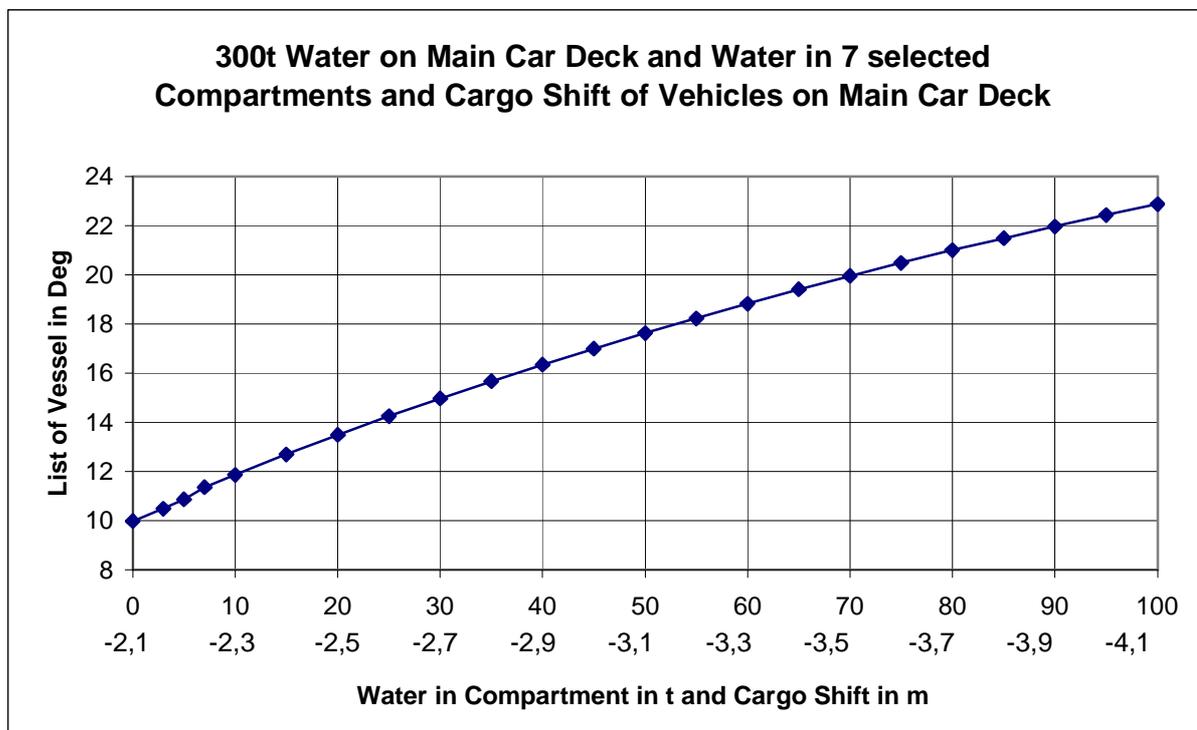
Figure 9.44: Scenario 18 – compartments under consideration

Figure 9.45: 300t water on Main Car Deck with additional water in selected compartments, mass and cargo shift over list

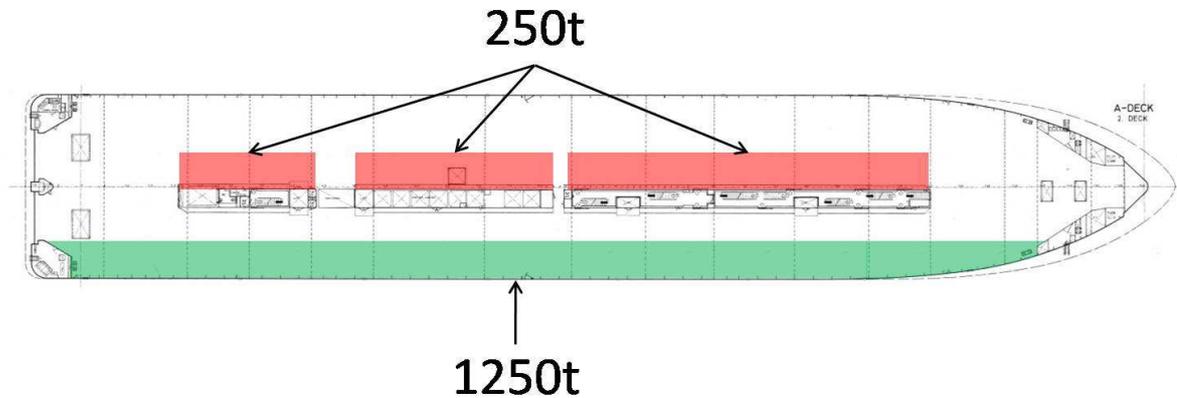
centre casing leading consequently to 1250t on the starboard side. The following *Figure 10.1* visualises this idea of retained water behind the centre casing:

Figure 10.1: Example of the visualisation of retained water behind the centre casing at starboard heel – here: 250t retained behind the centre casing

Generally, this retained water behind the centre casing is an intermediate stage and not a fully converged equilibrium floating condition, but this leads to decrease in heeling angle depending on how much water is retained on portside of the vessel. This shows clearly the necessity of dynamic calculations such as the following.

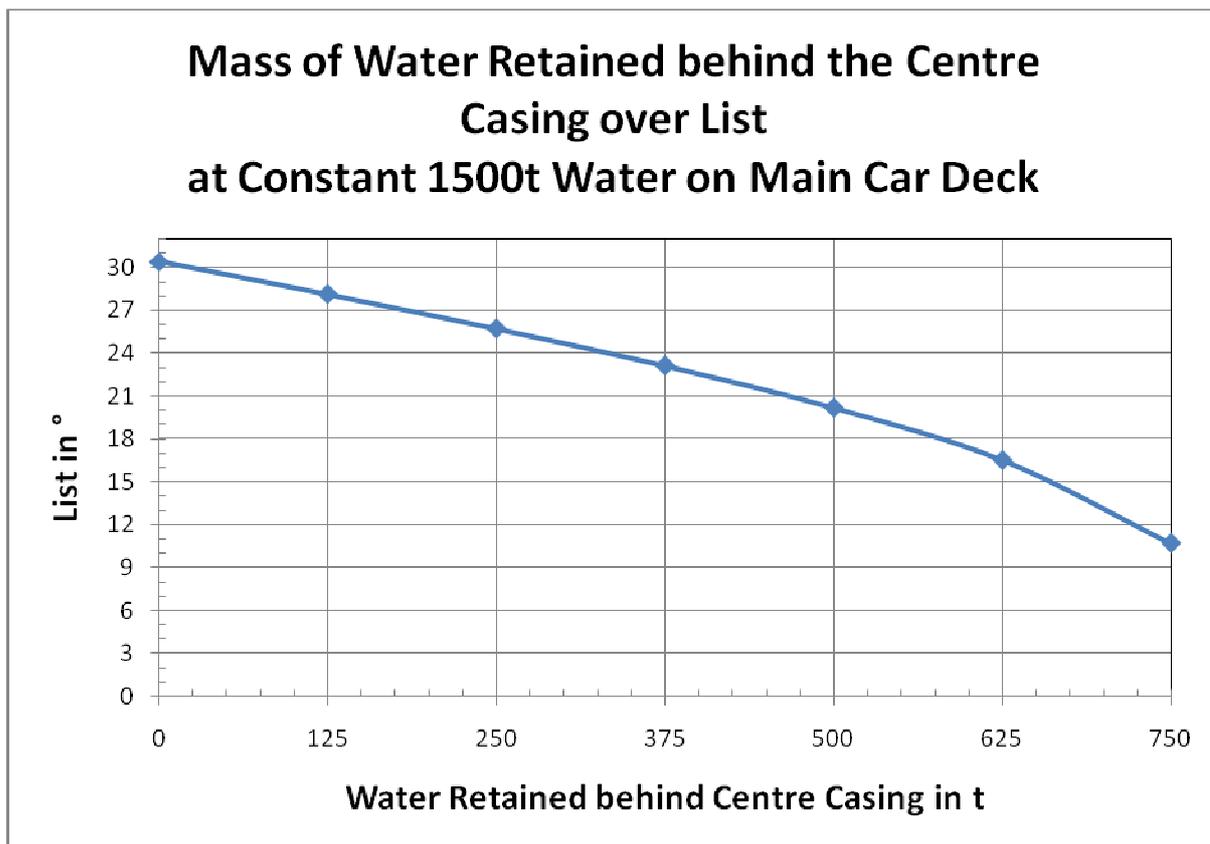
A few results of this experiment are shown in *Figure 10.2*.

Figure 10.2: Mass of water retained behind the Centre Casing over list at a constant 1500t of water on the Main Car Deck

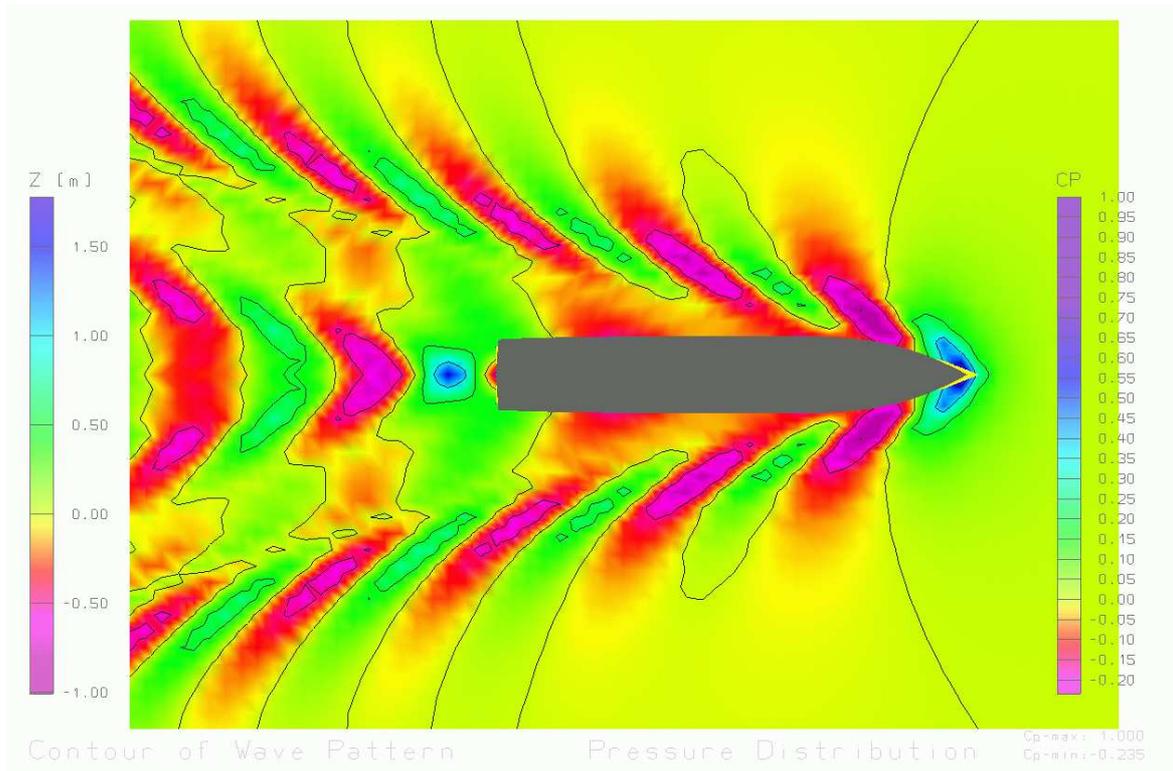
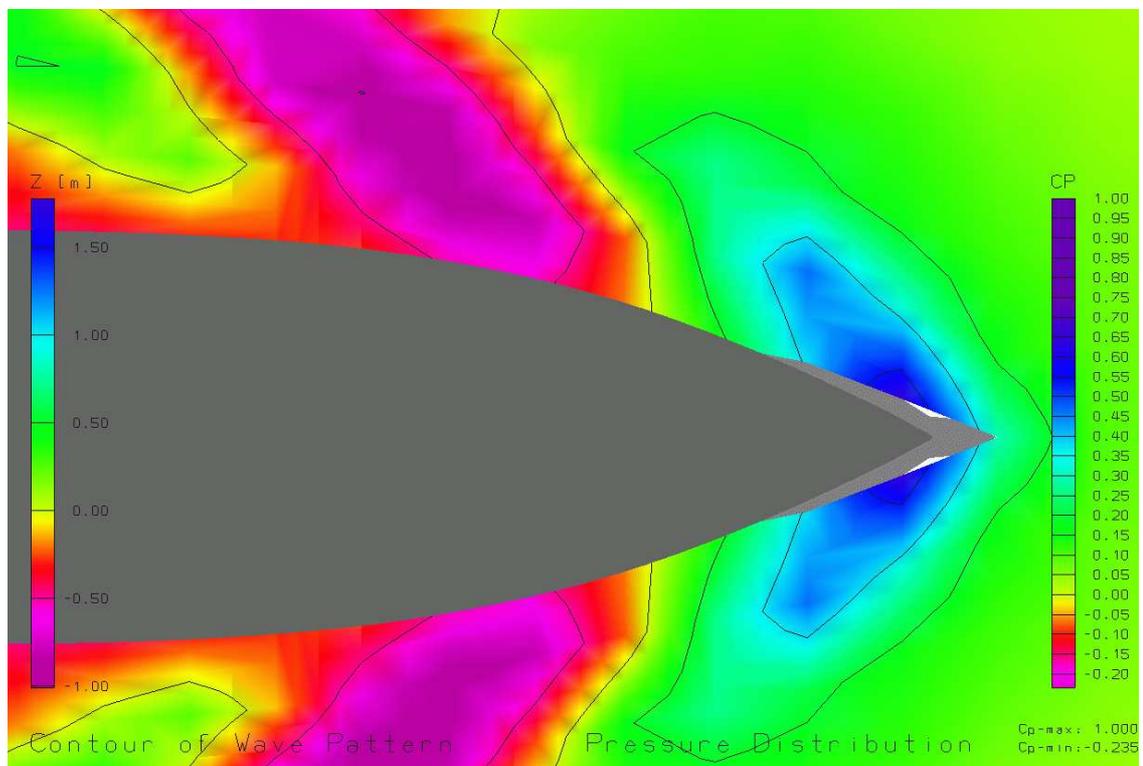
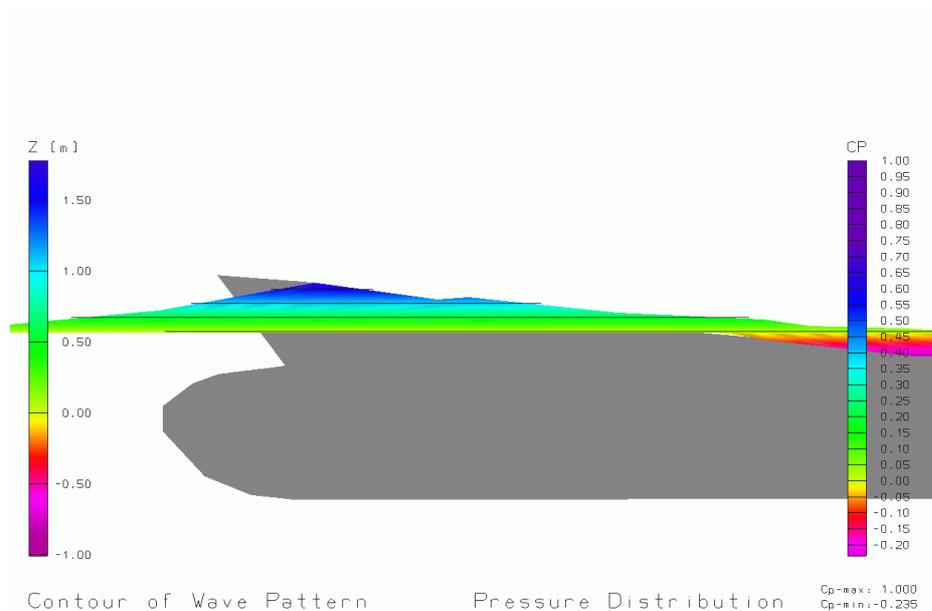
From the "Herald of Free Enterprise" accident it is known that water can be taken on even keel without rough seas simply through the interaction of the ship's own wave system and the open bow. Therefore, it was decided to determine the ship's own wave system, see *Figure 10.9 to 10.11* and to calculate how large amounts of water could have entered the Main Car Deck.

The determination of the ships' own wave system for a ship speed of 18 knots resulted in a bow wave of more than 1m in height, whereas the largest elevation close to the hull was determined to be 1.50m. Further to this, the vessel shows a clear tendency to dynamically trim down by the bow, the sinkage at the F.P. was determined to be 0.24m, where the sinkage at the A.P. was determined to be -0.04m . Therefore, it can clearly be concluded that both effects cannot be disregarded when determining inflow rates to the Main Car Deck. Immediately after the flooding of the Main Car Deck started, the theoretical freeboard of the Main Car Deck must be reduced by a minimum of $1.25\text{m} - 1\text{m}$ bow wave height plus sinkage - to a maximum of $1.75\text{m} - 1.50\text{m}$ bow wave height plus sinkage. These values will be taken into account when determining flow rates onto the Main Car Deck.
