The Sinking Sequence of MV Estonia

Dem Promotionsausschuss der
Technischen Universität Hamburg-Harburg
zur Erlangung des akademischen Grades
Doktor-Ingenieur (Dr.-Ing.)
genehmigte Dissertation

This thesis reconstructs the sinking of the RoPax Ferry MV Estonia on September 28th 1994, with a strong focus on describing the chain of events that caused the eventual sinking, and how the ship sank. Once the sinking is understood, this thesis explores possible safety improvements that should be implemented in the design of new vessels of this type. The investigation is based on a combination of testimonies of survivors as well as numerical calculations based on the framework of the testimonies.

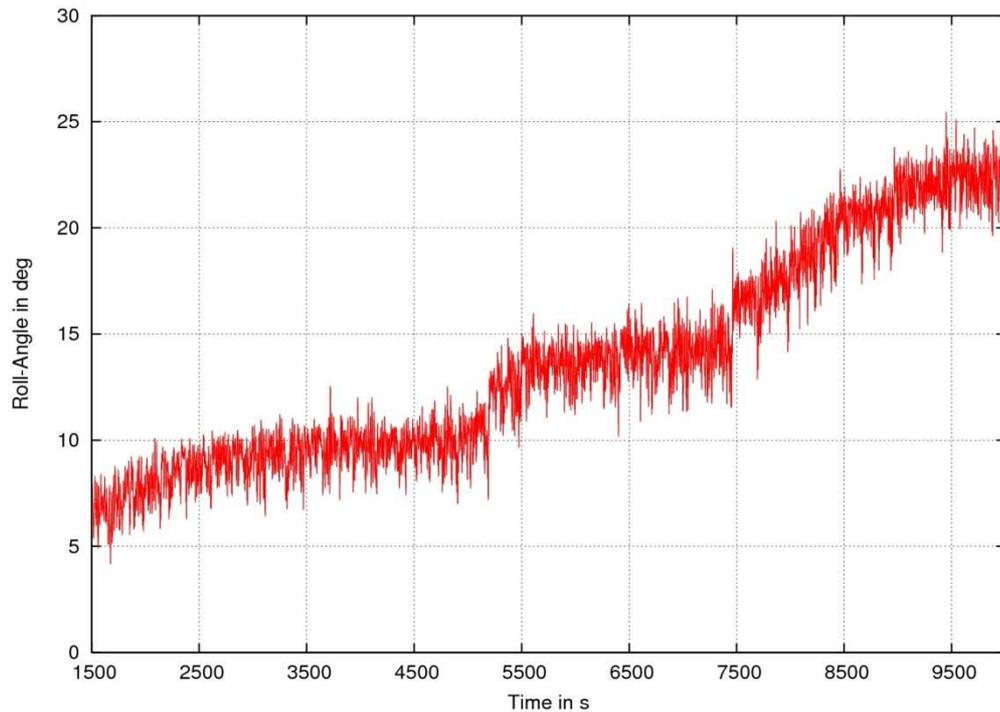
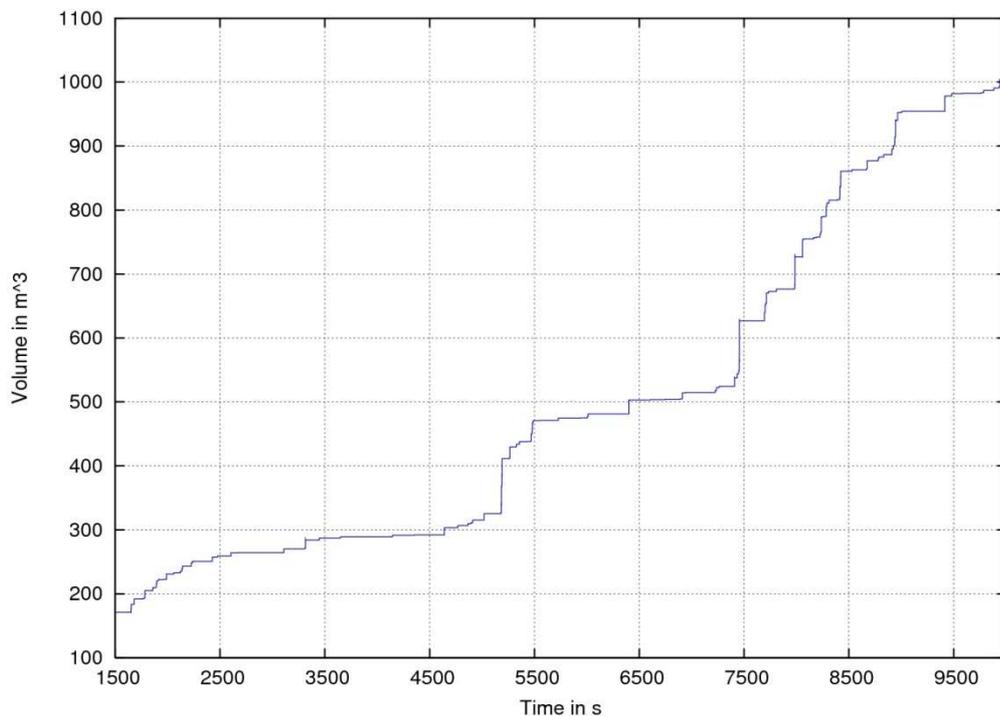
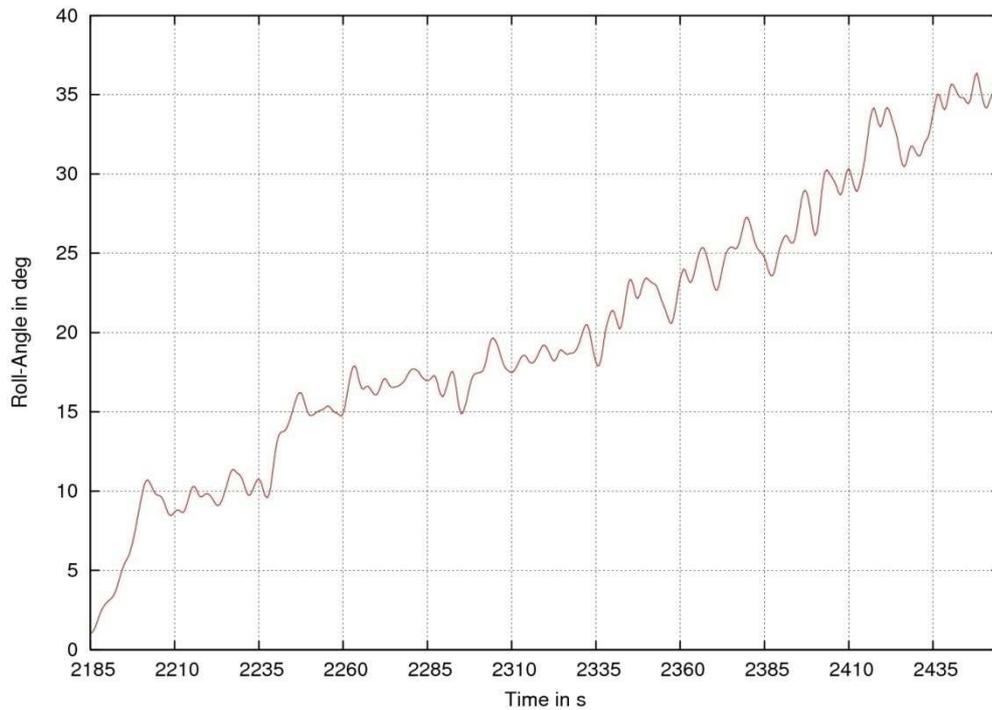
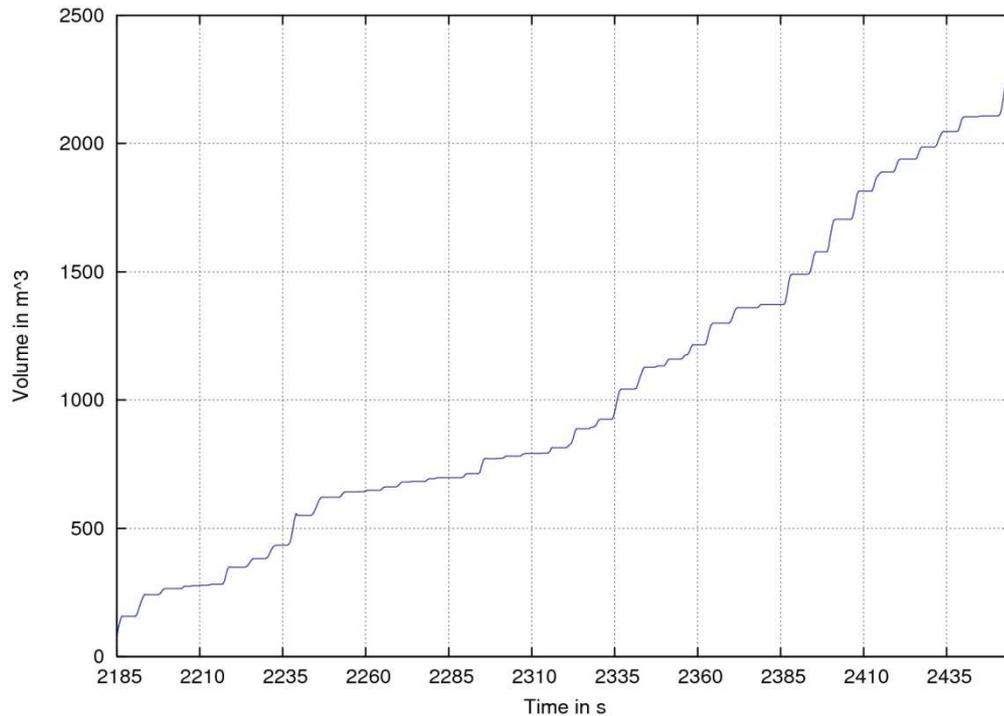
inclusion of the effect of the bow wave determined by our procedure are by far too low to accumulate 1500t in a time span of about 10min. On the other hand, the results including the simplified bow wave influence show that the flow rate increases drastically to values that do clearly lead to amounts of water on deck of the required order of magnitude. This was the intention -to demonstrate with the simplified simulations that it is possible to collect the required amount of water on the Main Car Deck in the time interval of interest, making the proposed scenarios generally plausible. The simplified calculations also show that the flow rates into the Main Car Deck do – as expected– strongly depend on the assumptions with respect to the inflow and freeboard. *Figure 10.17* shows a comparison of inflow rates with two different encounter angles and the ‘normal’ freeboard and the reduced freeboard.

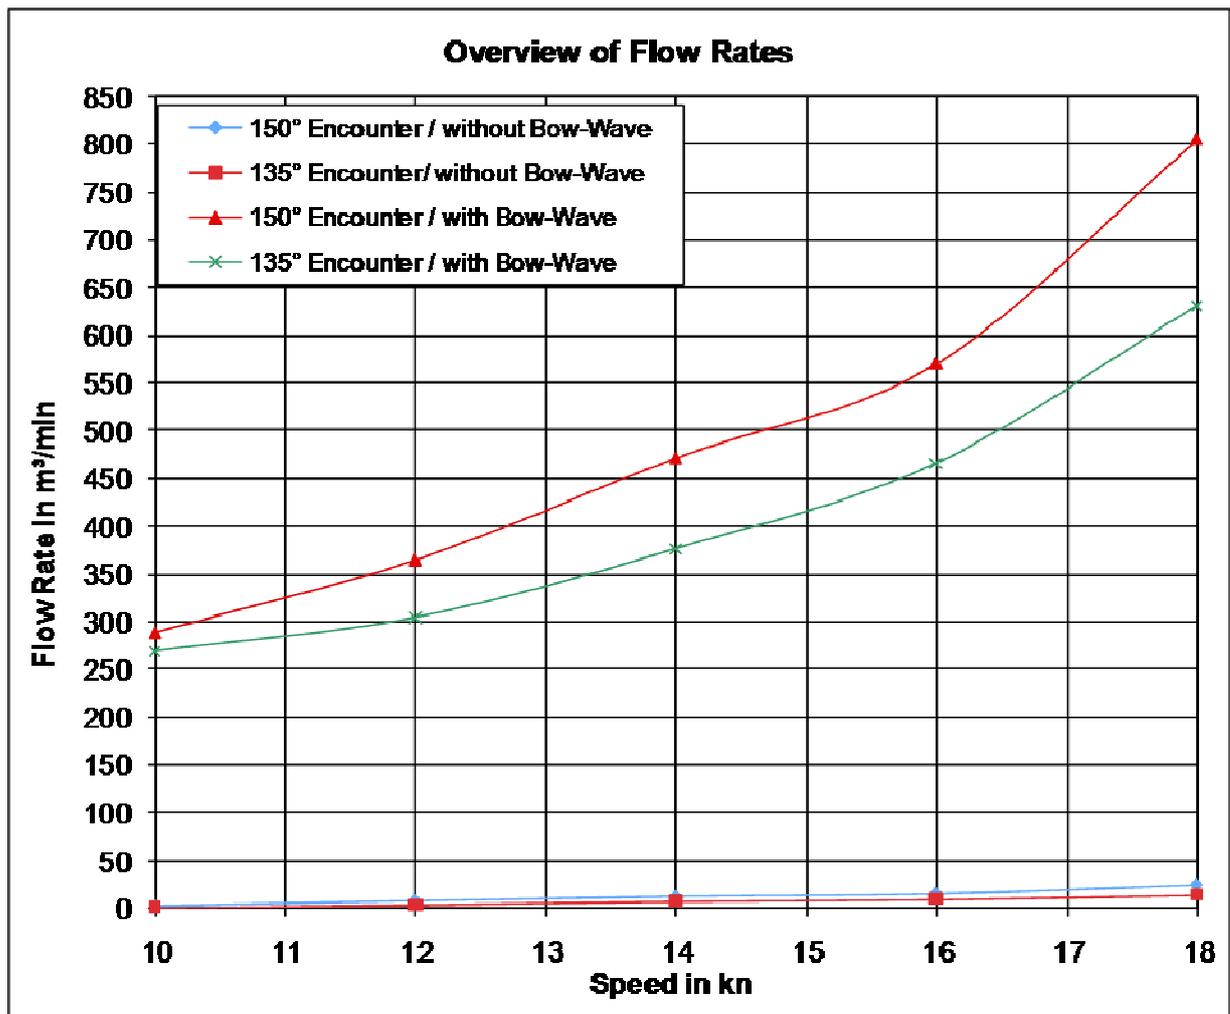
Figure 10.16: Flow rates with and without the ship's own wave system

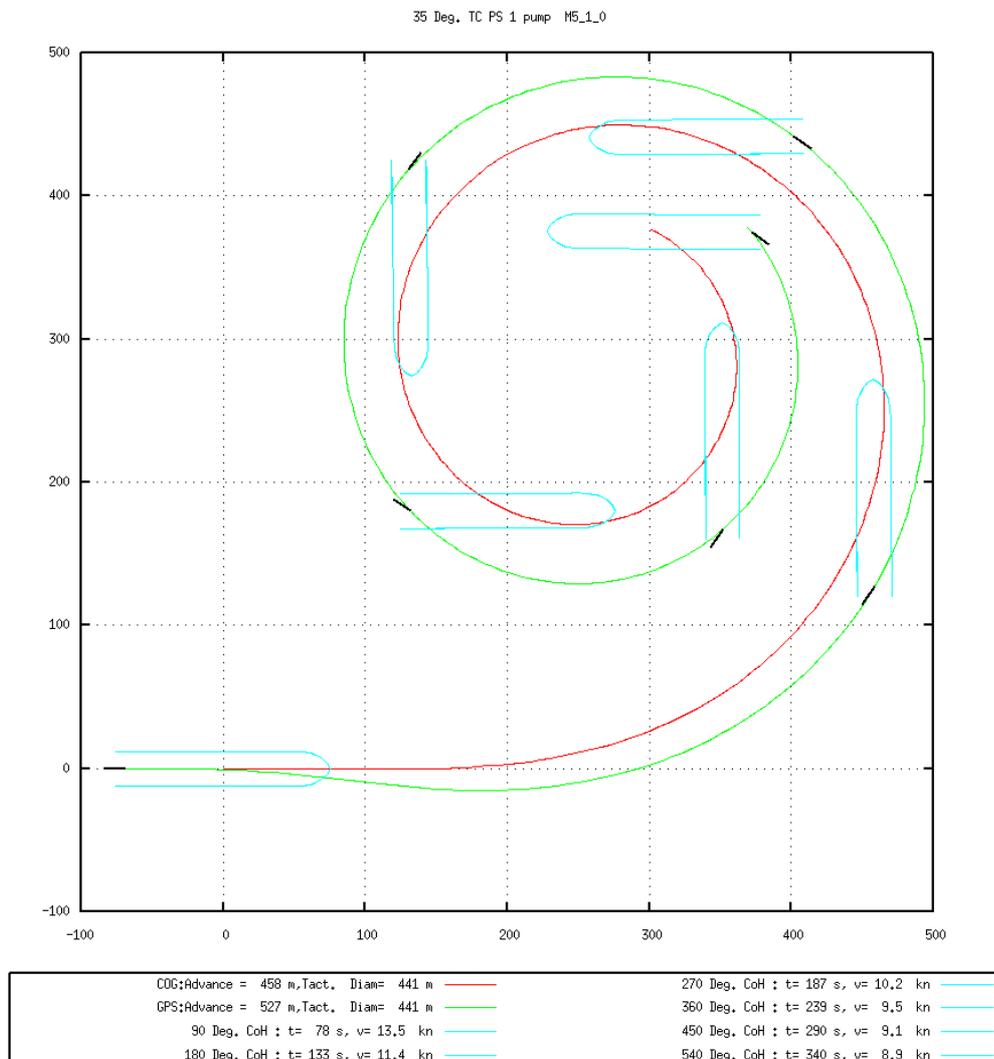
As exposed previous in a chapter, MV Estonia turned to the direction where she had come from. Therefore is probably sharp turn contributes the heeling of the ferry, which is investigated in this chapter. The initial speed is assumed in both to be about 14.4kn to 15.0kn and the tactical turning diameter was measured in model experiments by the SSPA-consortium to $3.01L_{PP}$ or 413.6m. [VTI] compared five different car and passenger ferries with regards to their turning diameters which resulted in an average of $3.1L_{OA}$, and worked out a tactical diameter of 480m for MV Estonia. The calculations of the author using the E4 software result in a tactical diameter of 441m or $3.21L_{PP}$ at an initial speed of 14.5kn, shown in *Figure 11.1*.

Figure 11.1: Graph of turning circle of MV Estonia with loss of speed

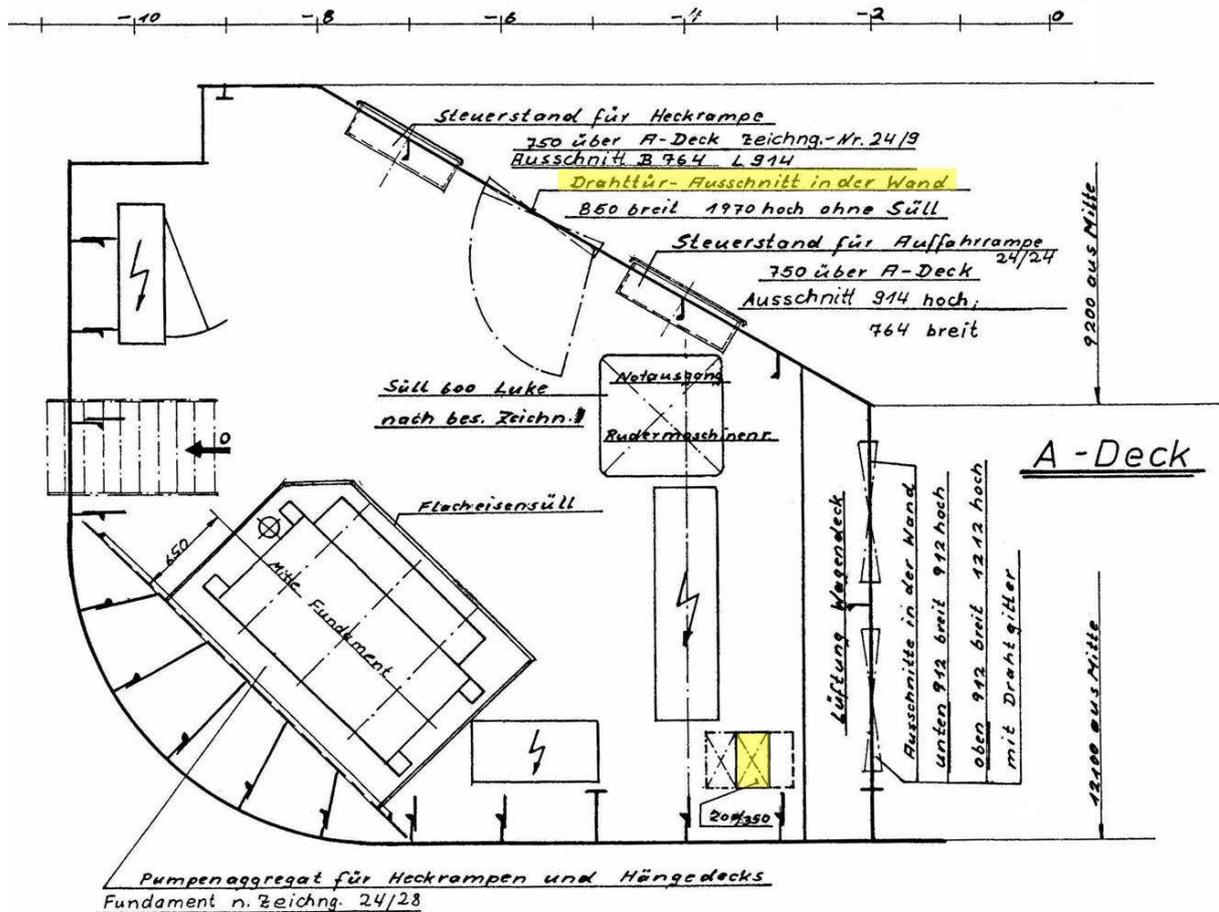
Figure 12.7: Aft Wing House on Main Car Deck level, starboard side, top view, Drawing S 590 – 24/2

The aft wing house of MV Estonia has access from the Main Car Deck via a mesh wire door, which is clearly not watertight, so water could easily flow into the aft wing house. See *Figure 12.7*⁸. The ventilation duct, supplying the aft wing house and the steering gear room with fresh air, separates 2.1m above Main Car Deck level into a duct for the wing house, and a duct for the steering gear room, see *Figure 12.8*. The cross section of the duct ending in the steering gear compartment is 0.07m². The result of a large amount of water on the Main Car Deck is that it can flow from Main Car

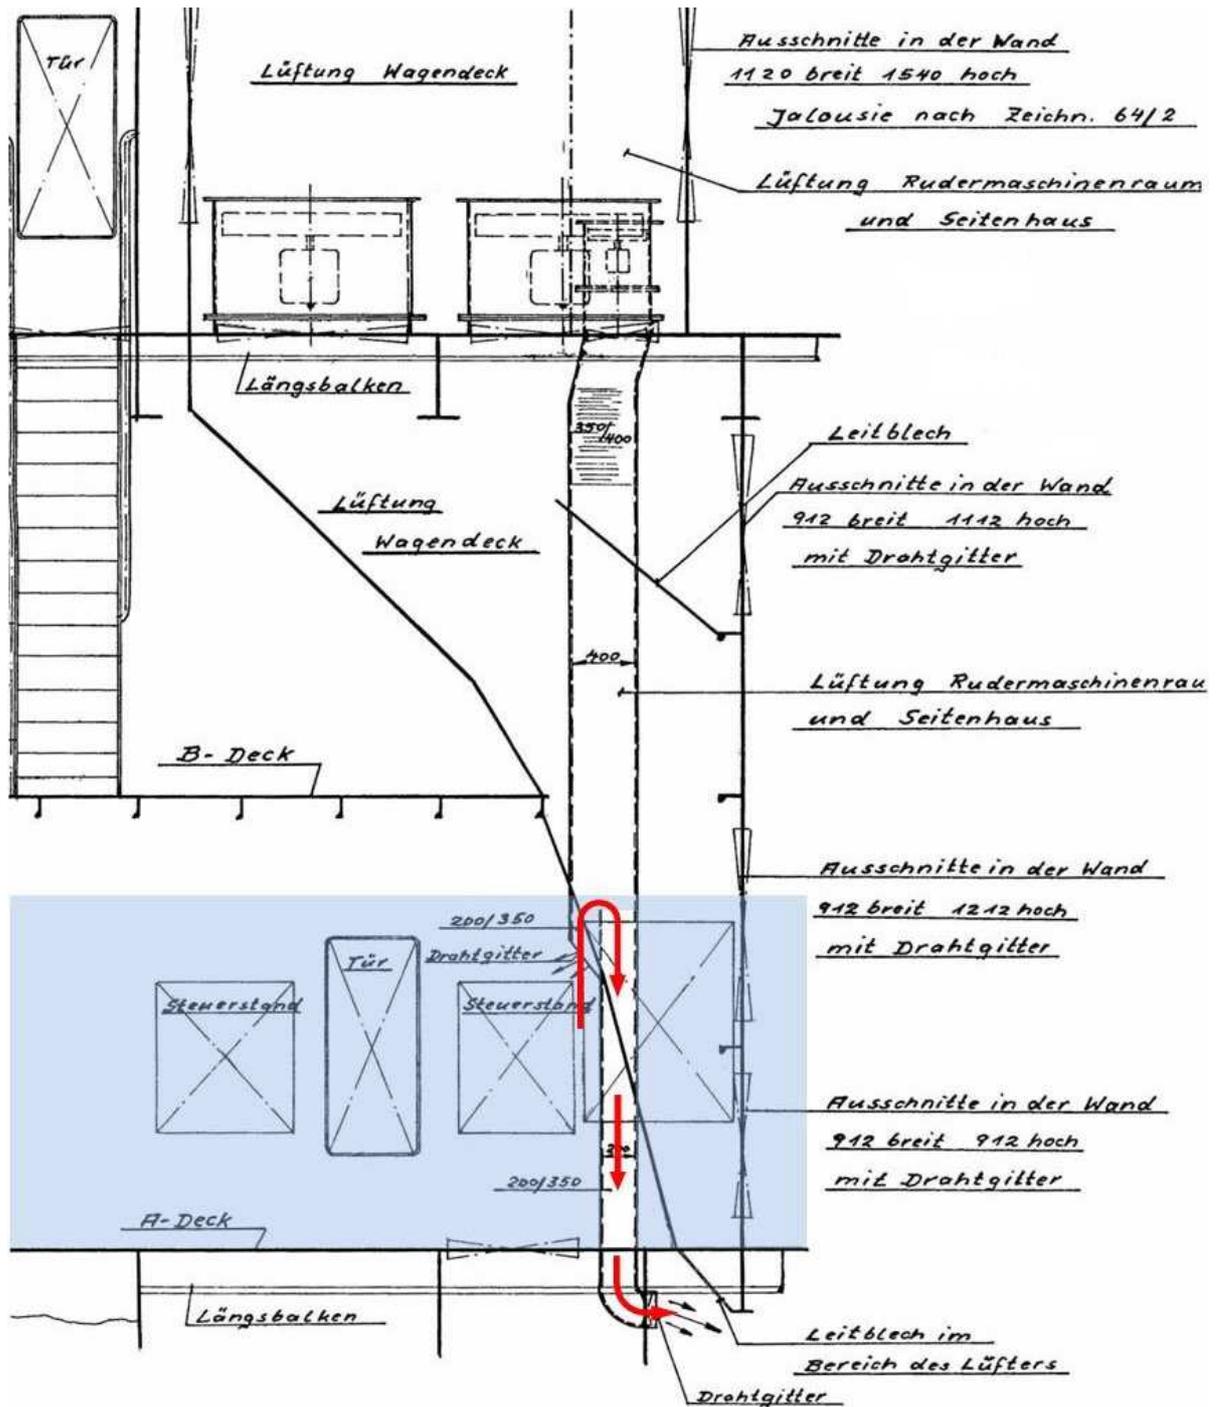
Figure 12.8: Aft Wing House from Deck 2 to Deck 4, starboard side, lateral view, Drawing S 590 – 24/2

Deck into the aft wing house and then into the ventilation duct and finally to the steering gear compartment, following the red arrows of *Figure 12.8*. The effect on MV Estonia is an increase of aft-ward trim with a comparably small mass of water, caused by the extreme aft position of the of the steering gear room.

In this thesis, water ingresses into the Steering Gear Compartment in a very early stage of the sinking, namely at about 01:05 or when 1000t water had flooded on to the Main Car Deck – see *Figure 12.8*. Due to the ingress to the Main Car Deck, the aft-ward trim decreases, however as the water ingress proceeds to the Steering Gear Compartment, this stops and the aft-ward trim increases again.

The lower opening of the ventilation duct - as shown in *Figure 12.8* - is not documented in any report of the SSPA-consortium. Even the corresponding upper

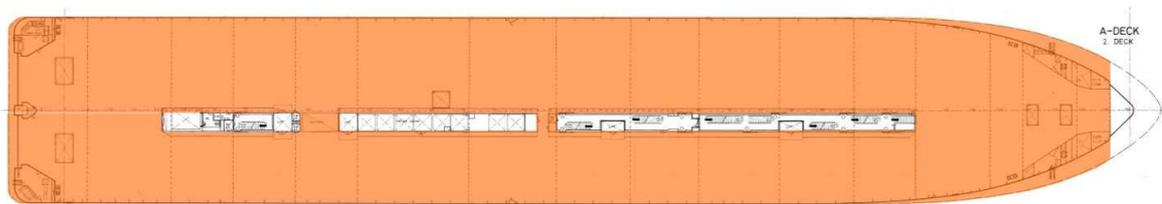
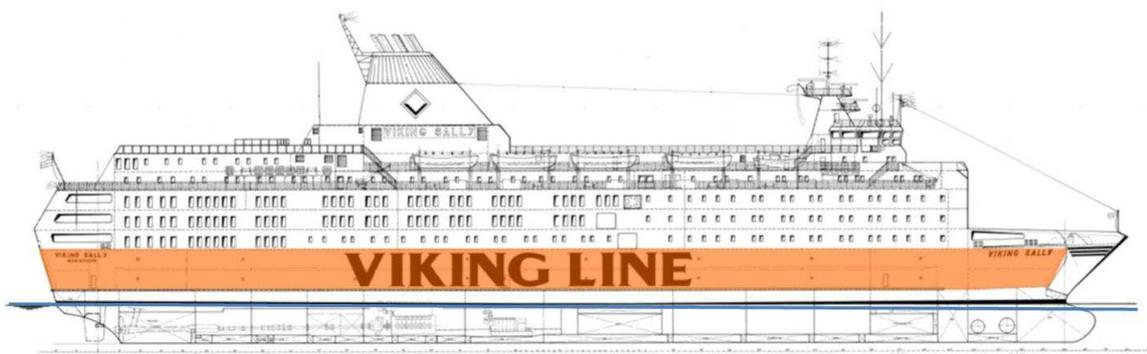
The loss of watertight integrity of the Main Car Deck is most likely related to the two or three metallic bangs numerous witness heard at different positions on MV Estonia. The water easily enters the wing houses from the Main Car Deck, because they were closed by mesh grid doors. The aft-ward trim of the ferry starts to decrease due to the water ingress, although during the whole calculations some aft-ward trim remains.

By the time some several hundred tonnes of water was taken on to the Main Car Deck, its free shifting fluid moments led to a quick increase of a previously steady list.

Figure 12.9 : Graphic of flooded areas in step 0, 01:00:00

Figure 12.10: Side view of step 0 with highlighted compartments beginning to flood and the waterline

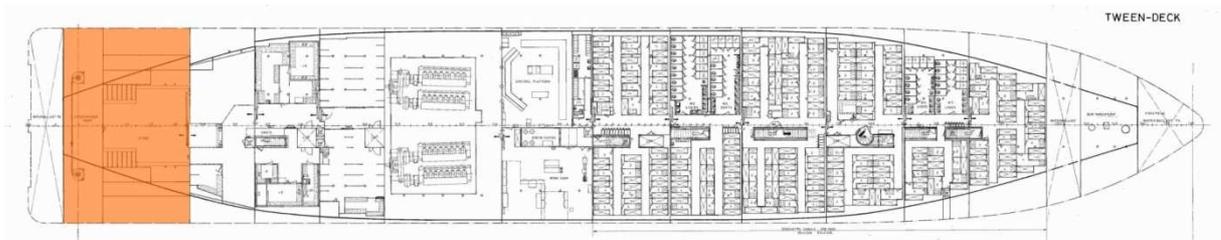
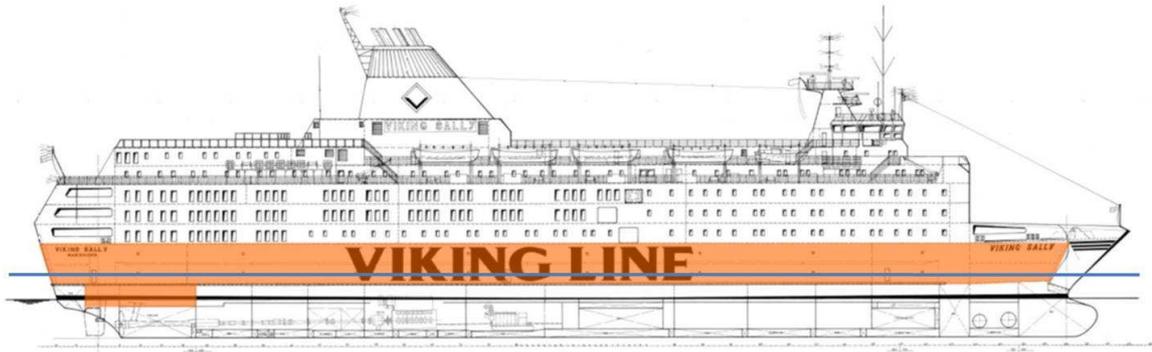
Water enters Deck 1 through the ventilation duct connecting the aft Starboard Side wing house on Deck 2 and the Steering Gear Room with the adjacent, non-watertight Store Room,. Note the technical drawings of this arrangement in the chapter “Detail of Aft Wing House”.

Figure 12.11: Graphic of flooded compartment in Step 2, 01:04:00

Figure 12.12: Side view of step 2 with highlighted compartments beginning to flood and the waterline

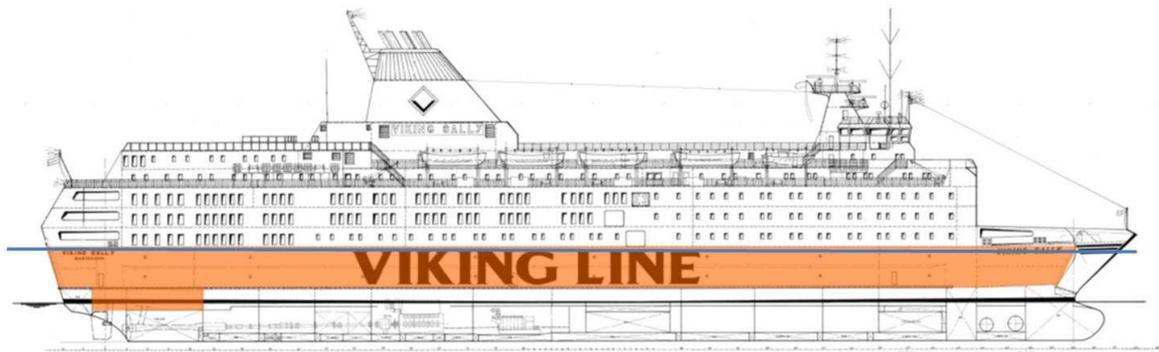
Step 6, 01:09:00

As the heel increases to more than 30° , a first cargo shift of all vehicles on the Main Car Deck is assumed: 1.00m to the starboard side.

Figure 12.13: Side view of step 6 with highlighted compartments beginning to flood and the waterline

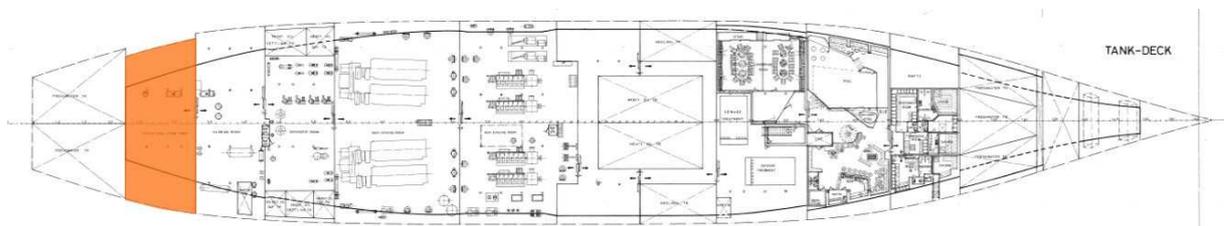
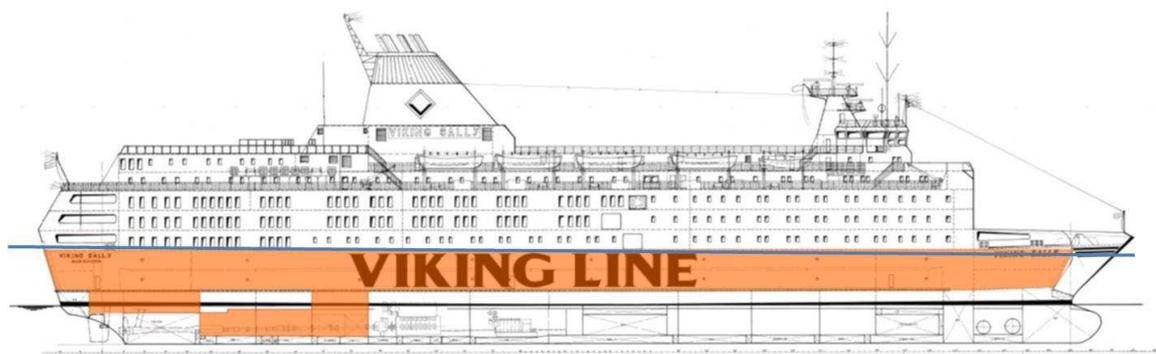
Step 15, 01:18:00

During the relatively long period of time from Step 6 to Step 15 the water ingress on the Main Car Deck is compareably low. This is in line with the testimonies of the witnesses: it is stated that there is, at this time, a quasi static euqilibrium floating condition. By successive water ingresses to the Steering Gear Compartment and the adjacent connected Store Room the aft-ward trim increases. In Step 15 the first side ventilation opening is immersed. This is the ventilation duct of the “Stern Tube/ Store Room” compartment on Deck 0. This second compartment below the Main Car Deck is also located in the aft part of MV Estonia and due to top this it contributes also the aft-ward trim.

Figure 12.14: Graphic of flooded compartments in step 15, 01:18:30

Figure 12.15: Side view of step 15 with highlighted compartments beginning to flood and the waterline

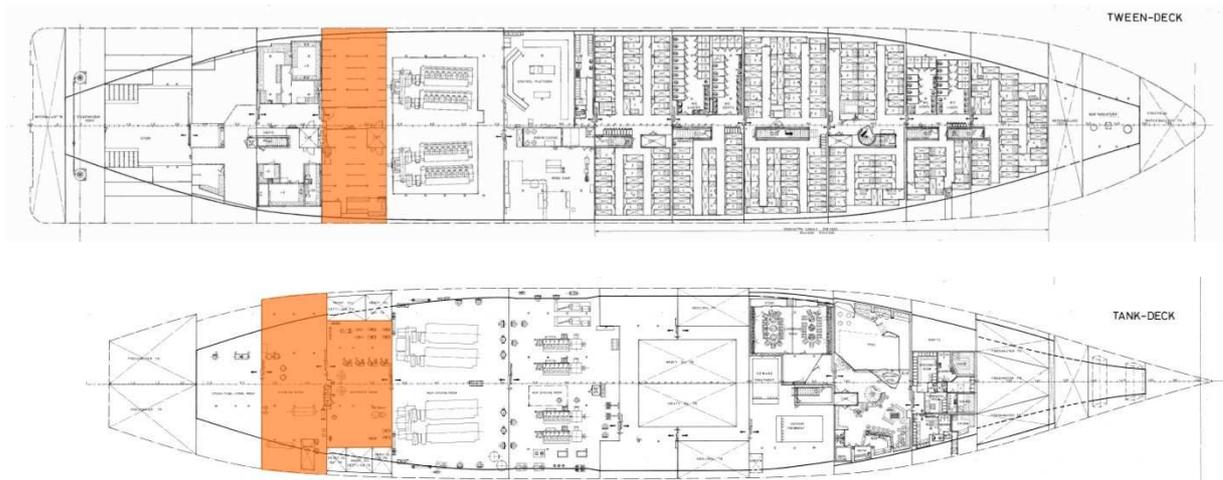
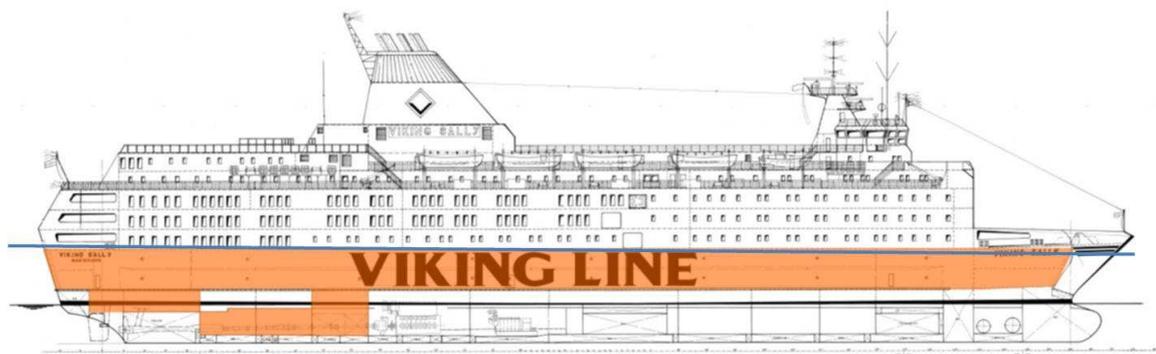
Step 16, 01:18:30

In Step 16, the next three side ventilation openings are immersed - in the Store Room on Deck 1 between frames 43 and 53, the Separator Room on Deck 0 and in the so-called “KaMeWa-Room”, also on Deck 0. Contained within the “KaMeWa-Room” is the hydraulic equipment necessary for the controllable pitch propellers (CPP).

Figure 12.16: Graphic of flooded compartments in step 16, 01:18:30

Figure 12.17: Side view of step 16 with highlighted compartments beginning to flood and the waterline

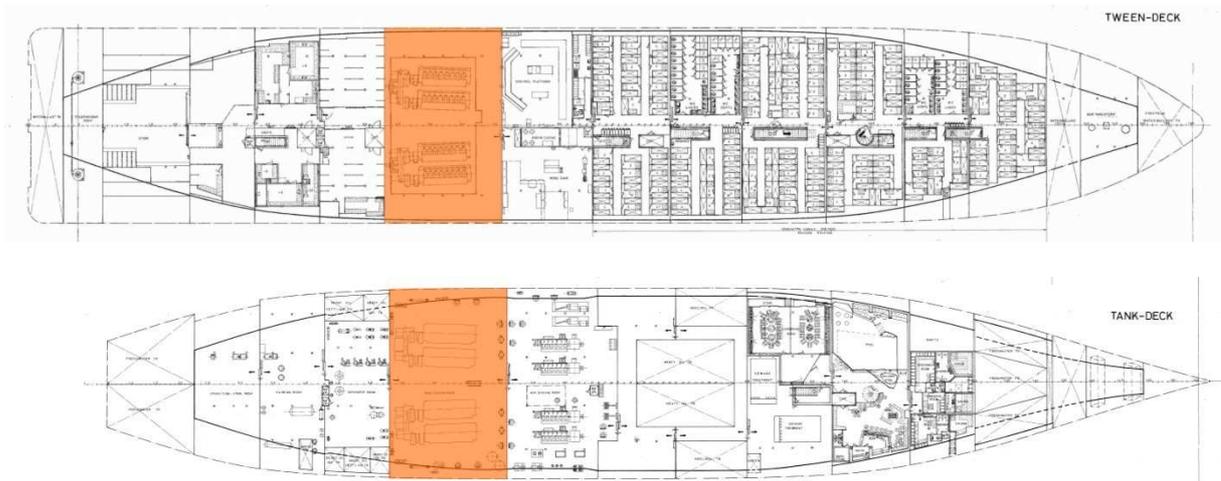
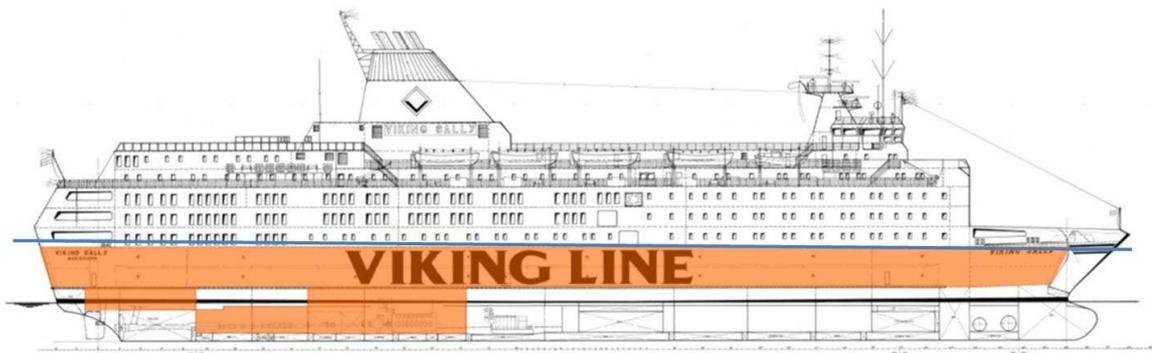
Step 17, 01:19:00

In calculation Step 17, the two starboard side ventilation openings of the main Engine Room are immersed. As in the cases before, the air escapes through the opposite side, because all ventilation openings on the Starboard Side are symmetrically arranged and there is an identical ventilation duct on the portside.

Figure 12.18: Graphic of flooded compartments in step 17, 01:19:00

Figure 12.19: Side view of step 17 with highlighted compartments beginning to flood and the waterline

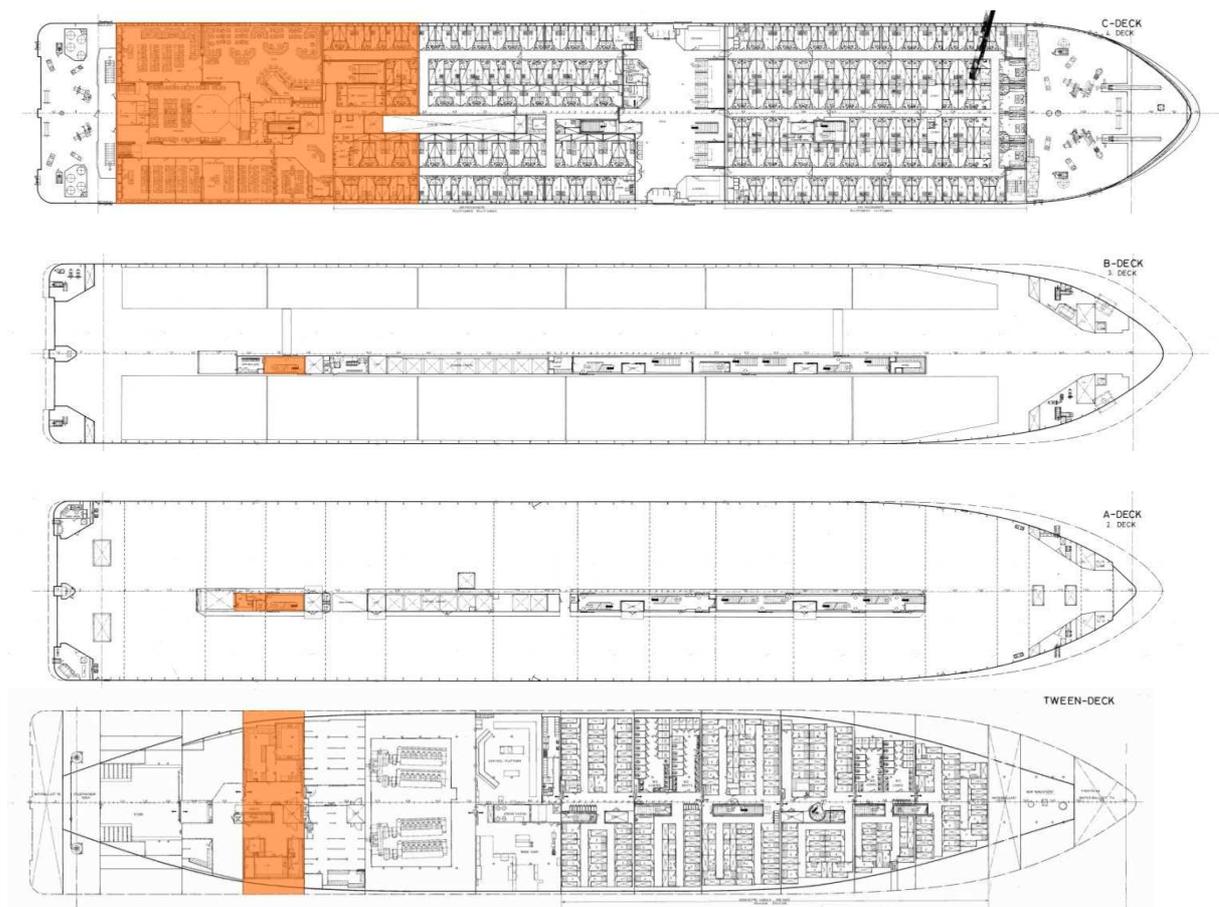
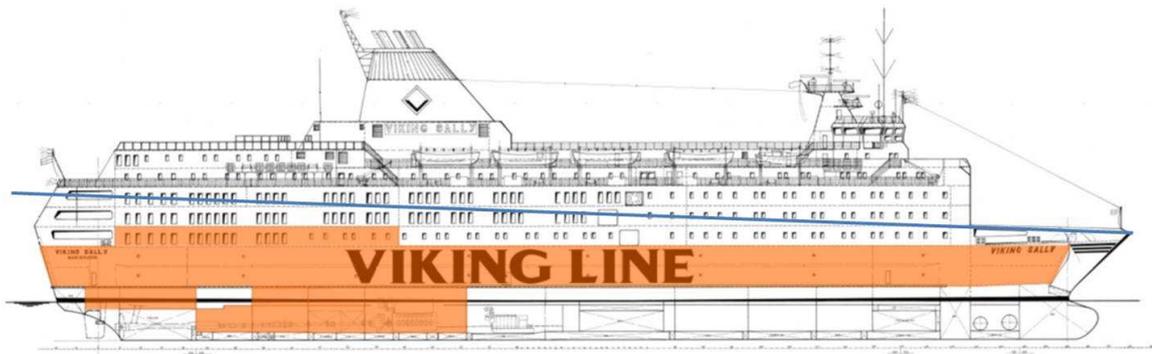
Step 23, 01:22:00

The resulting hydrostatic pressure corresponds to a static water column of 1.64m – but according to paragraph 7.2.1 of DIN ISO 3903, the whole window assembly – of type series „F“ – must resist a minimum pressure of 0.35bar. This is equal to a water column of 3.55m.

In Step 23, the first window collapses - due to a hydrostatic load of a column of over 3.55m. It is the last window on Deck 4 on the starboard side and the compartment behind the window is Main Fire Zone 3 (MFZ). Over subsequent steps, as the water level in this compartment rises, the water pours down to Deck 3, Deck 2 and finally in the Store Room between frames 33 and 43 on Deck 1. This last compartment floods in calculation Step 34.

Figure 12.20: Graphic MFZ 3, deck 4 with later flooding of the Aft Stair Case on Deck 2 and 3 along with the Store Room between frame 33 and 43 of Deck 1, see step 34

Figure 12.22: Side view of step 23 with highlighted compartments beginning to flood and the waterline

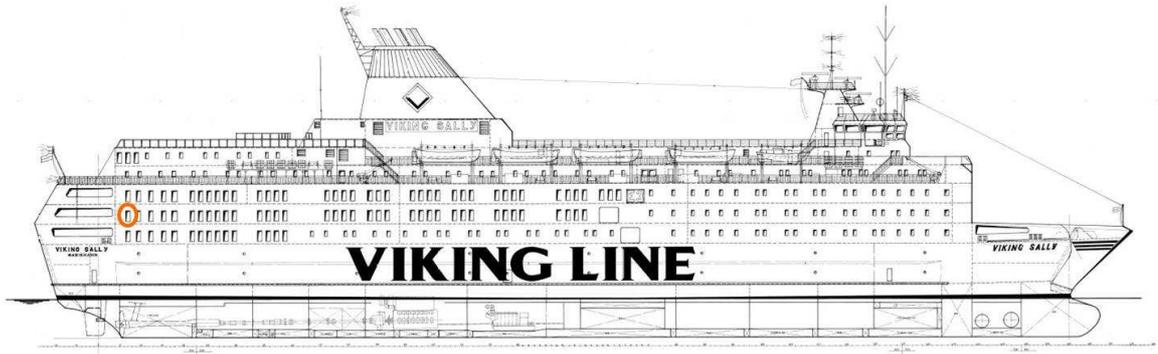
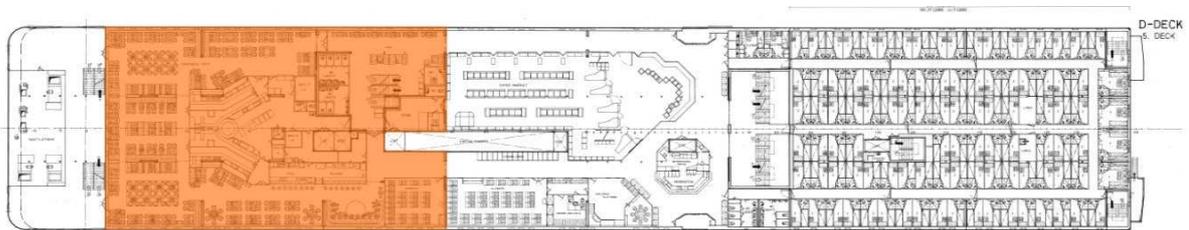
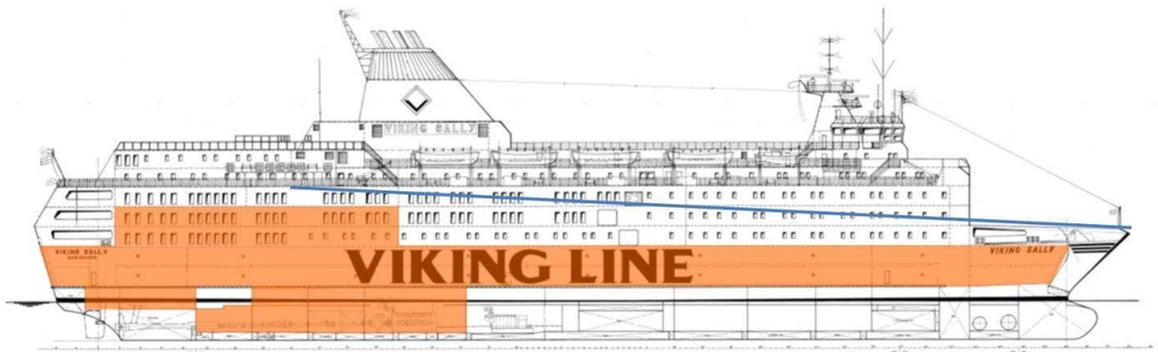
Step 26, 01:23:30

The 400mm x 800mm window resists a hydrostatic water column of 4.16m and the 600mm x 1500mm window resists a hydrostatic water column of 3.55m. These hydrostatical water columns are the minimum resisting values; a conservative approach. But the ferry rolled in a sea state and a additional hydrostatical water column should be added. It is assumed in the following simulation that these two effect compensate each other. The values of 4.16m and 3.55m were implemented in the sinking simulation.

In this calculation step, the second window collapses. The last window on the starboard side on Deck 5, connected to Main Fire Zone 3 with a size of 600mm x 1500mm.

Figure 12.23: Graphic of collapsed window in MFZ 3 on Deck 5 which fails in step 26, 01:23:30

Figure 12.24: Graphic of flooded compartment on Deck 5 in step 26, 01:23:30

Figure 12.25: Side view of step 26 with highlighted compartments beginning to flood and the waterline

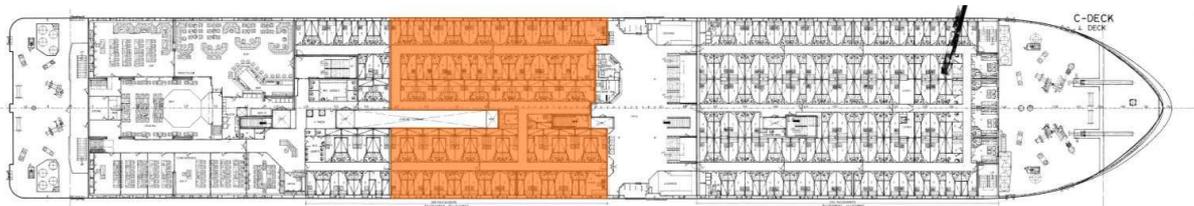
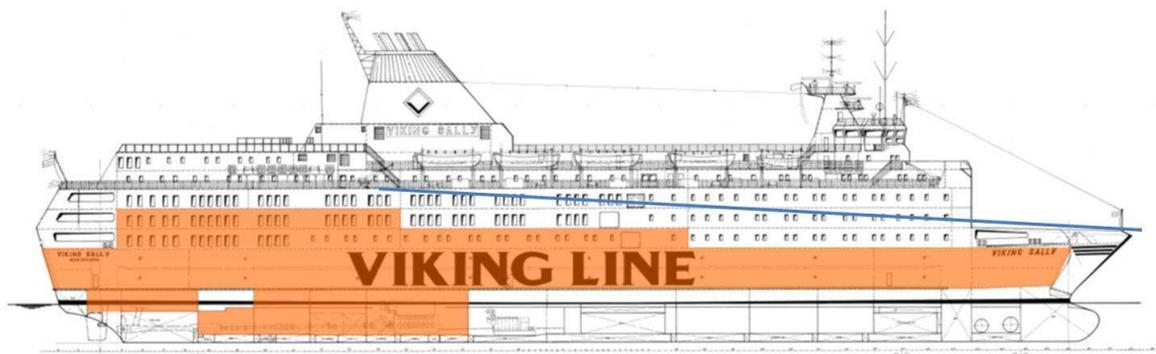
Figure 12.27: Graphic of flooded area on Deck 4, MFZ 2 in step 27, 01:24:00

Figure 12.28: Side view of step 27 with highlighted compartments beginning to flood and the waterline

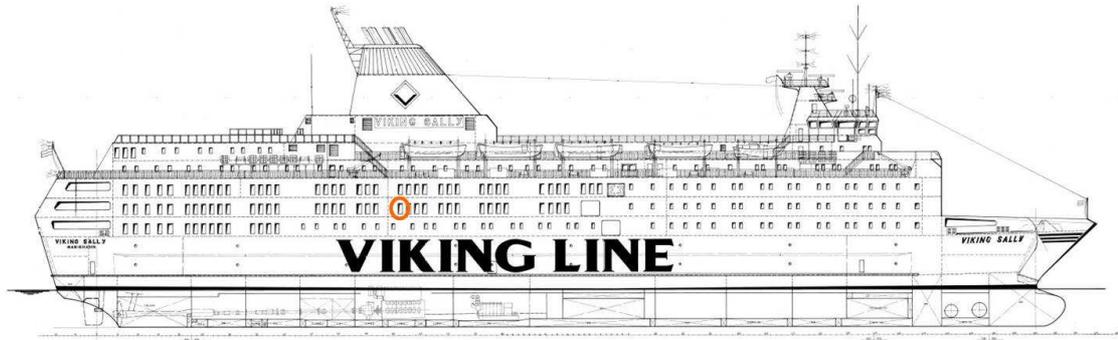
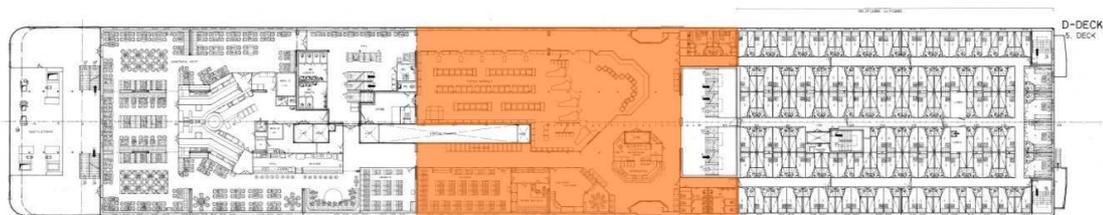
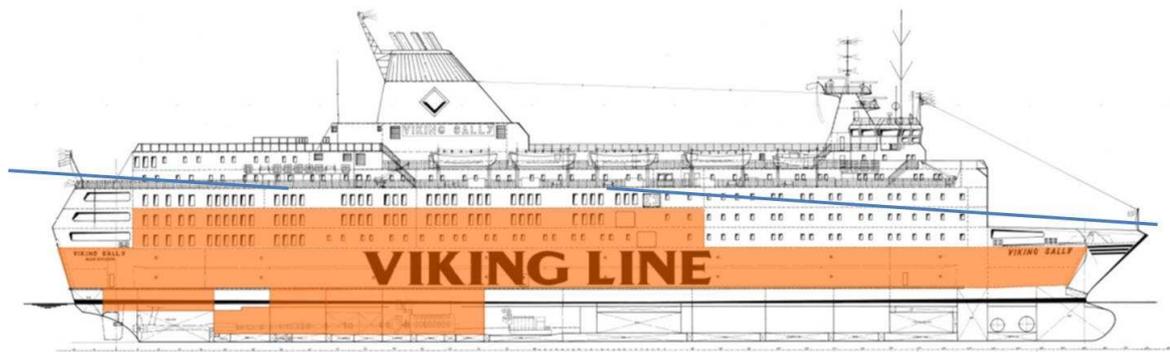
Nearly the same situation as in Step 27, but in this calculation step the large sized window on Deck 5 of Main Fire Zone 2 collapses.

Figure 12.29: Graphic of collapsed window on Deck 5 which failed in Step 29, 01:25:00

Figure 12.30: Graphic of flooded area on Deck 5, MFZ 2 in step 29, 01:25:00

Figure 12.31: Side view of step 29 with highlighted compartments beginning to flood and the waterline

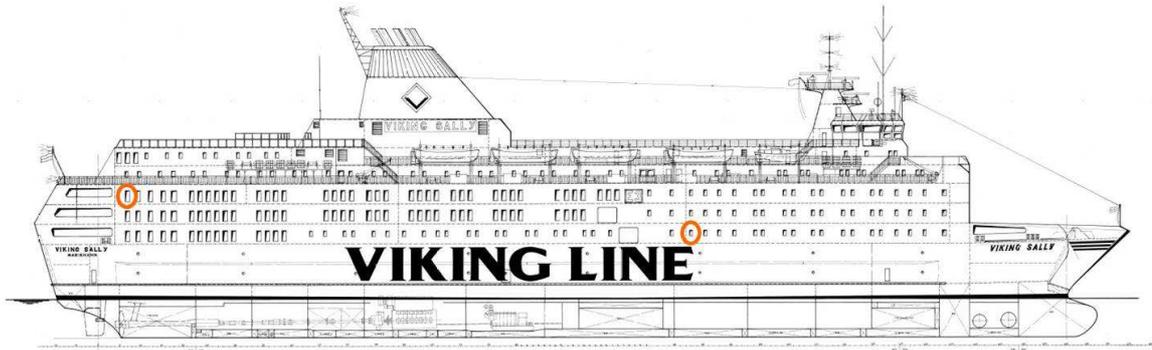
At 01:25:30, the large sized window on Deck 6 of the Restaurant, MFZ 3, as well as the small sized window on Deck 4 MFZ 1 collapsed. Just a glance at the side view of the general arrangement plan suggests the aft-ward trim increased to more than 6.00m, which is more than the height of two decks in the superstructure.

Figure 12.32: Graphic of collapsed windows on Deck 4 and Deck 6, which failed in step 30, 01:25:30

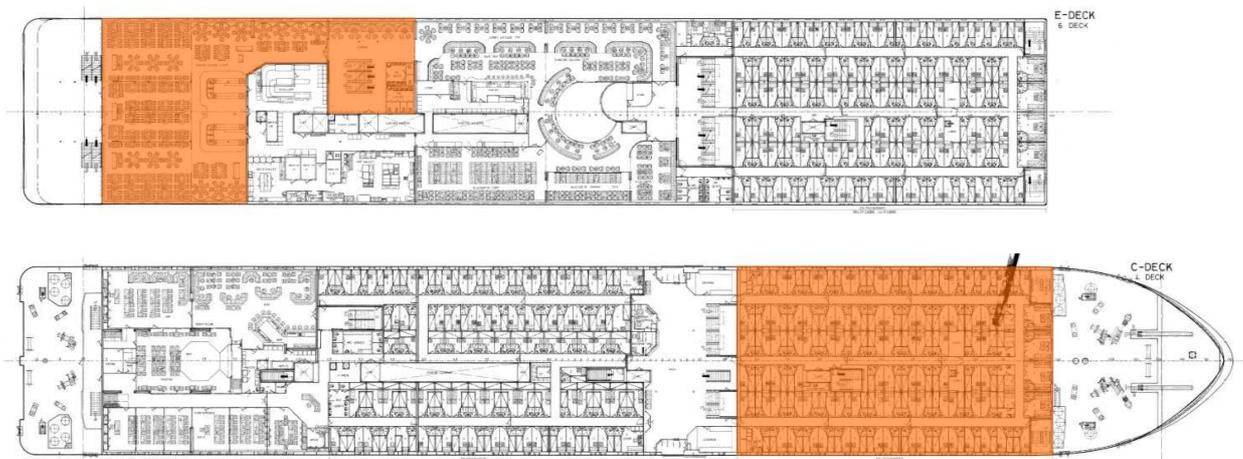
Figure 12.33: Graphic of flooded compartments on Deck 6, Restaurant, MFZ 3 and MFZ 1 on Deck 4 – in step 30

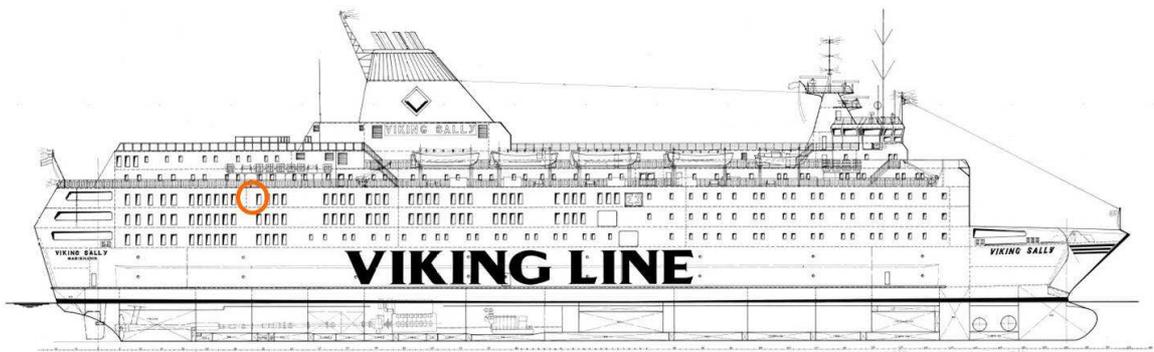
Another window fails, again in Main Fire Zone 3 on Deck 6 - along with the restaurant – this time in the Galley. The Galley is structurally separated from the Restaurant and its very aft ward window collapses in this time step. The following graphic indicates the collapsed window and the adjacent ‘bulkhead’, which divides the Restaurant from the Galley on the starboard side.

Figure 12.35: Graphic of collapsed window on Deck 6 in the Galley along with the ‘Bulkhead’, which divides the restaurant from the Galley

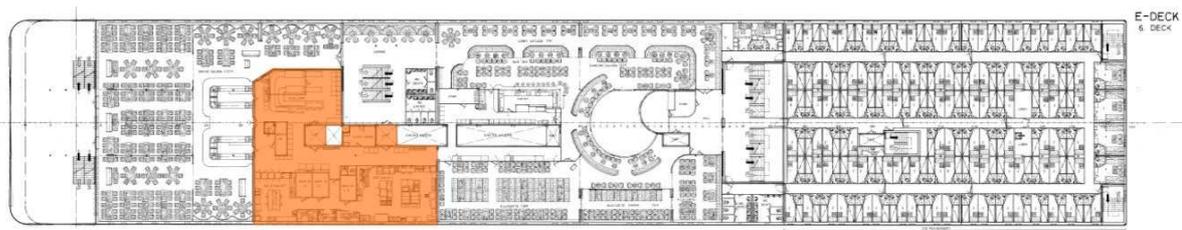
Figure 12.36: Graphic of the flooding of the Galley on Deck 6, MFZ 3, Step 31, 01:26:00

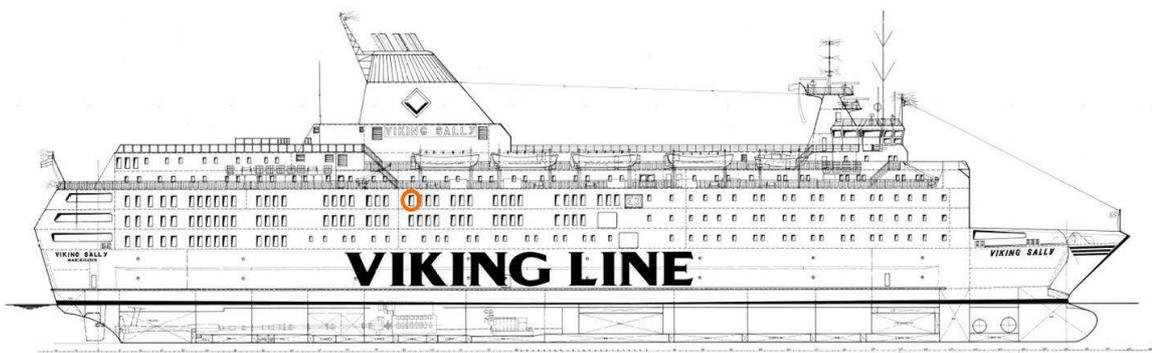
At 01:26:30, the most aft-ward window of Main Fire Zone 2 on Deck 6 on the starboard side collapses. Moreover, the gooseneck ventilator on the forecastle deck on the starboard side is immersed and connects, amongst other things to the Bowthruster Room and the outside of MV Estonia. Again, the gooseneck ventilator is symmetrically arranged, so that as well in this case the air can escape the gooseneck ventilator on Portside of MV Estonia.

Figure 12.38: Graphic of collapsed window on Deck 6, MFZ 2, Step 32, 01:26:30

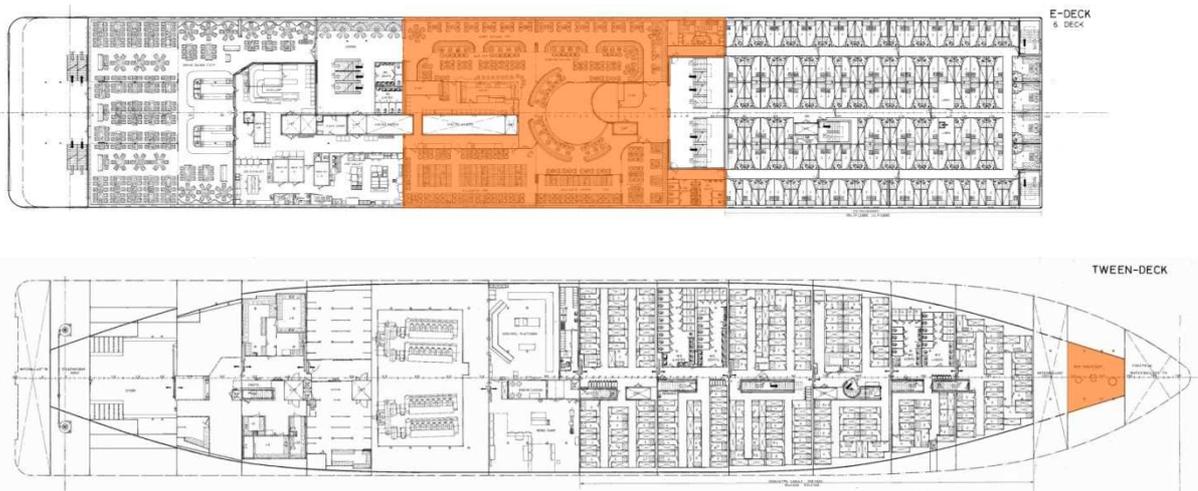
Figure 12.39: Graphic of flooding of MFZ2, Deck 6 and Bowthruster Room on Deck 1 during Step 32

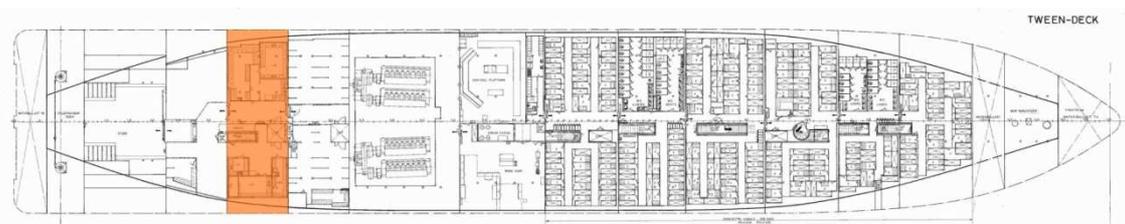
This calculation step follows on from Step 23: The water level of Main Fire Zone 3 on Deck 4 has reached the staircase and now starts flooding the store Room on Deck 1 between frame 33 and 43 via Deck 3 and Deck 2.

Figure 12.41: Graphic showing flooding of the Store Room between Frame 33 and 43 of Deck 1, see step 23
