The Sinking Sequence of MV Estonia

Dem Promotionsausschuss der
Technischen Universität Hamburg-Harburg
zur Erlangung des akademischen Grades
Doktor-Ingenieur (Dr.-Ing.)
genehmigte Dissertation

This thesis reconstructs the sinking of the RoPax Ferry MV Estonia on September 28th 1994, with a strong focus on describing the chain of events that caused the eventual sinking, and how the ship sank. Once the sinking is understood, this thesis explores possible safety improvements that should be implemented in the design of new vessels of this type. The investigation is based on a combination of testimonies of survivors as well as numerical calculations based on the framework of the testimonies.

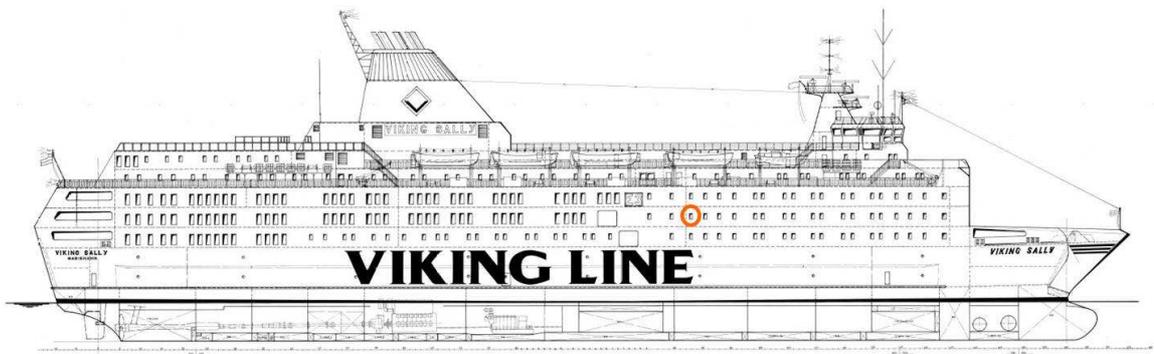
With calculation Step 35 at 01:28:00, a steady list of more than 60° has been reached. As described before, the second cargo shift takes place with an amplitude of 0.50m – leading to a total shift of 1.5m – of all vehicles on the Main Car Deck. At the same time, the aft-ward window of Main Fire Zone 1 on Deck 5 on the starboard side, collapses.

Figure 12.43: Graphic of collapsed window on Deck 5, MFZ 1, step 35, 01:28:00

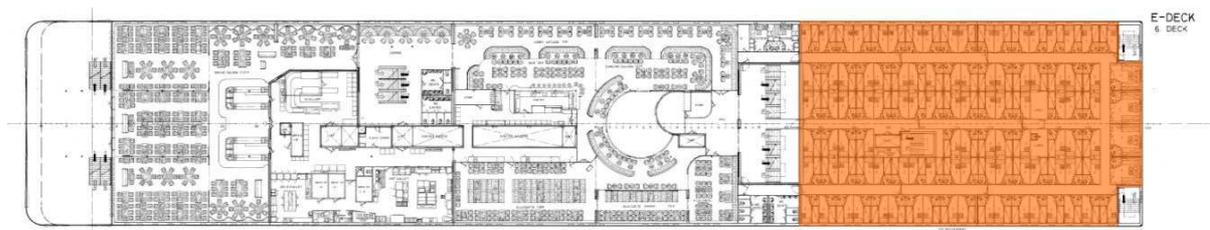
Figure 12.44: Graphic of flooded compartments on Deck 5, MFZ 1 in step 35, 01:28:00

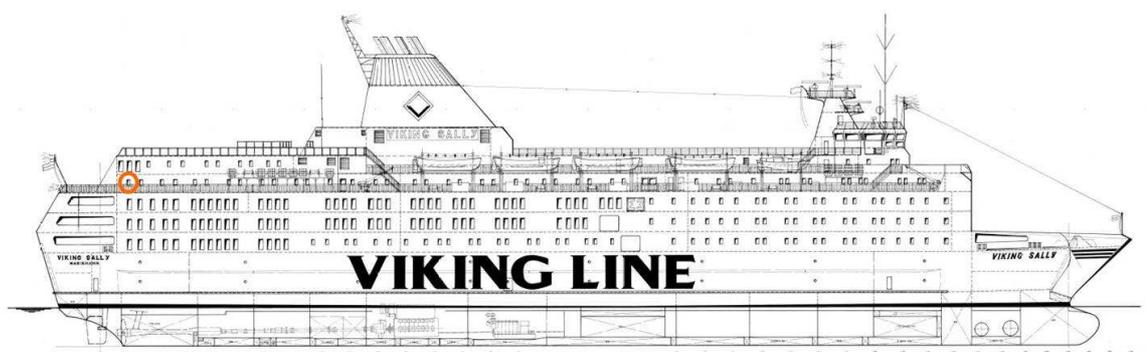
At 01:29:00, the most aft ward window of Deck 7 collapses. This is a large sized window in Main Fire Zone 3, which is non-water-tightly connected by an internal staircase to Deck 8. For these simulations, these two Main Fire Zones were calculated together. In later time steps the following occurs: in step 38, the door on Deck 7 at frame 48 collapses and in step 39 the aft most window on Deck 8, Main Fire Zone 3 collapses.

Figure 12.46: Graphic of collapsed window on Deck 7, MFZ 3, step 37, 01:29:00

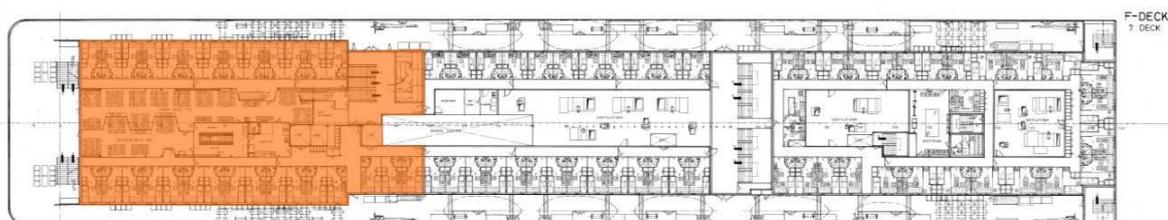
Figure 12.47: Graphic of flooded compartments on Deck 7, MFZ 3, step 37, 01:29:00

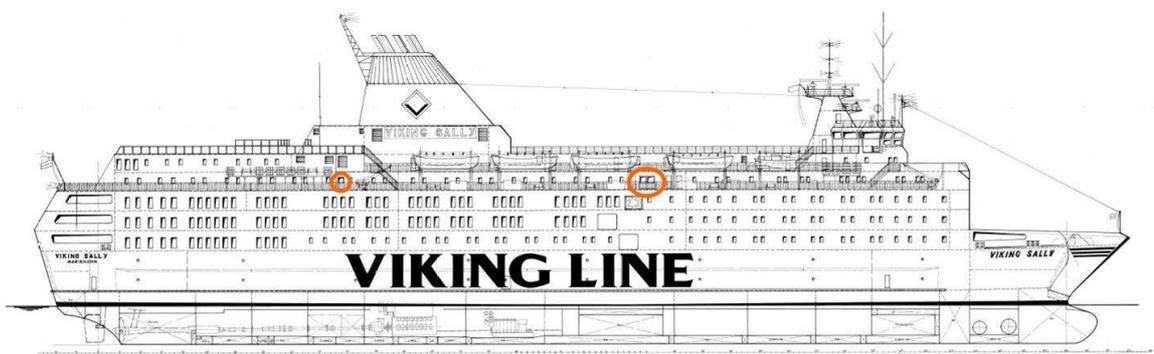
As mentioned in Step 37 the door on Deck 7, frame 48 collapses. Although the hydrostatic pressure is less on the door on Deck 7 at frame v leading to the Centre Stair Case than on the door at frame 48 on the same Deck they collapse in the same time step. This is due to the fact that the door at frame v is two-wing door, which can only resist a lower hydrostatic pressure.

Figure 12.49: Graphic of the two collapsing doors on Deck 7, MFZ 3 and the Centre Stair Case

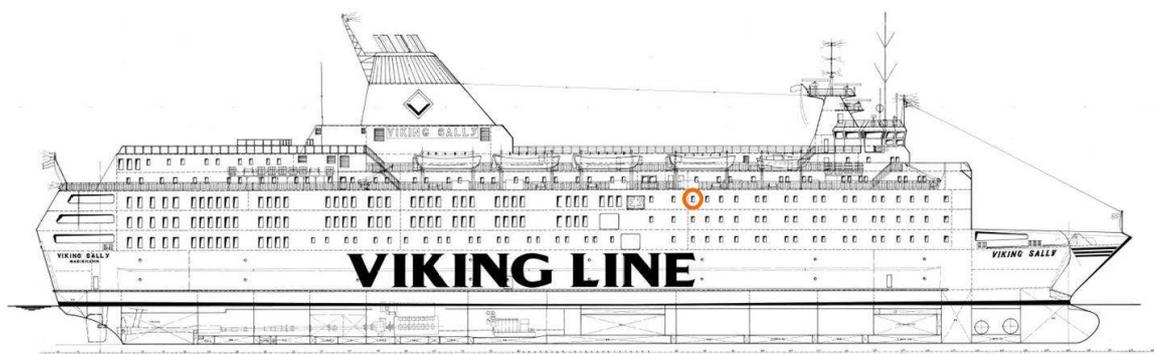
At half past one, the aft most window of Main Fire Zone 1 on Deck 6 collapses.

Figure 12.53: Graphic of collapsed window on Deck 6, MFZ 1, step 39, 01:30:00

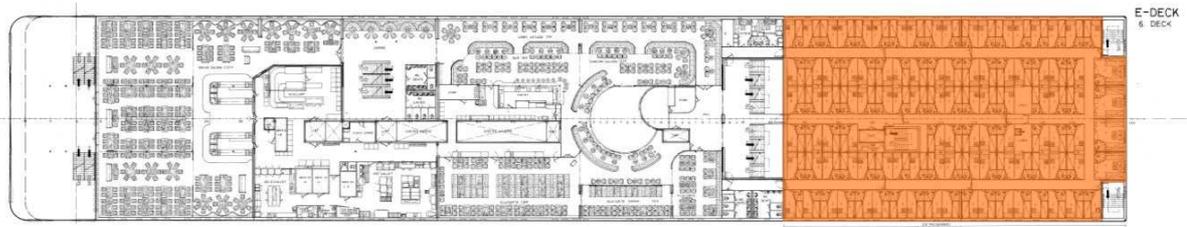
Figure 12.54: Graphic of flooded compartments on Deck 6, MFZ 1, in step 39, 01:30:00

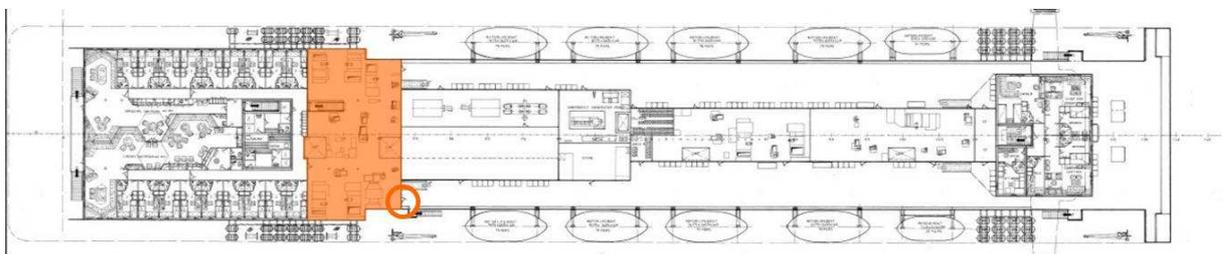
The Engine/Machinery Room on Deck 8 in Main Fire Zone 3 is calculated separately from crew-cabin area of this Main Fire Zone. The water ingress to this compartment takes place by the indicated door.

Figure 12.56: Graphic of flooded compartments, along with the door through which the water flows on Deck 8, MFZ 3, step 41, 01:31:00

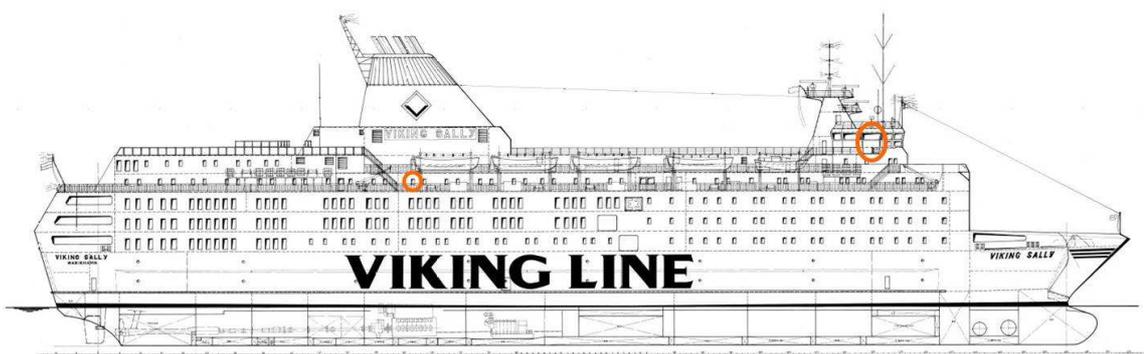
In this calculation step, the last window of Main Fire Zone 2 on the starboard side collapses, as does the window of the wing bridge on Deck 9. Additionally, the compartment on Deck 9 below the funnel is flooded, but note, that the jalousie is not the same as drawn on the side view. Nevertheless, the influence on the calculation is neglectable.

Figure 12.58: Graphic of Collapsed Windows on Deck 7, MFZ 2 and the wing of bridge, Deck 9

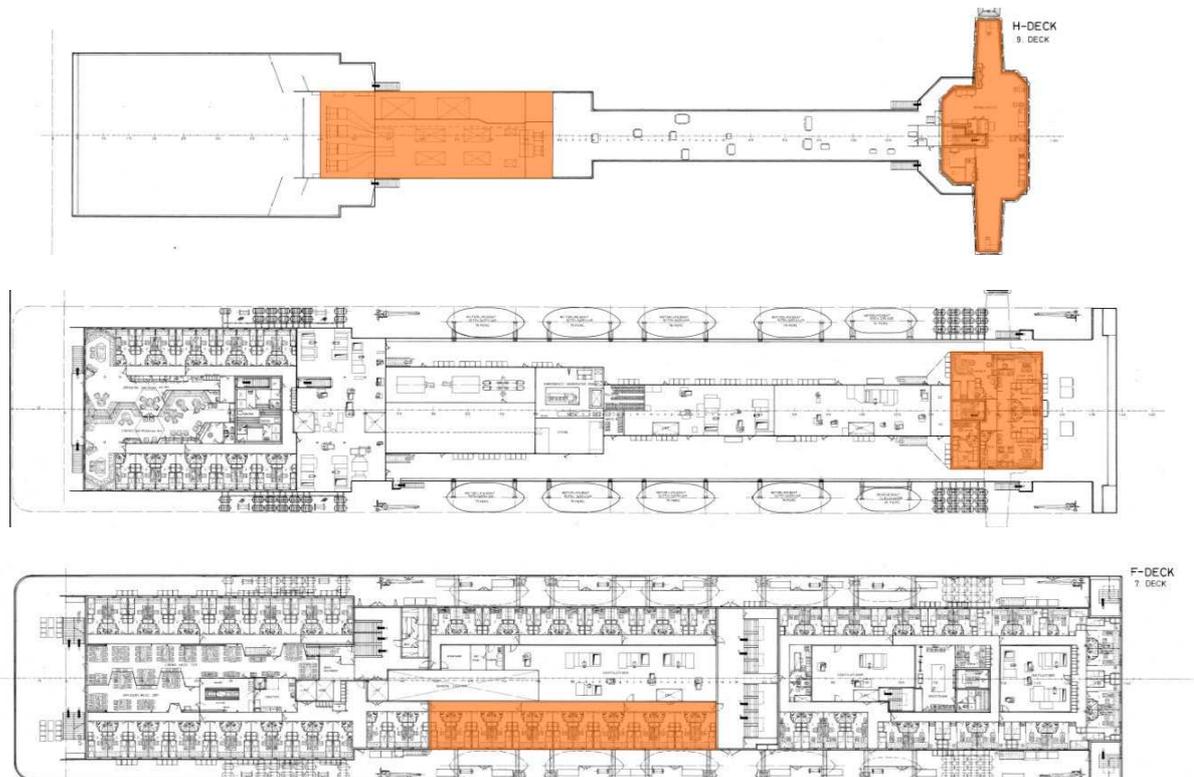
Figure 12.60: Graphic of the flooded compartments on Deck 7, Main Fire Zone 2, starboard side, the compartment below the funnel and the combined compartment of the Crew-Cabin Area of Deck 8, Main Fire Zone 1, and the Wheel House

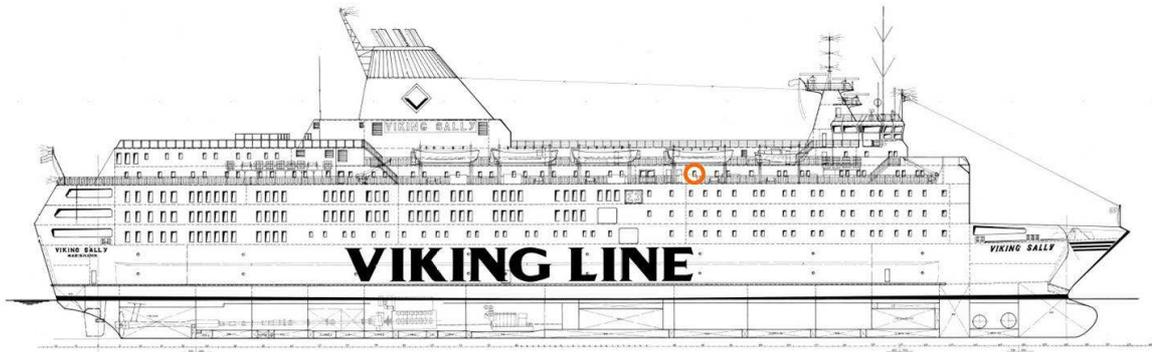
In Step 43, the aft most window of Main Fire Zone 1 of Deck 7 collapses.

Figure 12.61: Graphic of collapsed window on Deck 7, MFZ 1, step 43, 01:32:00

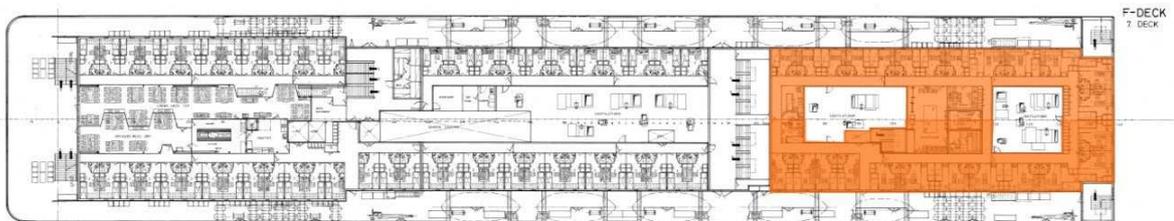
Figure 12.62: Graphic of flooded compartments on Deck 7, MFZ 1, step 43, 01:32:00

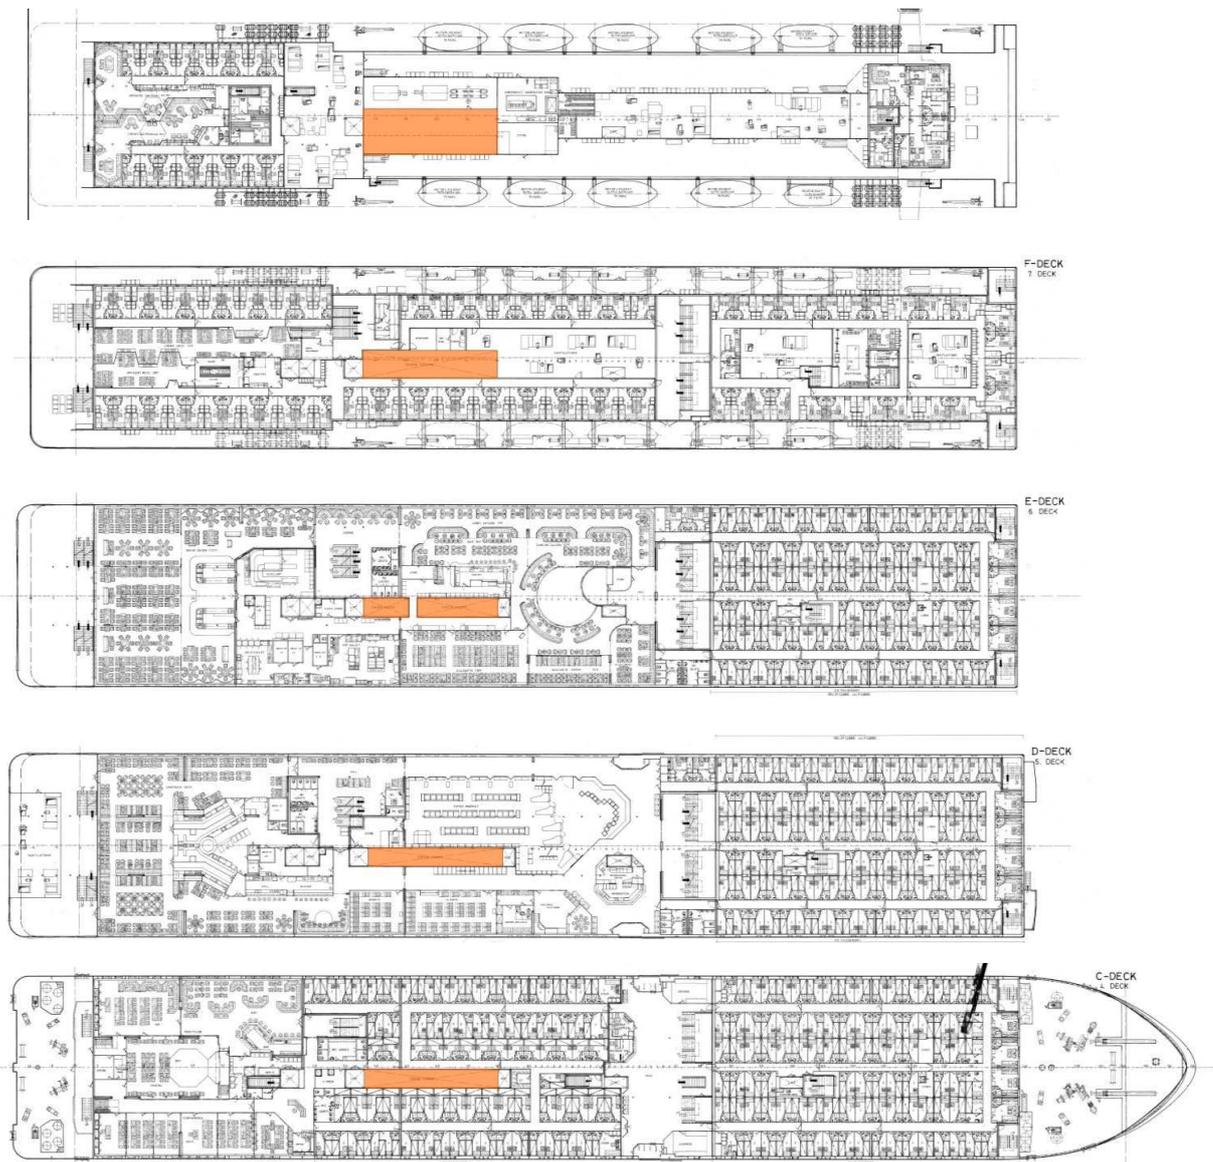
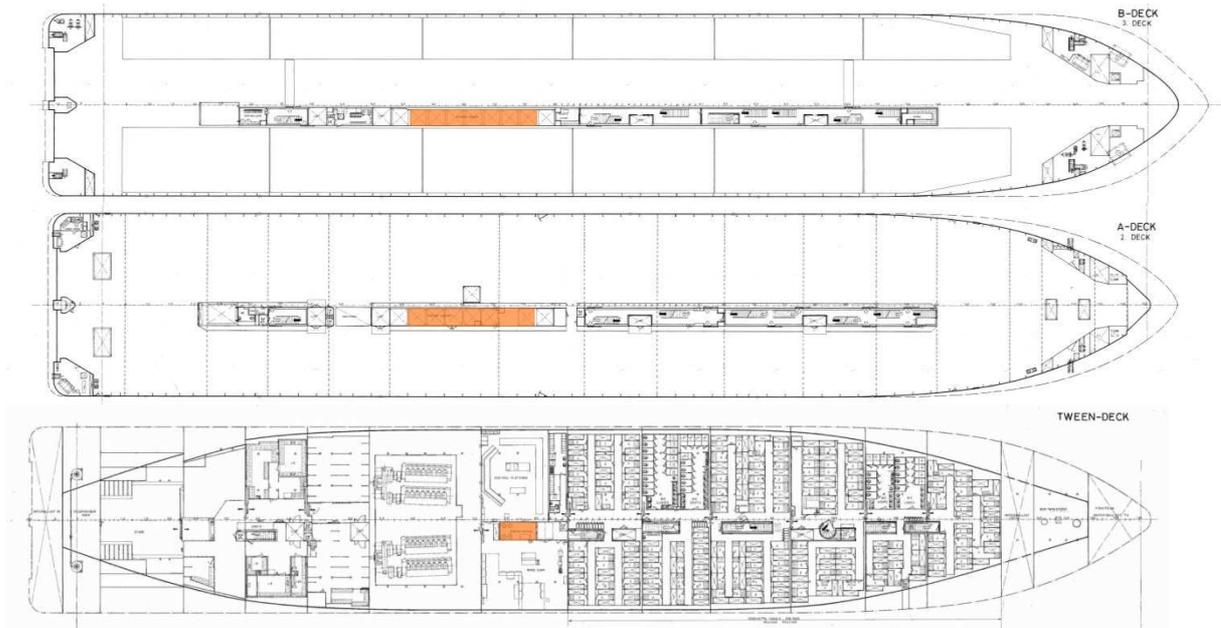
At 01:32:30, the Engine Casing of the Main Engine Room and the Auxiliary Engine Room are immersed. The water ingress into the two casing systems are via the large jalousies of the compartment below the funnel, which is immersed in step 42.

Figure 12.64: Graphic of the flooded engine casings for the Main and the Auxiliary Engine Room, part one

Figure 12.65: Graphic of the flooded engine casings for the Main and the Auxiliary Engine Room, part two

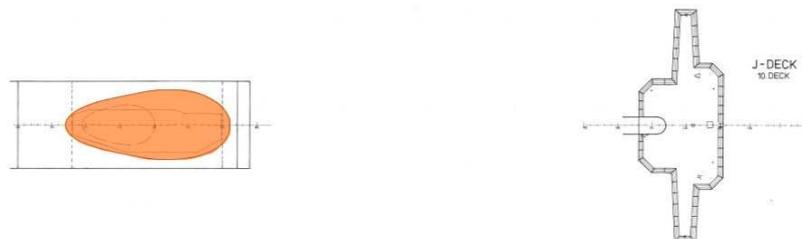
In this calculation step, the top of the funnel is immersed.

Figure 12.67: Graphic of the immersed area of the funnel in Step 46, 01:33:30

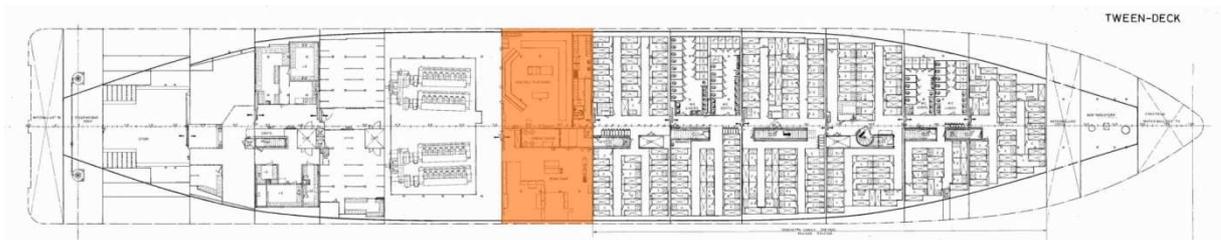
Via the Auxiliary Engine Case, the Engine Control Room and the Work Shop on Deck 1 are flooded.

Figure 12.69: Graphic of flooded compartments on Deck 1, Engine Control Room and Workshop

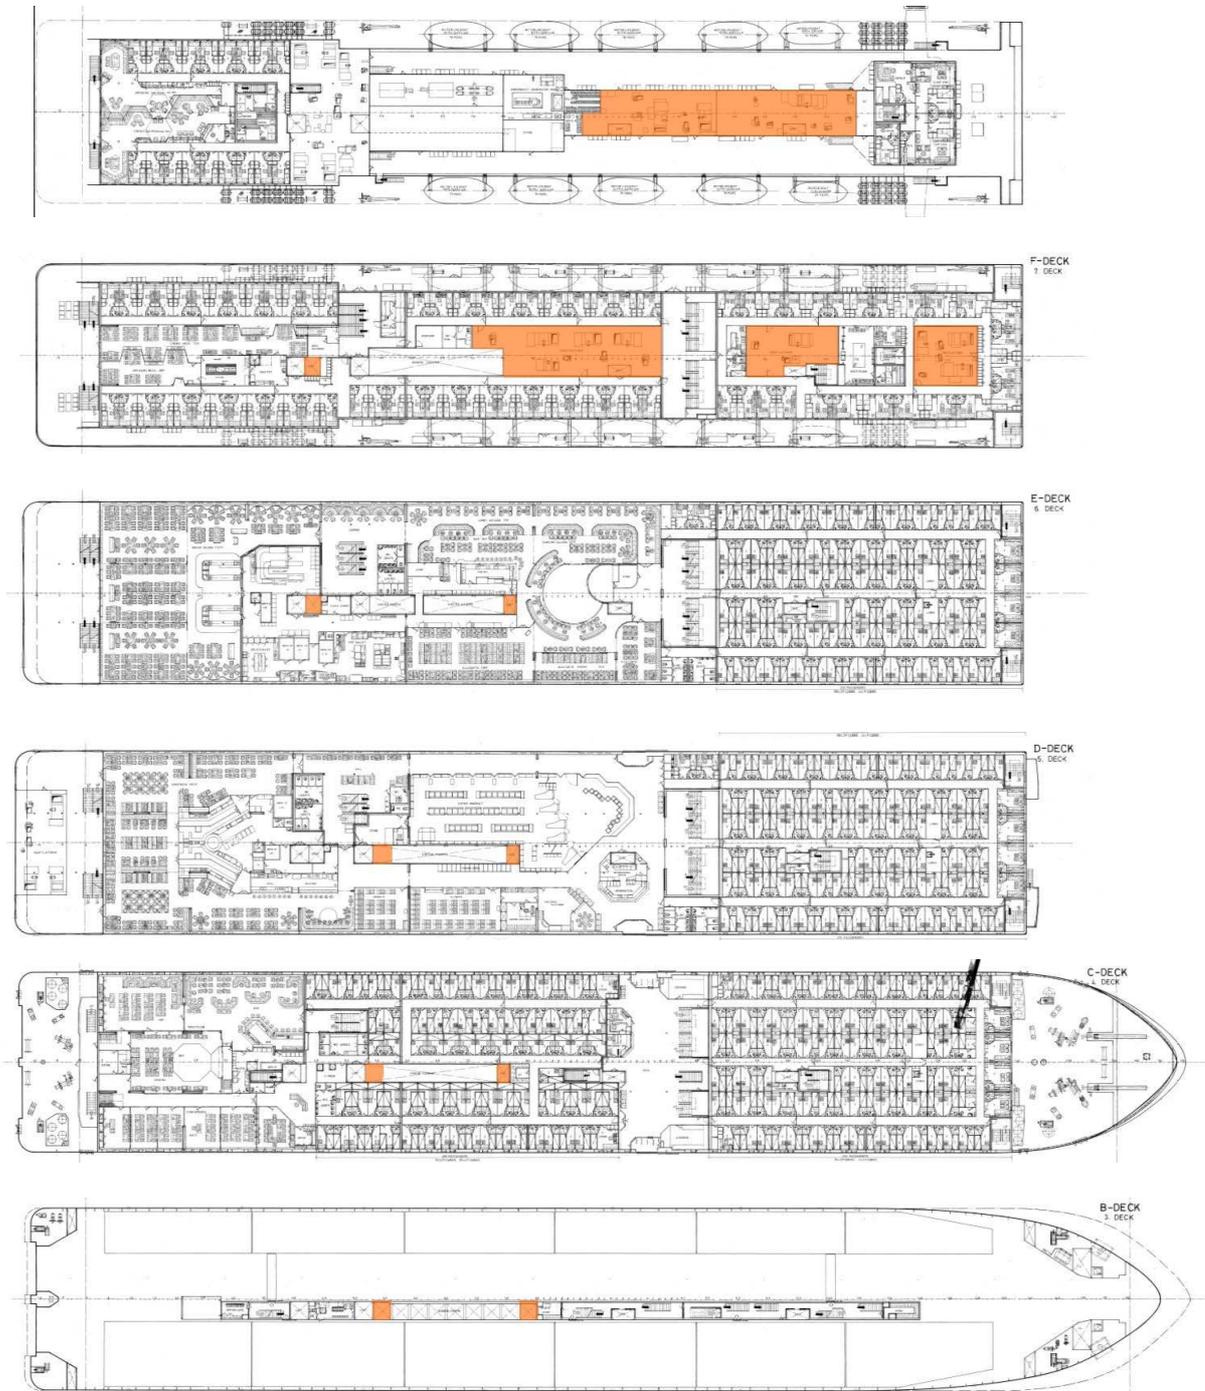
This step is very similar to step 44 in that the ventilation system cutting through nearly all decks becomes waterlogged via water ingress through the doors of the Ventilation Compartments on Deck 8.

Figure 12.71: Graphic of the flooded ventilation ducts and compartments, part one

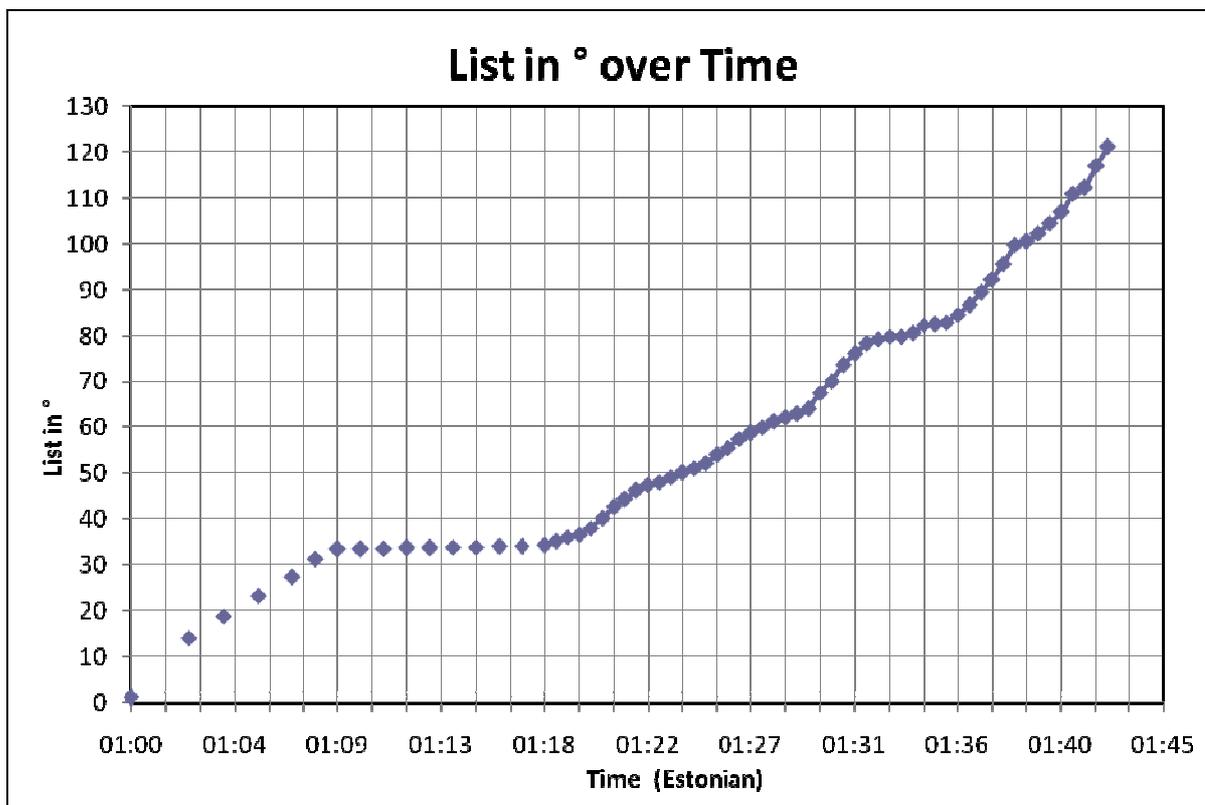
Figure 12.75: Graph of list in ° over local Estonian time

The main finding of the quasi-static approach, with its the hydrostatic calculation steps, is that the loss of watertight integrity started a chain reaction. The vast amount of water entering the Main Car Deck at 01:00 or very shortly after causes, due to the large free surface and the corresponding fluid shifting moments, a steady list of a little more than 30° to starboard in a period of less than 9 minutes.

The initial aft-ward trim was reduced by the ingressing water, but – from the static point of view – at no time was MV Estonia on even keel or had a forward trim. The phase of between 01:09 to 01:18 is a quasi-steady list. The average water ingress onto the Main Car Deck was 20t to 40t per minute during this period of time. Water then flowed into the Steering Gear Compartment on Deck 1 through the ventilation duct in

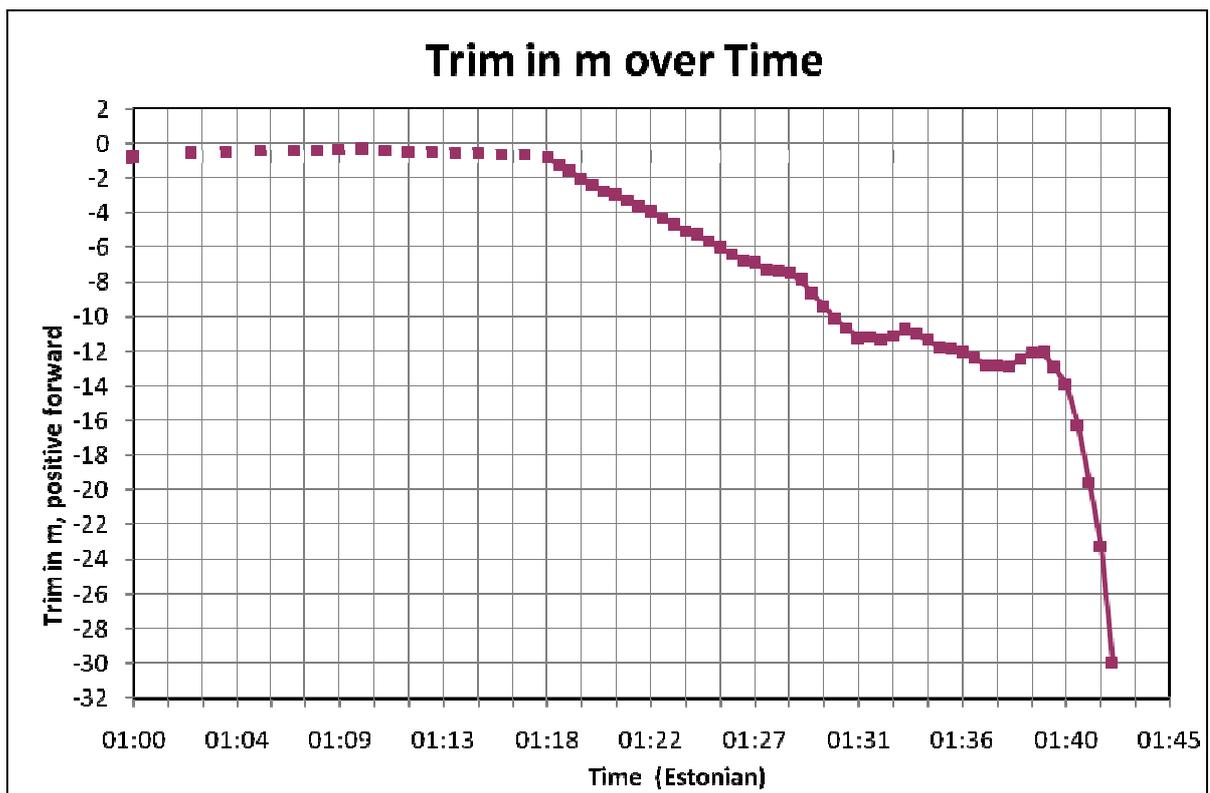
Figure 12.76: Graph list in $^\circ$ over local time

At about 01:22, the first window collapses on the first deck above the vehicle decks, Deck 4, at the aft part of the ferry. This again increases the starboard list and the aft-ward trim. The rate of increase of the trim however decreases as more and more of the forward compartments begin to flood. From 01:39 onwards, the trim increases rapidly until 01:43 when the the stern of the vessel hit the sea bed. At this time the heeling angle is a little more than 120° and thus about the angle of the vessel on the seabed, as described in the Rockwater Report [Rock].

This is an explanation for both the completely intact port-side stern part of the vessel and the circumstances of the wreck, dug in the sea bed nearly to the centre line (CL).

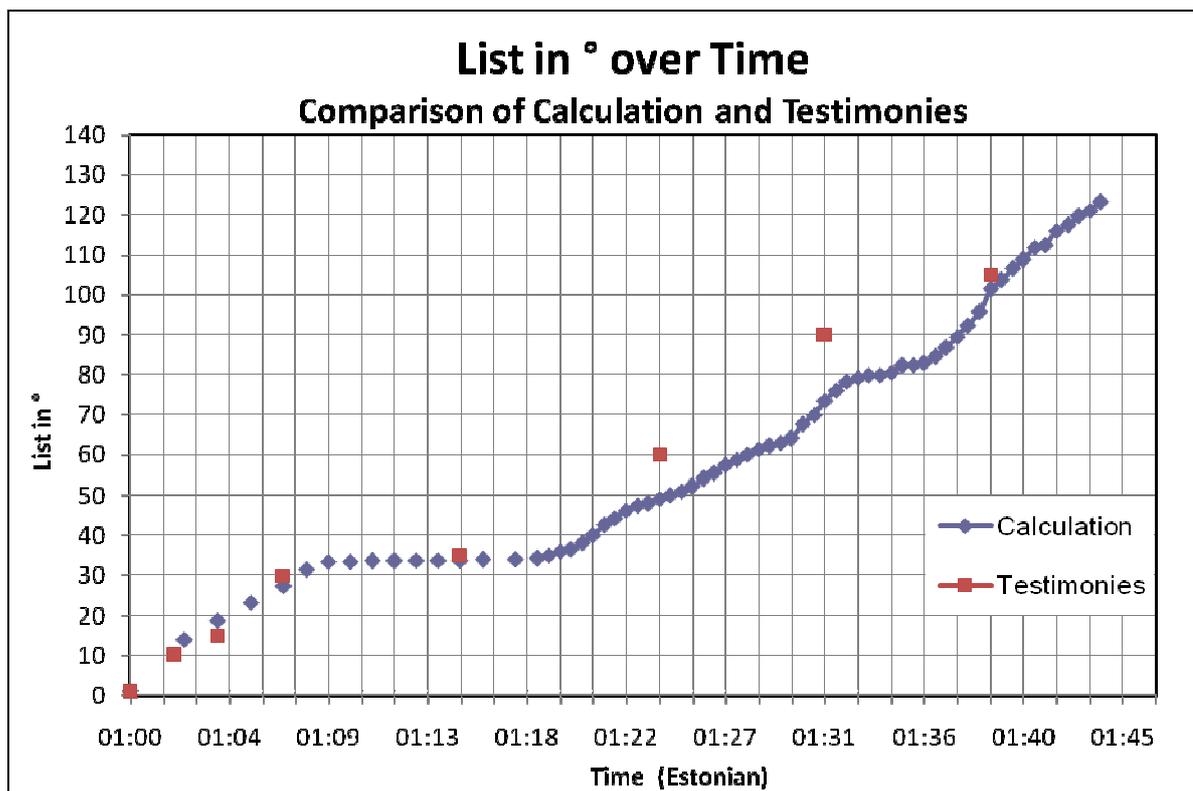
Figure 12.77: Graph showing a comparison of calculation with testimony, list in ° over local time

Note: many survivors report of walking on the shell of the Portside of MV Estonia. The time for which the heeling angle is from about 80° to 100°, when walking on the

To sum it up, the results of the calculations are in line with the testimonies of the witnesses, see also *Figure 12.77*.

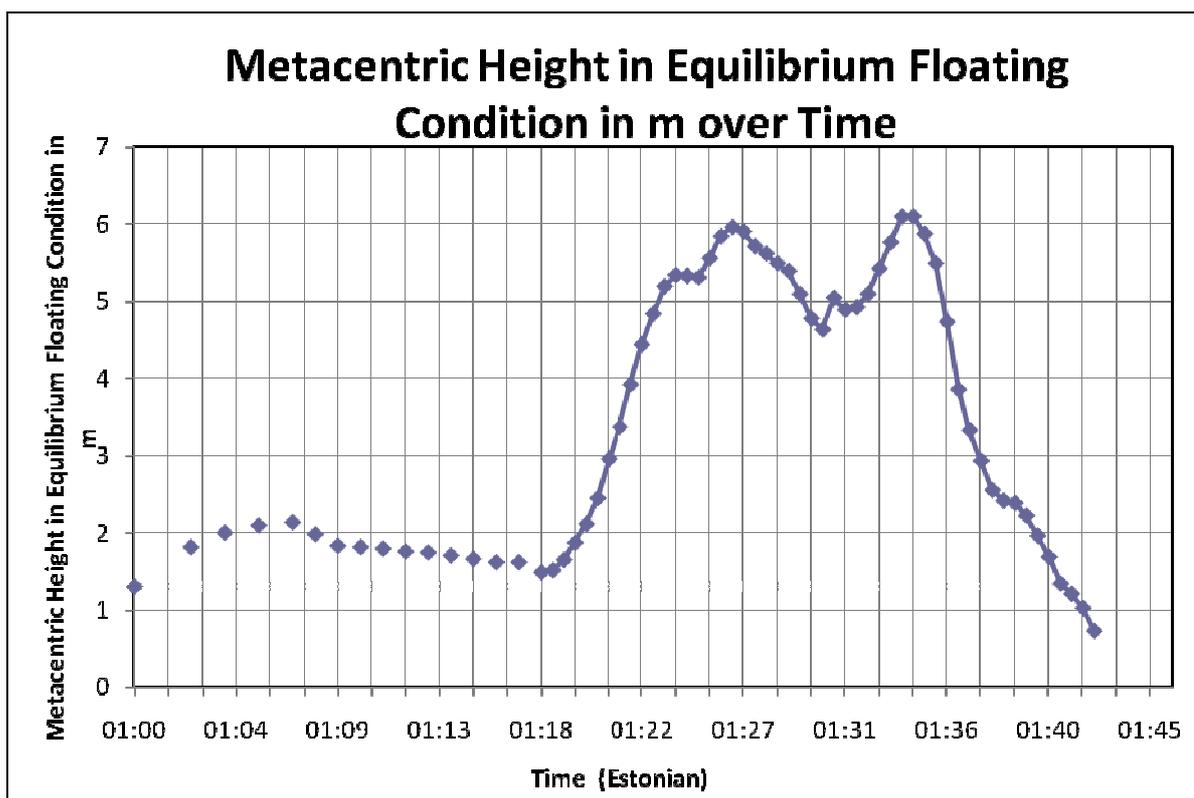
Figure 12.78: Graph of metacentric height in equilibrium floating condition over local time

The diagram “Graph of metacentric height in equilibrium floating condition over local time”, *Figure 12.78*, shows very clearly a high level for the metacentric height over a large period of the sinking sequence. As the metacentric height is an indicator of the energy needed to move a vessel out of its equilibrium floating condition, it is very unlikely, that MV Estonia completely overturned. In other words: it is very unlikely that MV Estonia capsized upside down within a very short period of time, as explained in [JASIO01].

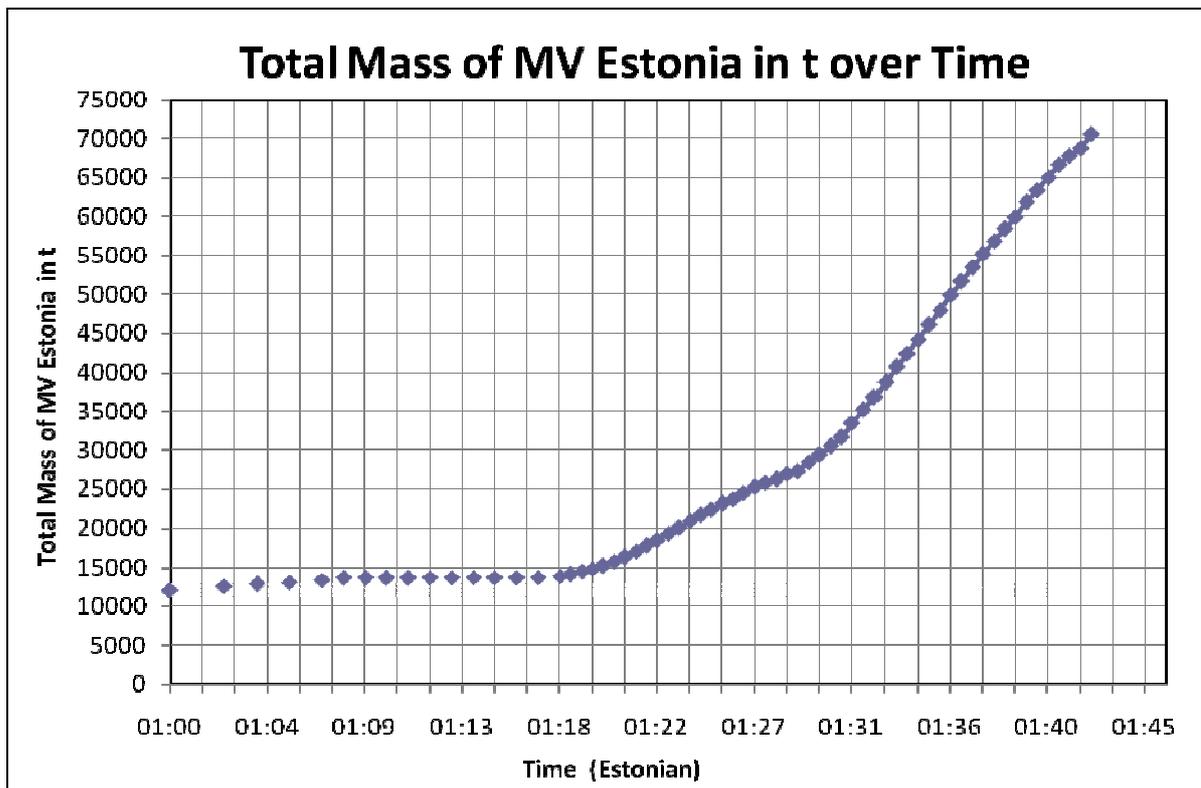
Figure 12.79: Graph of total mass of MV Estonia over time

The figure “Graph of total mass of MV Estonia over time”, *Figure 12.79*, indicates a smooth and steady increase of the mass of the vessel with an acceleration of the

sinking sequence beginning at about half past one. This again goes in line with the testimonies of the survivors. At that time, the double door on Deck 7 connecting the Centre Stair Case with the boarding area of the lifeboats bursts and a large amount of water flushes in to the Centre Stair Case.

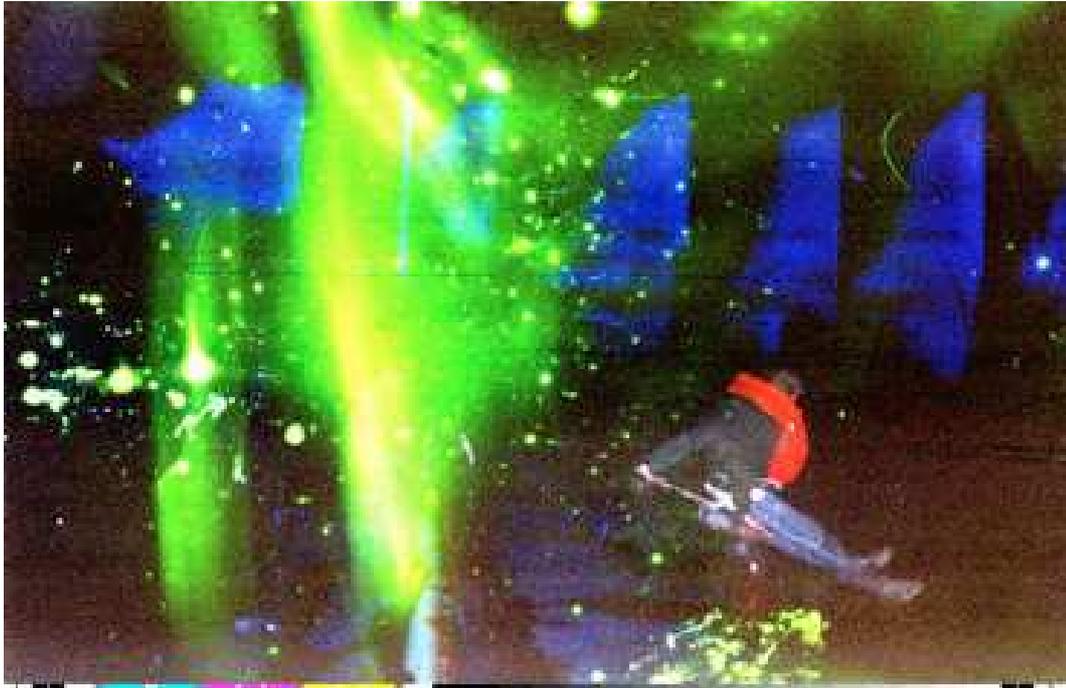
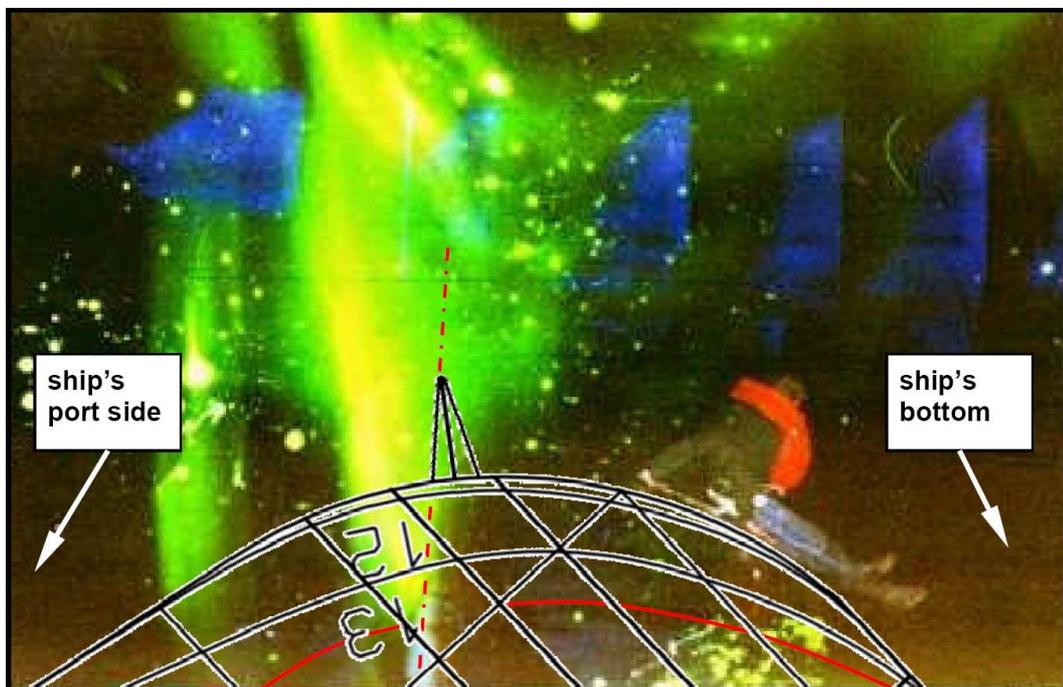
A survivor of the catastrophe, P92, who took the picture *Figure 13.2/ Figure 13.3* sitting on the bilge keel a few minutes before MV Estonia disappeared from the surface, noted after the presentation of the results of both consortia in May 2008 in

Stockholm, that the trim presented by the SSPA-Consortium was too low compared to his experience.

Figure 13.2: Picture taken by a survivor a few minutes before MV Estonia disappeared from the surface whilst sitting on the Bilge Keel [P92]

Figure 13.3: The same picture like Figure 13.7, but the body plan of MV Estonia also plotted in this picture, [HSVA02]. [HSVA02] calculated a list of 133°

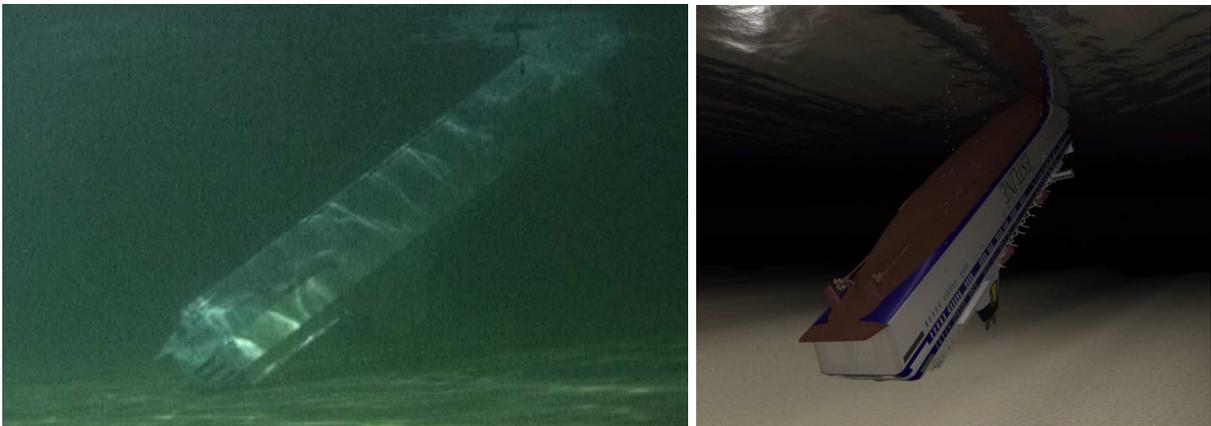
Beside the observations of passenger P92, another fact is to supplement in this context. The SSPA-consortium calculated and found out by experiment that MV Estonia turtle turned completely in a upside-down condition to a list of 180° before she hit the sea floor. A picture of the experiment can be seen in see *Figure 13.4* as well as a snapshot of the simulation. In Chapter 6 was exposed that the stern had no or only on Deck 8/ Deck 9 minor damages. The observation of P92 and the none existing damage situation of the stern of MV Estonia does not fit to the last step of the sinking sequence of the SSPA-consortium.

Figure 13.4: Hitting the sea floor in complete up-side-down condition, a list of 180° in model test and simulation of [SSPA05]

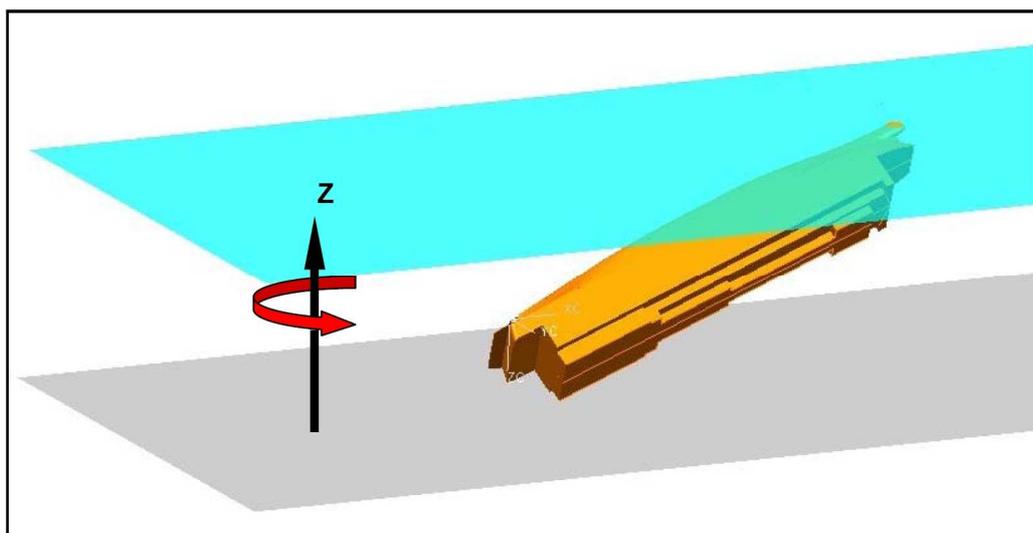
*Figure 13.5: Hitting the sea floor **not** completely turtle turned, at a list of about 130° like the author calculated [HSVA02]*

It seems to be more likely that MV Estonia developed more trim than the SSPA-consortium calculated. And it also seems to be more likely that MV Estonia hit the sea floor about in that list how she was found by the salvage company Rockwater. *Figure 13.5* shows the heeling angle in which MV Estonia probably hit the sea floor, about 130°.

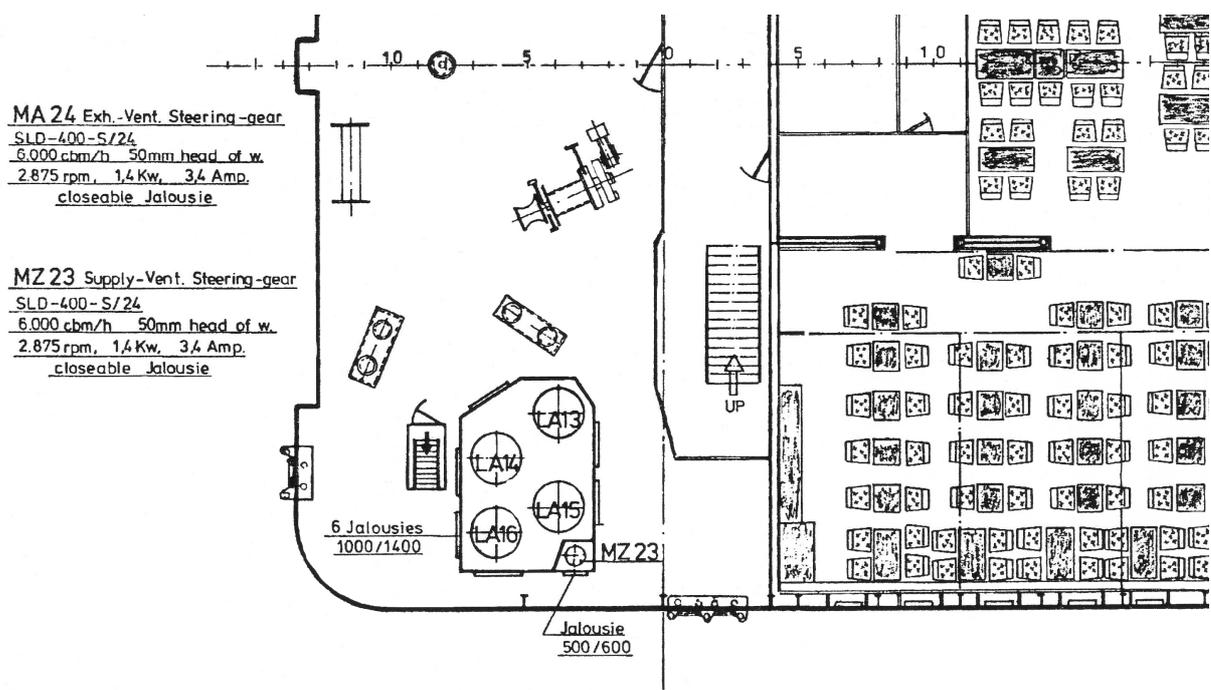
Figure 13.6: Aft Wing House, Starboard Side, Deck 4, top view, Drawing S590 – 64/1

The upper opening of this ventilation duct, called ‘MZ23’ see *Figure 13.6*, is immersed between 01:19:00 and 01:19:30 whilst the trim is registered to be 1.65m to 2.0m.

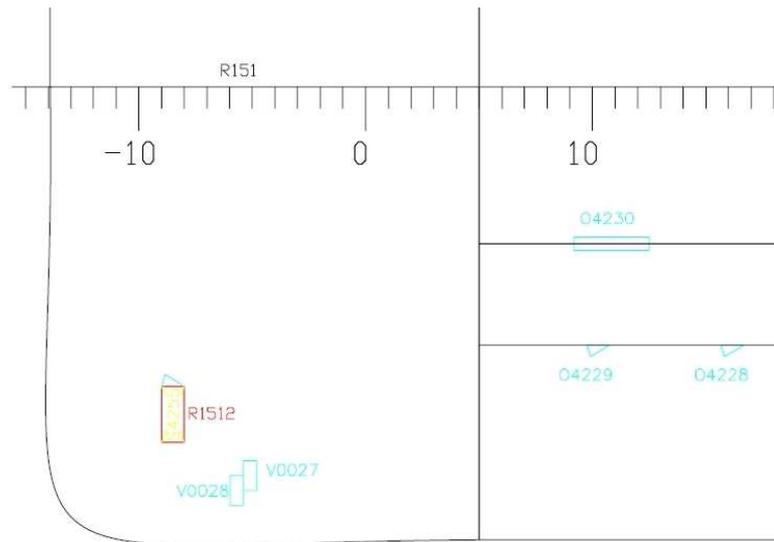
Figure 13.7: Aft of MV Estonia, Deck 4, digital-model, spaces and opening codes [JASIO02]

ventilation opening is not modelled in the digital model showing spaces and is not listed in the opening codes of the SSPA-consortium, as shown in the detail *Figure 13.7*. Only the four ventilation ducts, cylindrical in shape, which pump out the exhaust air off the Main Car Deck were modelled to be two rectangular ducts. Consequently, the Steering Gear Compartment and the horizontally non-watertight linked compartment stays dry.

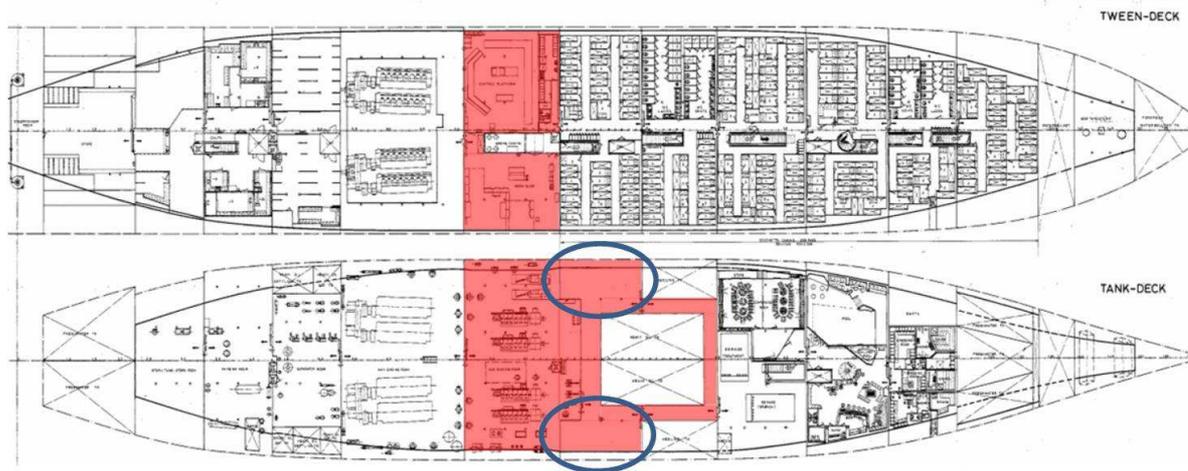
Engine Room. Looking at *Figure 13.8*, where in this particular compartment the stabiliser fins were fitted, [JASIO01] states that this compartment was not flooded, however, the digital model of [SSPA03] indicates that this compartment will flood - by its white colour in this figure , *Figure 13.9*.

Figure 13.8: The blue circles mark the areas of the Stabiliser Fins which are not considered in [JASIO01]

Drawings of *Figure 13.8* and *Figure 13.9* do not fit together, because *Figure 13.8* shows the Steering Gear Compartment and the linked, non-watertight, compartment to be flooded, but again without modelling the appropriate ventilation duct.

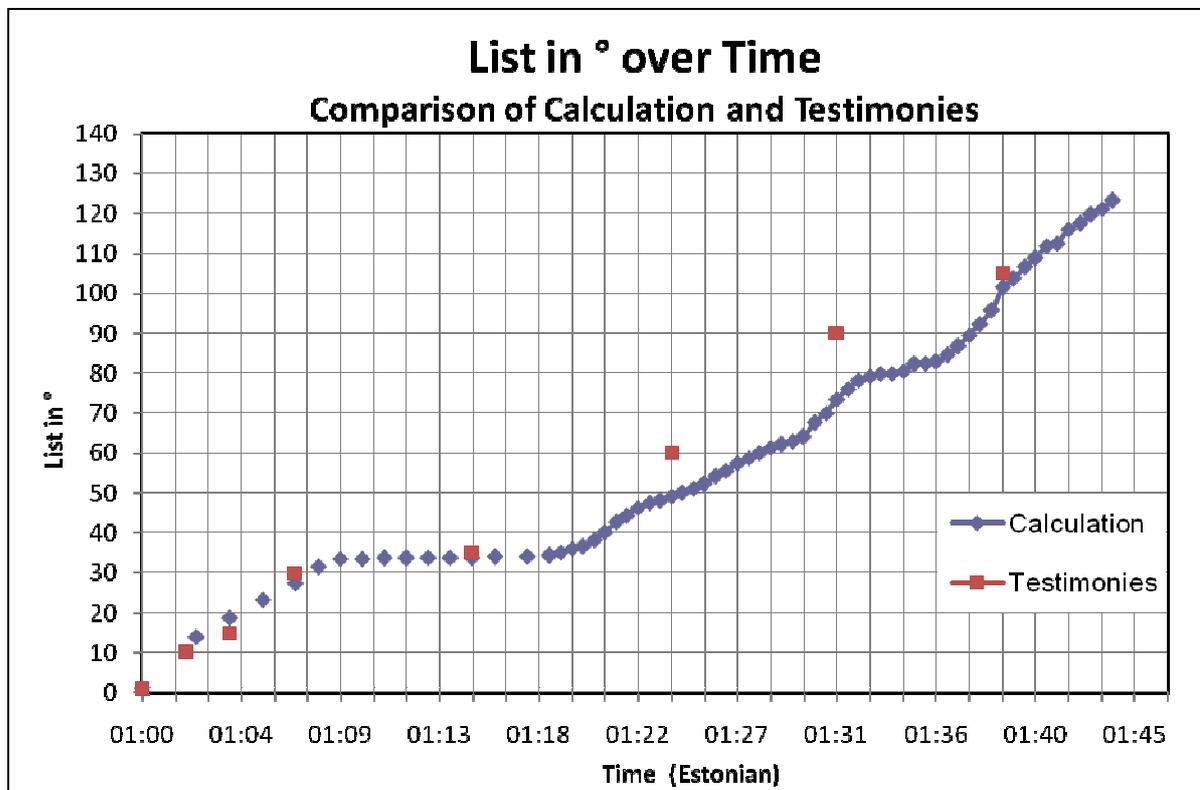
Figure 14.1: Graph of comparison of calculation and testimonies, list in ° over local Estonian time

MV Estonia sank stern first with a list of a little more than 120° to starboard and consequently hit the seabed, with the top of Deck 9 making first contact. This corresponds to the observation of the diving company Rockwater, which surveyed the vessel a few days after its sinking. The computed list over time graph is roughly in line with the testimonies of the survivors as investigated and evaluated at the beginning of this thesis. The “Graph of comparison of calculation and testimonies, list in ° over local Estonian Time”, *Figure 14.1* documents this result. This physically plausible

sinking scenario suggests that the sinking sequence has taken place more or less or like these calculations.
