RESEARCH ARTICLE

Quantification of the Contact Area at the Head-Stem Taper Interface of Modular Hip Prostheses

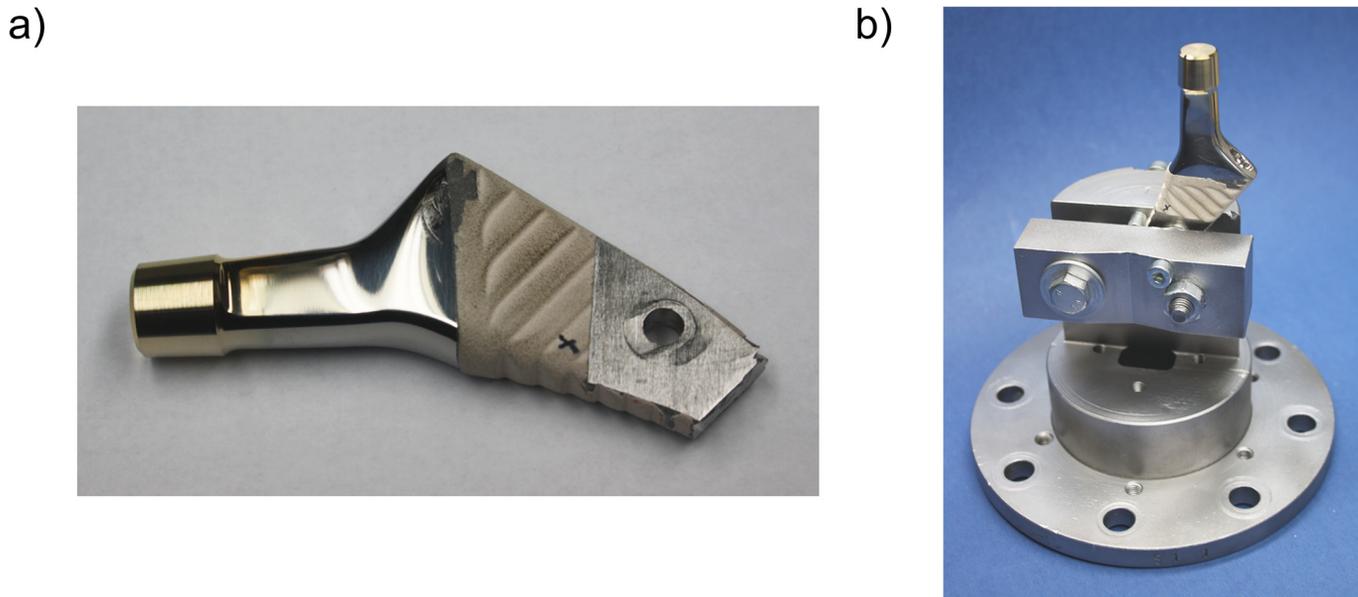
Fig 1. Stem design modifications. (a): Geometrical limitations of the sputtering machine necessitated modification of the stem: It was shortened, parallel planes were milled and a hole was drilled for anchorage. (b): These modifications allowed fixation in a clamping block.

The hip stems were shortened and bolted to a mount (Fig 1), providing reproducible positioning of the taper for surface coating, head assembly and surface measurements. The taper surface was sputtered on the lateral aspect with a 25.3 nm gold layer (SCD 050 sputter coater, BAL-TEC, Scotia, NY, USA; device settings: argon gas, 0.05 mbar working pressure, 40 mA current, 50 mm working distance, sputter time \approx 150 s). Layer thickness was controlled with a quartz crystal film thickness monitor (EM QSG100, Leica, Wetzlar Germany). The taper contact area was determined after disassembly of the head, by measuring the area of the gold layer removed due to abrasion.

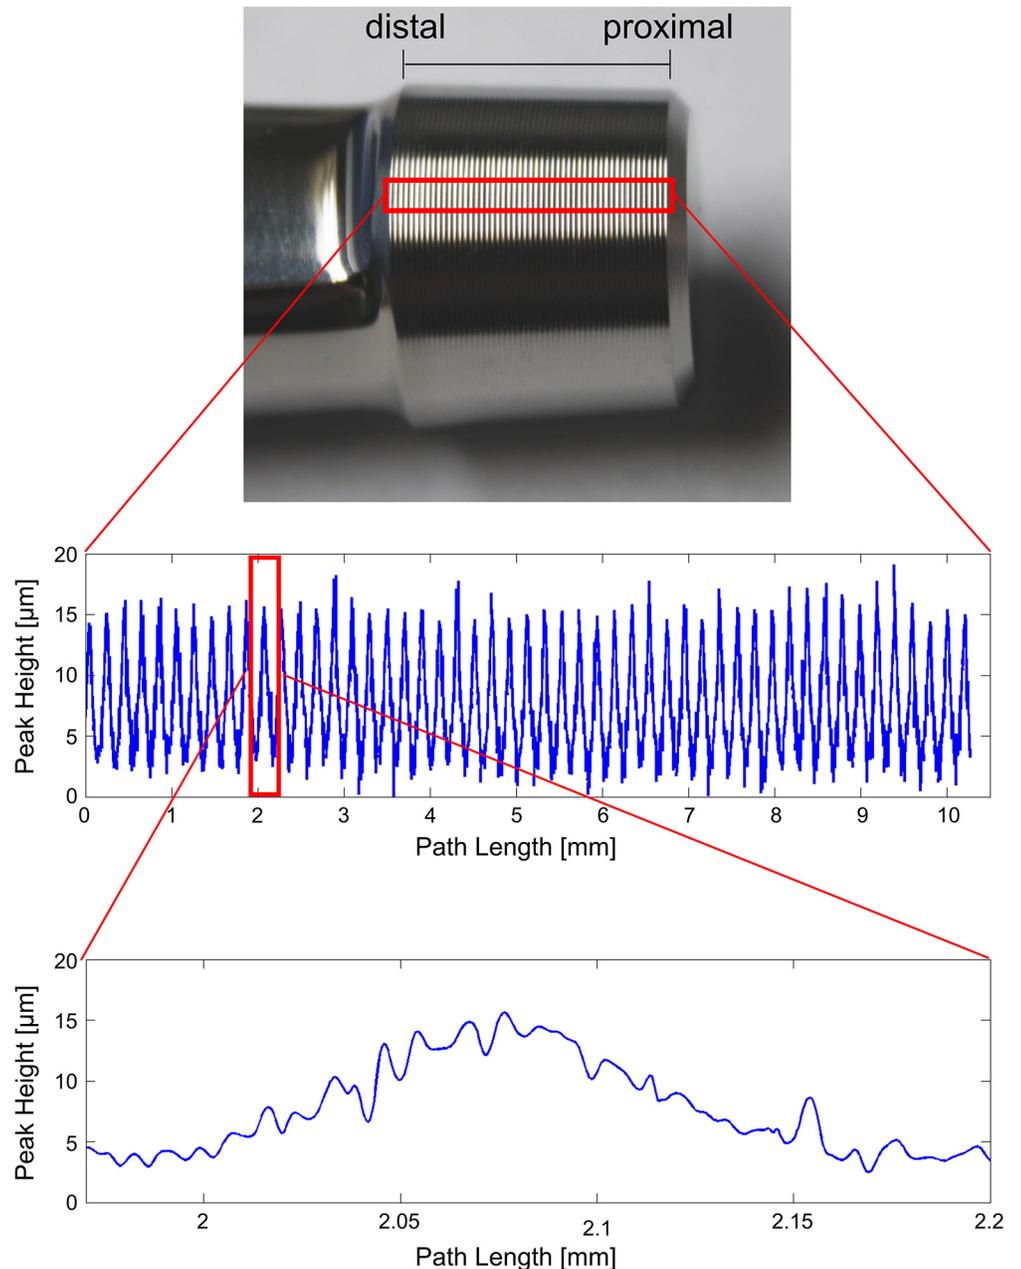
Fig 2. Stem Taper profile. Multiple measurements of the same stem region (red rectangle, top) were performed. A 100 μm wide path from distal to proximal was chosen to obtain a mean profile (middle). It is noted that each profile ridge demonstrates a surface roughness of about an order of magnitude smaller amplitude and period (bottom).

A regular wave profile was observed on the surface of the stem taper, with a wavelength of $\sim 200 \mu\text{m}$ and an amplitude of $\sim 10 \mu\text{m}$ (Fig 2). This profile is a right-handed thread spiral, with 51 ridges along the length of the taper. This manufactured surface profile was superimposed by a surface wave of shorter wavelength and lower amplitude (by roughly an order of magnitude).

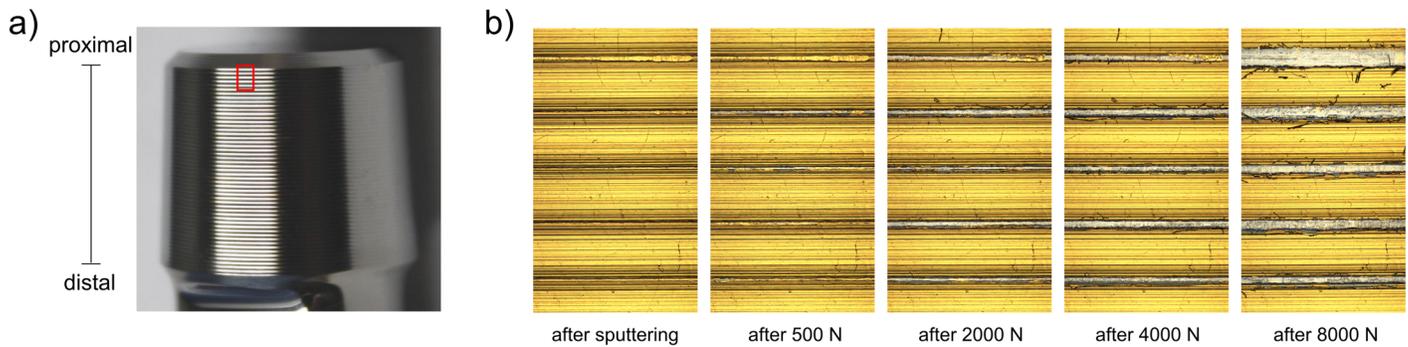
Fig 3. Surface contact. a) The red rectangle on this non-sputtered taper represents the magnified regions in b). b) The first five proximal ridges of stem taper profile #3 are shown. The gold coating is removed from the ridges by shear abrasion during assembly (uncoated silver areas), but remains in the valleys. With increasing assembly force a greater area of the gold coating is removed from the ridges of the threaded surface profile due to increased contact between head and stem.

The extent of surface contact was revealed by abrasion of the gold coating from the stem taper surface (Fig 3). The contact area increased with increasing assembly force, both in terms of the number of ridges demonstrating contact as well as the total area of contact (Fig 4).

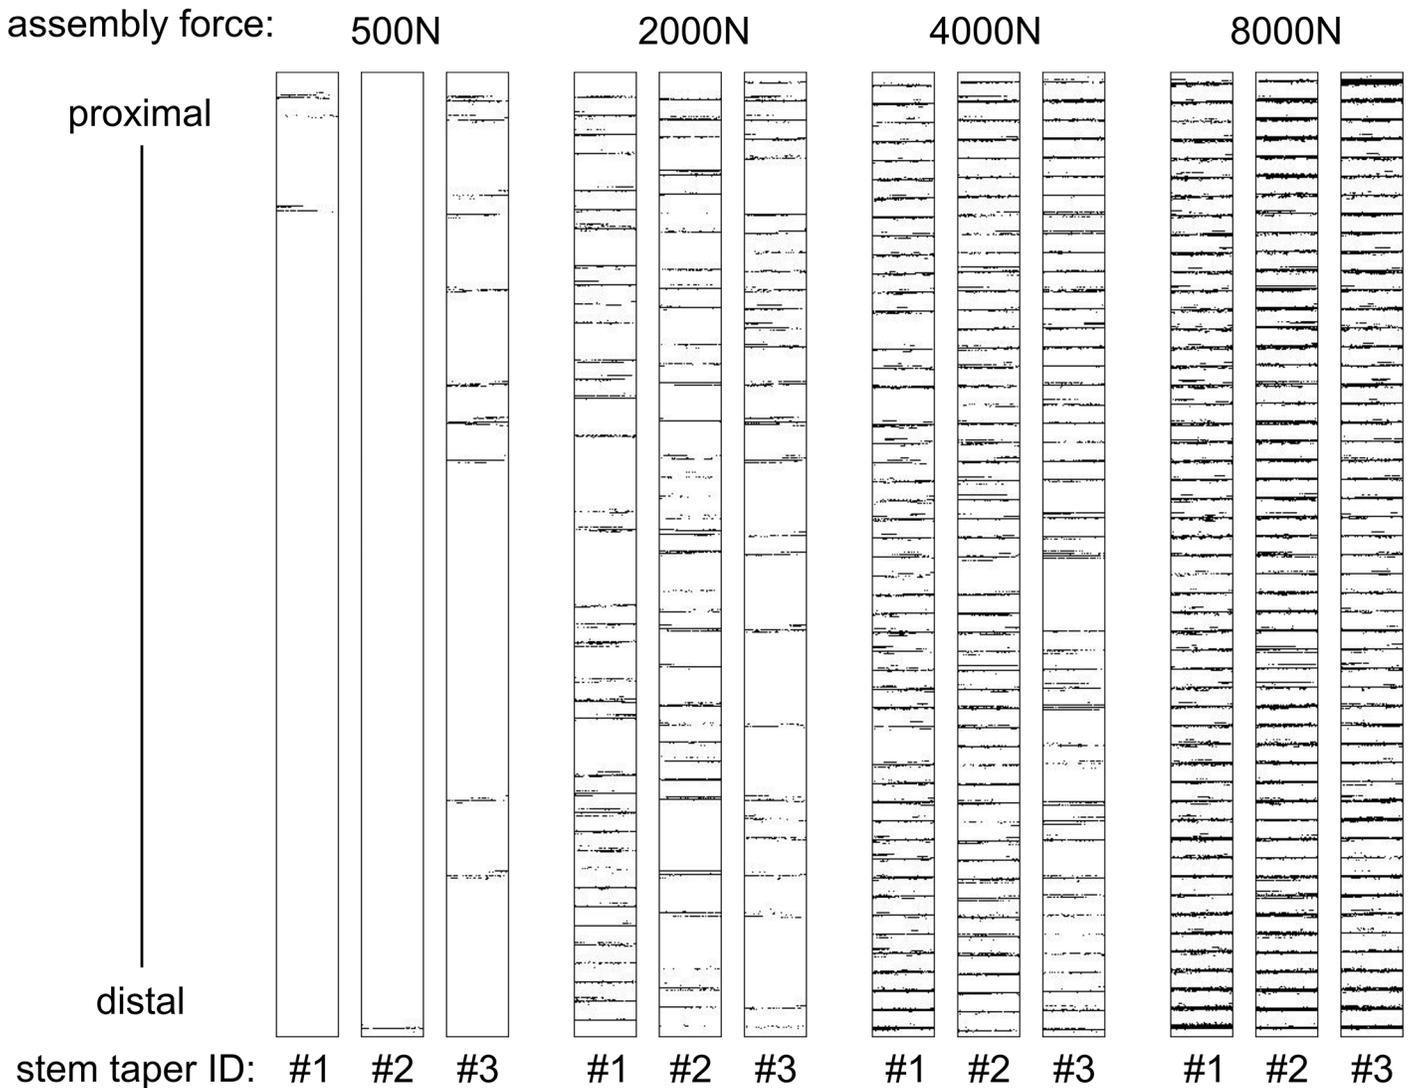
Fig 4. Quantification of surface contact. Black pixels within boxes represent contact areas and contact locations between stem and head component pairs. Profiles are presented for the three tapers under increasing assembly forces.

At the lowest assembly force (500 N) as few as one single ridge was in contact for pair #2, at the distal end of the stem taper (Fig 4). In contrast, only proximal ridges were in contact for pair #1. Contact was distributed over the length of the taper for pair #3. A total of $9.2 \pm 9.3\%$ (mean and standard deviation, Fig 5) of stem taper ridges were in contact and resulted in $0.6 \pm 0.7\%$ (mean and standard deviation, Fig 6) surface contact. Under an assembly force of 2000 N (this is similar to lower joint force magnitudes measured during walking [26]) $65.4 \pm 10.8\%$ of ridges

were in contact and resulted in an increase of surface contact to $5.5 \pm 1.0\%$. The distribution of ridges in contact along the length of the taper followed no clear pattern (Fig 4). For 4000 N assembly force both the number of contact ridges and the proportion of surface contact increased to $92.8 \pm 6.0\%$ and to $9.9 \pm 1.1\%$, respectively. For 8000 N assembly force, all of the ridges were in contact for all of the samples with $16.1 \pm 0.9\%$ of the surface in contact. The increase of the mean proportion of stem taper ridges in contact, with increasing assembly force, followed an exponential function ($R^2 = 0.978$, Fig 5) and the mean proportion of the surface in contact demonstrated a linear dependency on assembly force ($R^2 = 0.972$, Fig 6). Significant differences in the contact area were observed between each assembly force ($p \leq 0.003$).

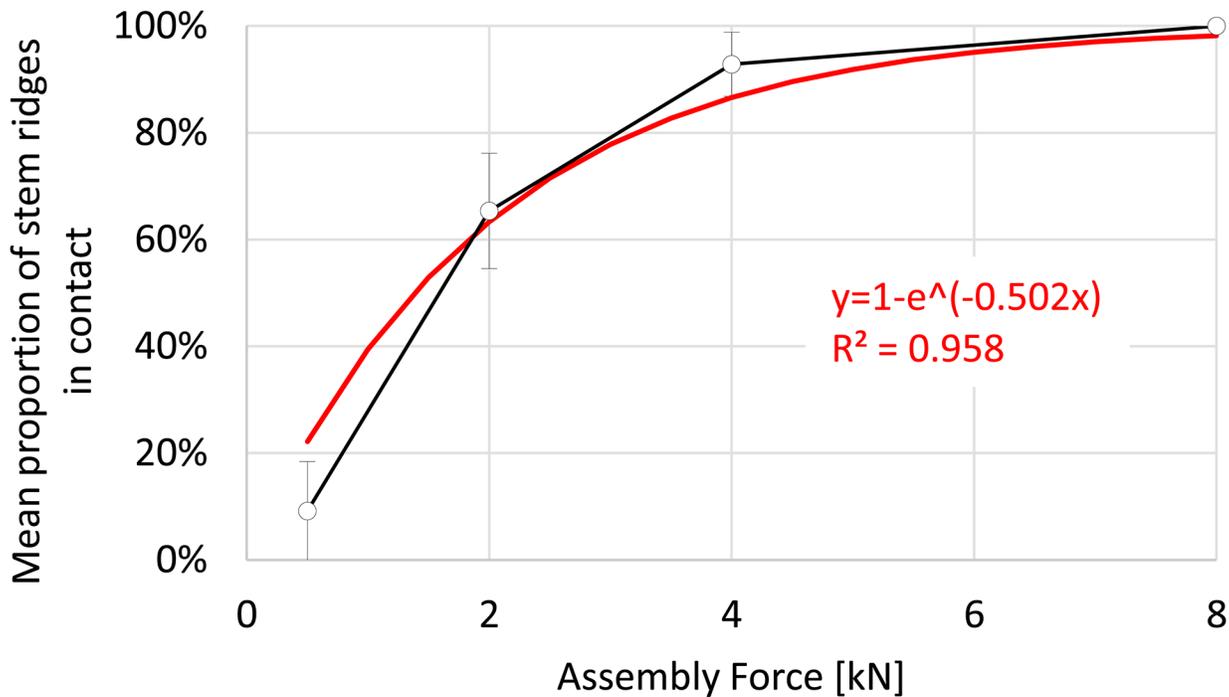
Fig 5. Stem taper ridges in contact. With increasing assembly force an increasing number of stem taper surface ridges came into contact with the head taper surface. For an assembly force of 8000 N all stem taper surface ridges were in contact.

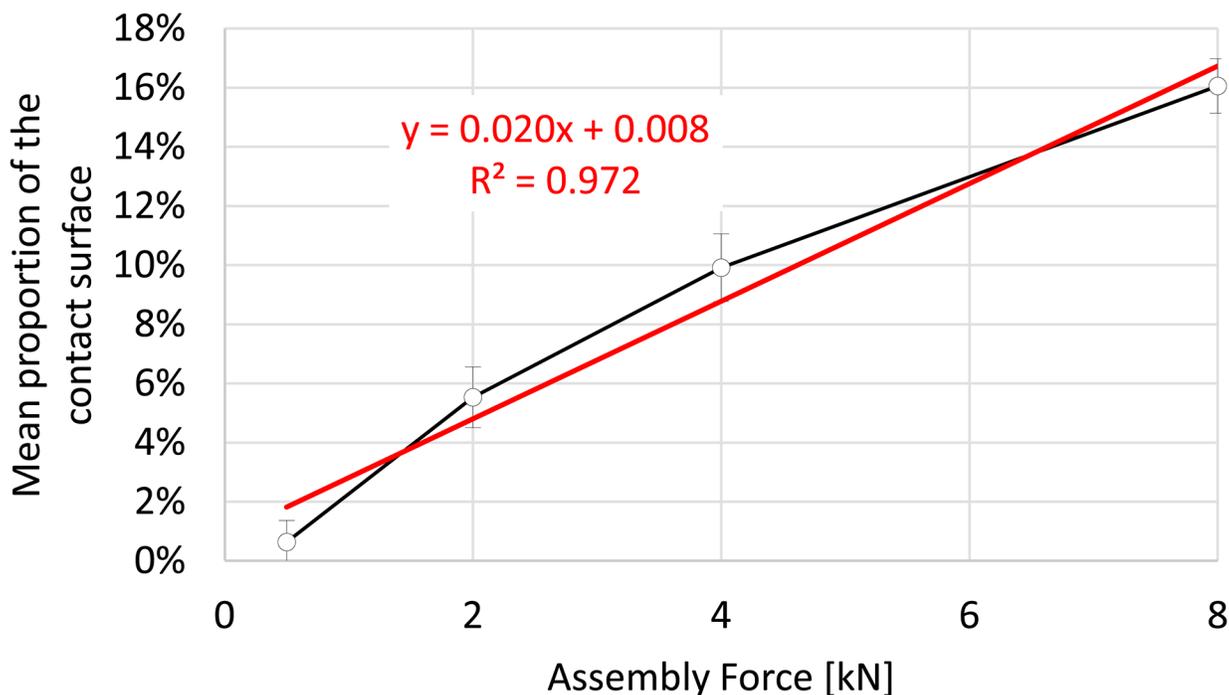
Fig 6. Stem contact area. With increasing assembly force a linear increase of the proportion of the surface in contact was observed.

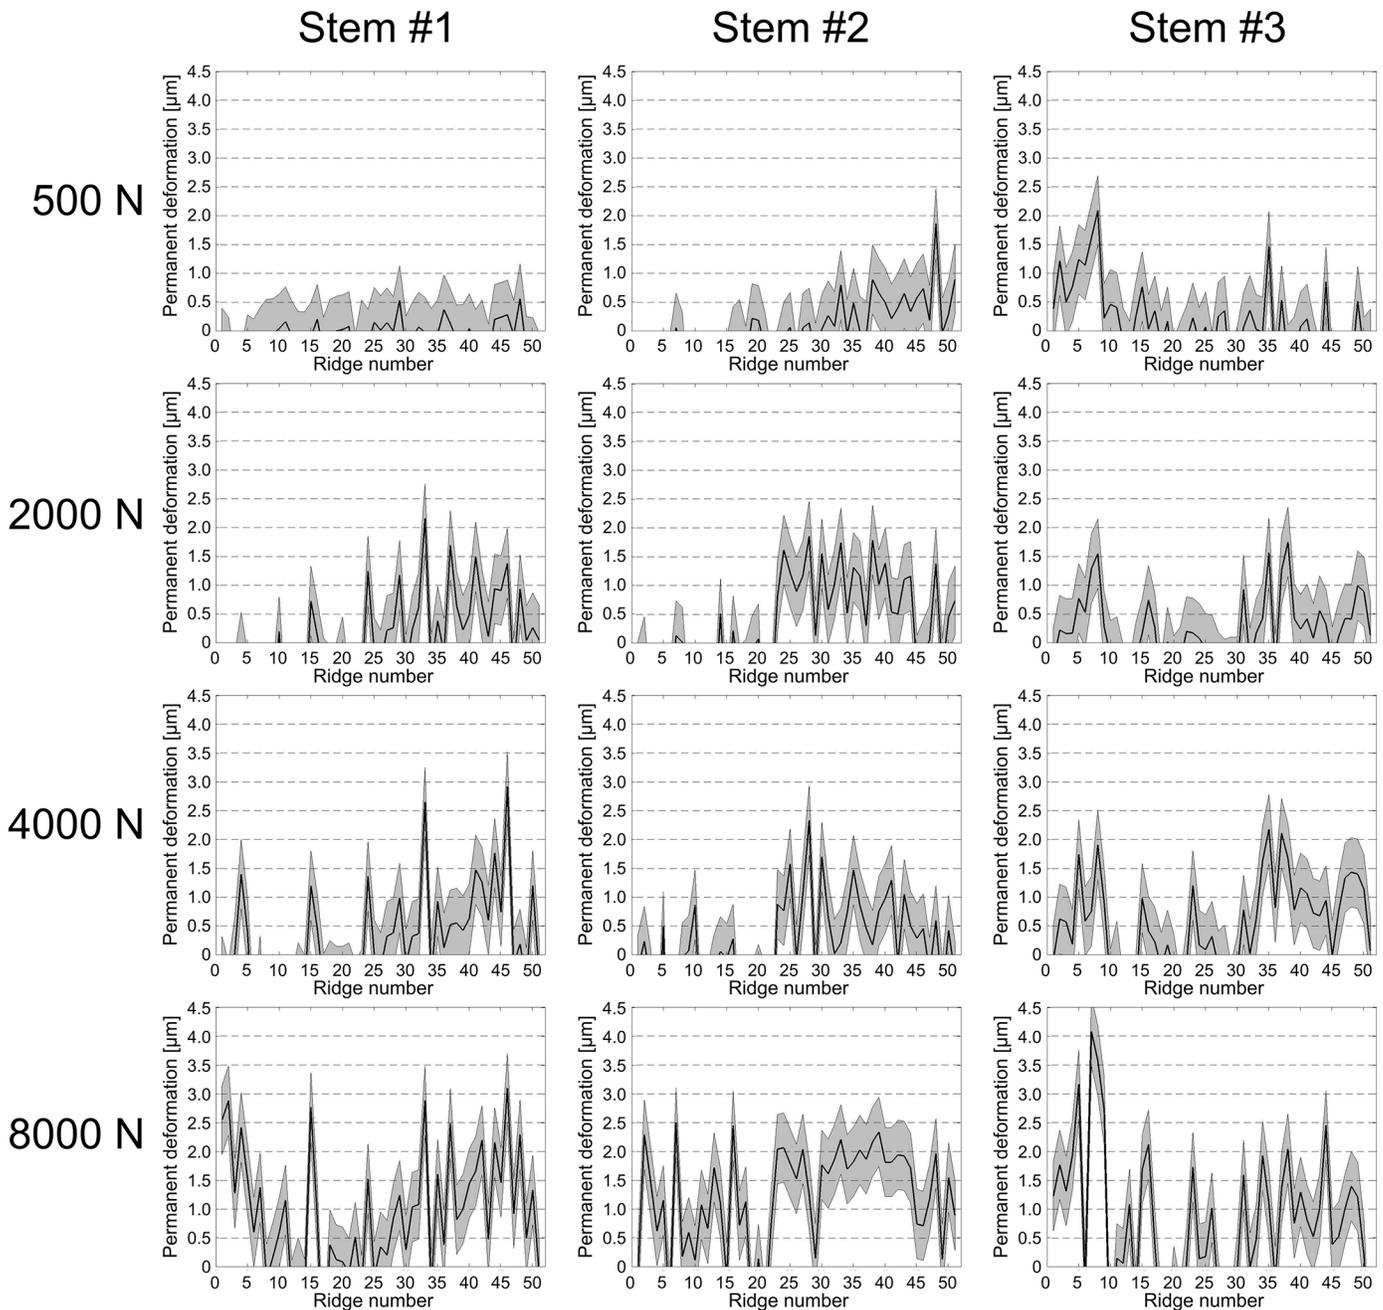
Fig 7. Permanent radial deformation of the stem taper surface profile. The height difference of the stem taper profile between assembled and original condition for each ridge is plotted as a black line, with the measurement accuracy (0.6 µm) in grey.

The distribution of permanent deformation of the ridges was irregular along the length of the taper surface and varied between the three specimens according to the respective contact patterns (Fig 7). Not all of the ridges demonstrated permanent deformation, even for the highest assembly force of 8000 N (for which contact with every ridge was demonstrated). The maximum permanent deformation measured was $3.5 \mu\text{m}$ at 8000 N. Permanent deformation of the wave profile was characterised by flattening of the ridges, which resulted in a material expansion at the sides (Fig 8). Similarly to the increasing number of ridges in contact and their area of contact with increasing assembly forces, mean ridge deformation over the taper length also increased with increasing assembly force (Fig 9). For an assembly force of 500N, the total mean deformation ($-0.05 \pm 0.14 \mu\text{m}$) was below the measuring accuracy. An assembly force of 2000 N resulted in a mean permanent ridge deformation of $0.1 \pm 0.14 \mu\text{m}$, an assembly force of 4000 N resulted in $0.21 \pm 0.22 \mu\text{m}$ and an assembly force of 8000 N resulted in $0.96 \pm 0.25 \mu\text{m}$. The increase of mean permanent deformation of the ridges was linearly related to assembly force ($R^2 = 0.953$, Fig 9). Significant differences in permanent ridge deformation were observed only for comparisons of 8000 N with lower assembly forces ($p \leq 0.009$).

magnitudes for all ridges, even for the high (8000 N) assembly force (Fig 7). A very high assembly force would be expected to generate the safest situation, with the greatest resistance to relative motion. However, assembly forces of 8000 N or higher, cannot be applied with hammer blows due to the risk of bone fracture. It is noted that lower proportions of permanent deformation for lower assembly forces do not suggest a poor local press fit, but simply indicate that stresses remained within the elastic range of the material.

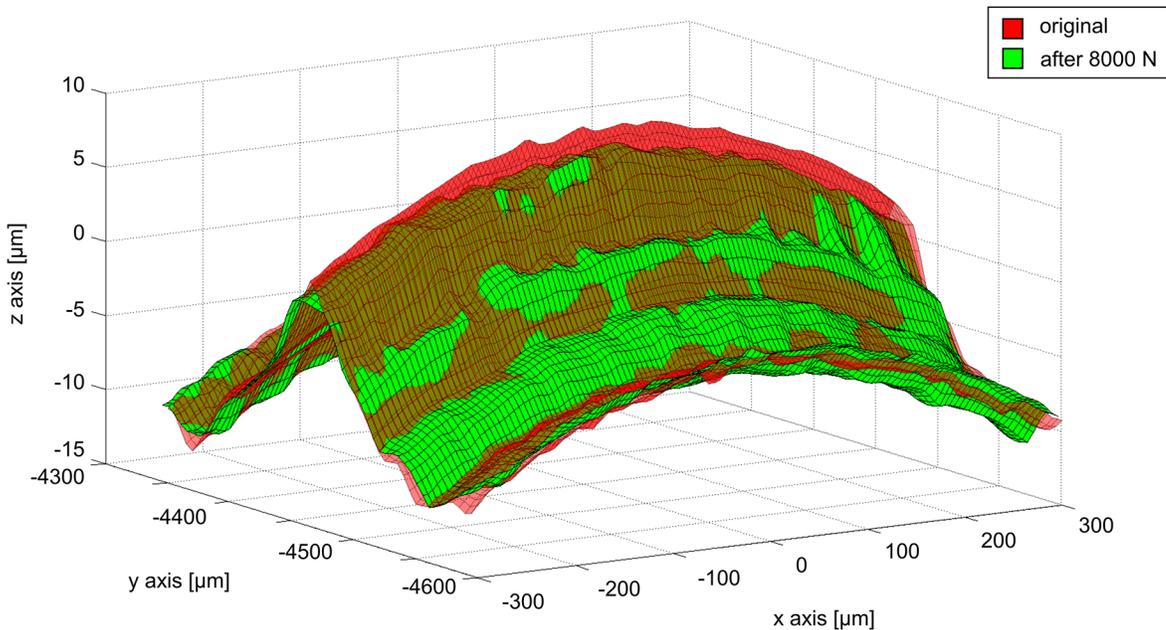
Fig 8. Permanent deformation of a single surface ridge. Regions of permanent deformation of the stem surface profile were identified by superimposing the profile of the stem taper interface after disassembly on the initial stem taper profile. The original shape (red transparent surface) was deformed after assembly with 8000 N (green surface). The ridge height was reduced. Note that the axes are not equally scaled, so that the height and curvature of the wave are exaggerated.

Regions of permanent deformation of the stem surface profile were determined by superimposing the profile of the stem taper interface after disassembly on the initial stem taper profile and calculating the height reduction of the ridges. Deformation profiles were calculated as the mean of 100 μm wide bands, running from the distal to proximal ends of the taper. Imaging artefacts can be caused by the gold layer due to light reflection. Each profile was therefore filtered for outliers using a threshold of 1 μm . Superimposition of the profiles before and after assembly was achieved by least-squares best-fit of the troughs of the surface profiles (values less than the mean profile height), where the profiles were assumed to remain undeformed. Measurement accuracy was evaluated by repeated positioning and scanning of the same sputtered stem taper ($n = 3$). The highest deviation along the whole taper length was 0.6 μm .

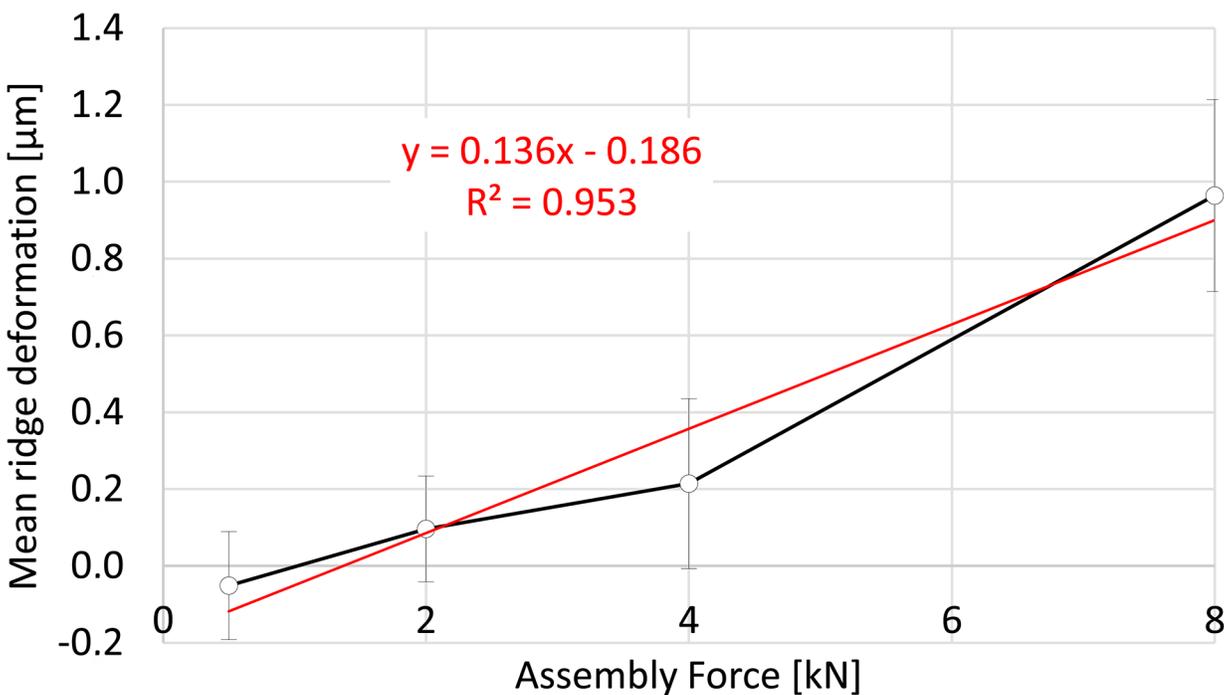
Fig 9. Mean ridge deformation. With increasing assembly force the mean ridge deformation increased.
