Near-infrared laser surface treatment of milled CFRP aircraft structures for bonded repair applications

genehmigte Dissertation

von
Sergej Harder

2020

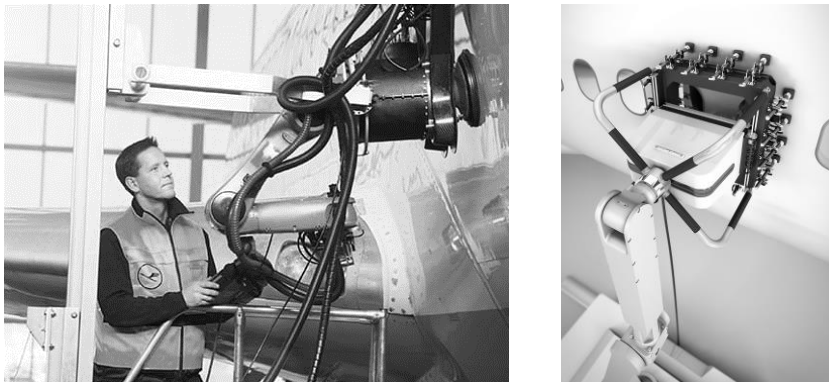
Figure 1.1: Left: CAIRE repair robot from Lufthansa Technik, Right: ULTRASONIC mobileBLOCK composite repair milling robot from DMG Mori [6,7].

In several projects milling tools and robots were designed to substitute the manual grinding process and make an on-site repair possible (e.g. CAIRE repair robot from Lufthansa Technik or ULTRASONIC mobileBLOCK from DMG Mori, see Figure 1.1) [6,7]. While solutions for the automated removal of the damaged material exist, the necessary subsequent surface treatment relies on manual solvent cleaning so far. Generally, surface treatment is a

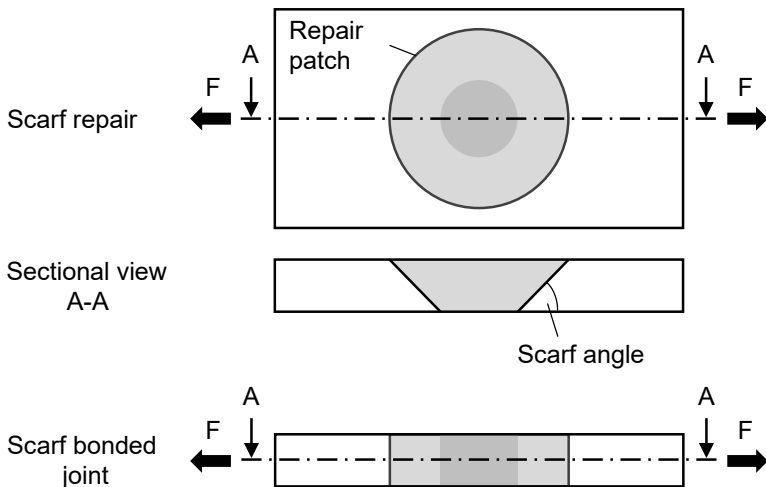
Figure 2.1: Scarf repair and the derived scarf bonded joint geometry. The sectional view A-A applies for both geometries (own illustration according to [14]).

Bonded composite repairs are usually performed by circularly removing material in the damaged zone and thereby creating a scarf. The scarf increases the bonding surface and creates a uniform load transfer to the repair patch that is applied afterwards. The uniform load transfer makes the scarf repair more weight-efficient than a bonded overlap repair and therefore, the chosen technique for composite repairs [12,13]. As the manufacturing of composite repairs is expensive for research purposes, most studies use the simplified scarf bonded joint for mechanical testing. The derivation of the scarf bonded joint from the composite scarf repair is shown in Figure 2.1. For further simplification, the specimen geometry can be reduced to one bond line.

Two main differences can be observed: First, for scarf bonded joints, only the direction with the highest load is considered [15]. Second, the load can only be transferred through the joint. An alternative path through pristine material, as it is the case in composite scarf repairs, is not possible. A numerical model showed that a two-dimensional scarf bonded joint underestimated the strength by more than 40 % compared to a three-dimensional composite scarf repair [16]. Therefore, the scarf joint is considered to show a conservative estimation of the behaviour in industrial applications [17].

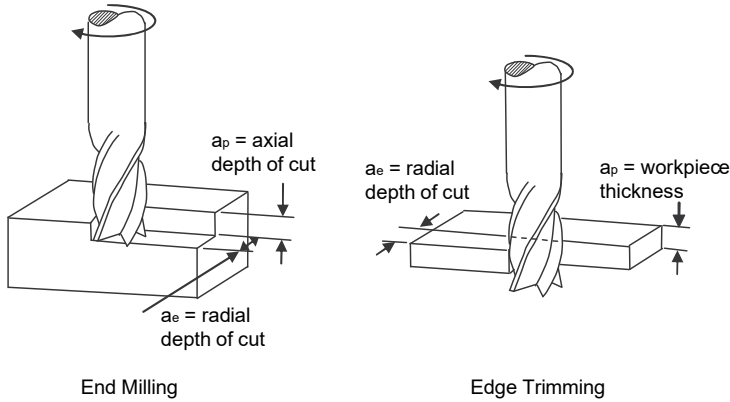
Figure 2.2: Comparison of the engagement conditions of end milling and edge trimming [31].

While milling of CFRP has been extensively investigated in the literature, most studies focused on the edge trimming. This is due to the fact that CFRP parts are produced near net shape, and edge trimming is often necessary to achieve the final shape of the part [30]. Edge trimming differs from end milling in terms of engagement conditions. In edge trimming, the material is removed in-plane, whereas in end milling it is mainly removed in the thickness direction perpendicular to the laminate plane as shown in Figure 2.2 [31,32].

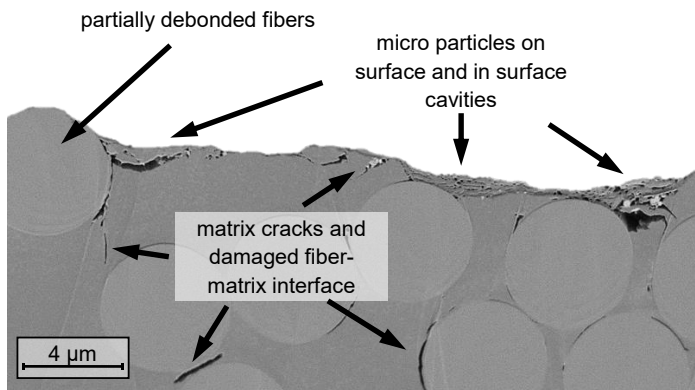
Figure 2.3: SEM image of a CFRP cross-section after milling and manual cleaning with a lab wipe and acetone [46].

The study by de Freese et al. was the first to systematically investigate the effect of milling microparticles and the cleaning method on the adhesive bond strength. They found that microparticles are present despite a manual cleaning with lab wipes in combination with acetone as can be seen in Figure 2.3. While other defects were also present on the milled surface, the authors concluded that microparticles were the main limiting factor on the adhesive bond strength. Additionally, the authors showed that with ultrasonic cleaning, they were able to remove microparticles, increase the surface roughness and consequently improve the bond strength [46]. Except for the study by de Freese et al. [46], no research about further treatment of milled CFRP surfaces has been published. Given the fact that milling is an essential step in an automated CFRP repair approach, additional research about the characteristics of milled surfaces and cleaning methods are necessary.

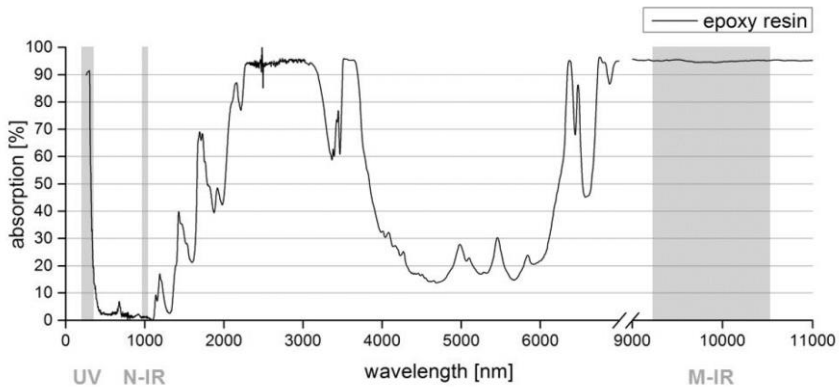
Figure 2.4: Absorption behaviour of epoxy resin. The typical laser source ranges ultraviolet (UV), near-infrared (N-IR), and medium-infrared (M-IR) are indicated [10].

Laser beam and CFRP surface interaction can be differentiated by the wavelength of the laser. The energy of the photons is inverse to the wavelength. In order to break the covalent bonds between the carbon atoms in a polymer and achieve ablation through the photochemical effect, wavelengths below 250 nm are necessary. This is the range of ultraviolet (UV) laser sources. For higher wavelengths, that include near-infrared (N-IR) and mid-infrared (M-IR) laser sources, the material is heated through excitation, which causes the photothermal effect. Additionally, the absorption behaviour of the constituents is essential for the process [48]. Figure 2.4 shows the absorption behaviour of epoxy resin for different laser sources that are typically used for industrial applications. The absorption behaviour shows a strong dependence of the wavelength with an absorption rate of around 90 to 95 % for UV and M-IR laser sources and almost 0 % for N-IR laser sources [10]. The absorption behaviour has further implications for the effect of material removal as the carbon fibre has a high absorption over the complete wavelength spectrum. Consequently, for the N-IR laser, the material is removed through the heating of the fibre and subsequent

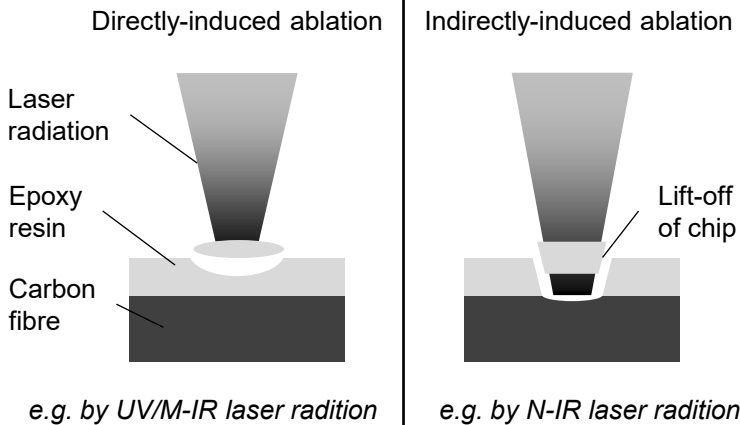
Figure 2.5: Comparison between the directly- and indirectly-induced ablation of epoxy resin on a CFRP surface (own illustration according to [49]).

sublimation of the epoxy resin [49]. This is illustrated in Figure 2.5, where the direct- and indirect-induced ablation is compared for a CFRP surface.

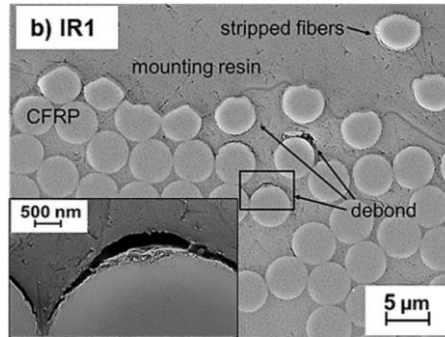
Figure 2.6: Debonding and formation of cavities after N-IR laser surface treatment [73].

Keeping the characteristically low absorbance of N-IR laser radiation in epoxy resin in mind, a complete stripping of the carbon fibres is necessary to avoid cavities at the surface. Several studies showed that the stripping of the fibres is possible with an N-IR laser. This could be achieved with UD laminate [73,95] as well as fabric laminate [96,97] that has more resin-rich areas. It was hypothesised that the stripping of the fibres benefits the interlocking between the CFRP surface and the adhesive [98]. On the other hand, the formation of cavities in the topmost carbon fibre layer has been reported by some authors, as seen in Figure 2.6 [70,73]. It was assumed that this was caused by the high transmission coefficient of the matrix. Most of the energy is absorbed by the fibre. While the energy in some cases was enough to cause a fibre-matrix debonding, the resulting heat was not able to sublime the matrix leaving cavities near the surface as a result [73]. The stripping of the fibres is usually accompanied by a narrowing of the fibres. It was therefore concluded that the temperature must reach 400 °C and more during the process as this is the temperature at which the fibre begins to oxidize [73]. Some authors concluded that functionalization of the fibre takes place during the oxidation that improves the adhesive properties [73,97]. In contrast, Sun et al. published XPS results where the oxygen and nitrogen content decreased after N-IR laser surface treatment [98]. Still, the lap shear strength could be improved compared to an untreated configuration as the fibres were stripped, which was accompanied by a removal of a release agent layer [98]. Likewise, the wetting behaviour improved after N-IR laser treatment, and some authors even reported a complete wetting [70,99].

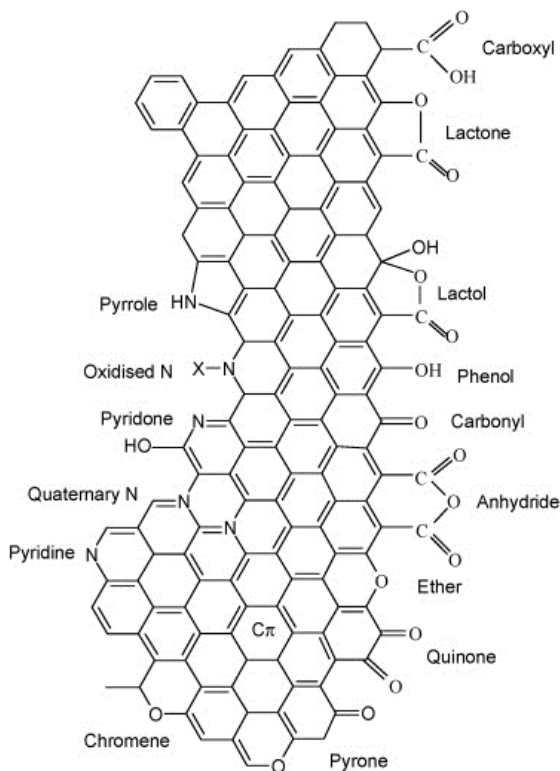
Figure 2.7: Nitrogen and oxygen containing functional groups on carbon [117].

The surface of carbon fibres mainly consists of carbon, oxygen and for PAN-based fibres also a considerable amount of nitrogen [104,111]. An increased oxygen and nitrogen content is associated with an increase of functional groups that naturally benefits the adhesion to epoxy resin [112–115]. Consequently, the oxygen content can range from 2 % for untreated up to 20 % for oxidised fibres [104,112]. The nitrogen content on the other hand, is significantly lower and ranges from 0 to 3 % [111,116]. Figure 2.7

illustrates different oxygen and nitrogen containing functional groups on carbon.

While various functional groups can be present on the surface, most of the studies focus on hydroxyl (-OH, phenol contains a hydroxyl group in Figure 2.7), carboxyl (-COOH) and ester (-COOR, lactones in Figure 2.7 are a type of ester) groups. Several authors reported that carboxyl, ester and amide functional groups are of special importance for the interfacial shear strength, which is a characteristic parameter for the fibre-matrix adhesion [112,113]. The carboxyl group can react with the epoxy groups, the amine

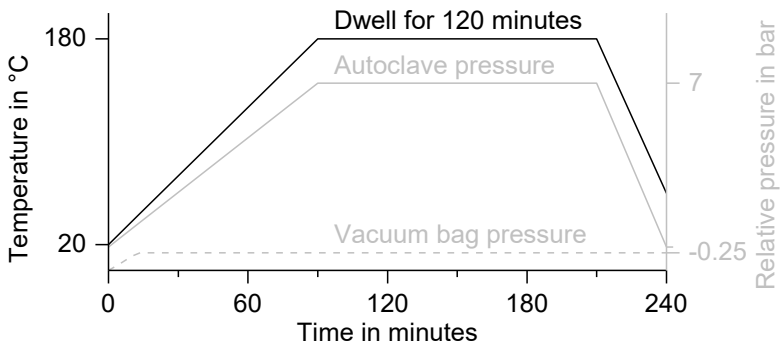
Figure 3.2: Curing process for the primary laminate HexPly M21/34%/UD194/T800S from Hexcel.

The primary laminate was manufactured in an autoclave according to the guidelines provided by the manufacturer. Curing was done at 180 °C for 2 h. The relative pressure in the oven was 7 bar and -0.25 bar in the vacuum bag.

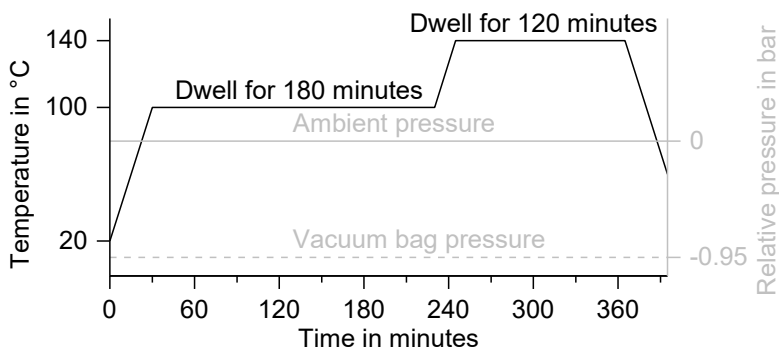
Figure 3.3: Curing process for the repair patch consisting of the Hexply M20/34%/UD194/IM7 T800S prepreg from Hexcel and the adhesive FM300-2M.06PSF from Solvay.

The repair laminate was cured together with the film adhesive under ambient pressure in a co-bonding process. In this way, an out-of-autoclave repair process was supposed to be emulated. The relative pressure in the vacuum bag was -0.95 bar. Two temperature dwells, 100 °C for 3 h and 140 °C for 2 h, were applied. The lay-up of the primary laminate was matched by the repair laminate.

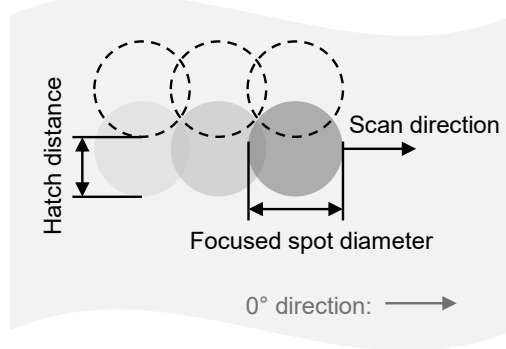
Figure 3.5: Schematic representation of the laser treatment process.

The primary scanning direction was parallel to the 0° fibre direction, as shown in Figure 3.5. The primary laminate was fixed on a vacuum plate and rotated in order to account for the scarf angle. This was necessary in order to treat the complete scarf area in the focus distance of the laser. Each surface was only processed once. This way process times between 1.0 cm²/s to 7.4 cm²/s were achieved.

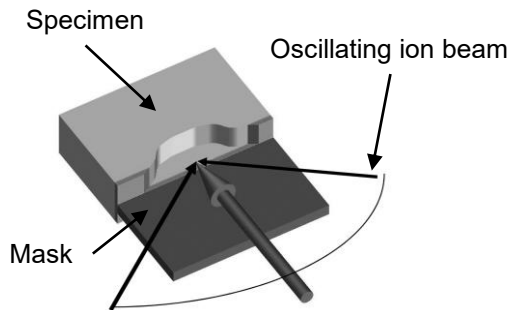
Figure 3.6: Principle of ion beam milling [135].

Ion beam milling of the specimens and acquisition of the images of the unbonded surfaces has been done by the Wehrwissenschaftliches Institut für Werk- und Betriebsstoffe in Erding, Germany. The preparation of the bonded surfaces has been done by the following procedure. The specimen was placed in a slope cutter holder. The surface to be investigated faced the tungsten carbide mask (see Figure 3.6). A three-step process was applied where the surface was cleaned, polished and contrast enhanced in the EM RES102 ion beam milling system from Leica (Wetzlar, Germany). The corresponding process parameters are summarized in Table 3.4.

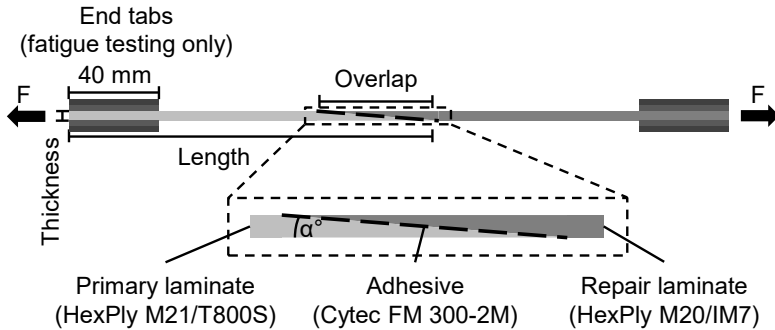
Figure 3.7: Scarf joint specimen geometry. The scarf angle is labelled as α .

A schematic illustration of the specimen geometry can be seen in Figure 3.7. Four different configurations constituting of four different scarf ratios between 1:10 and 1:30 have been tested. The corresponding geometry measurements can be found in Table 3.5.

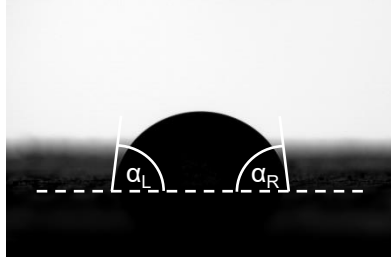
Figure 4.1: Measurement of the left and right contact angle α_L and α_R .

The change of surface energy free energy (SFE) was assessed through a contact angle measurement. Therefore, a 10 μ l droplet was placed with a syringe on the surface, and the contact angle was measured with a high-resolution camera facing in the 0°-direction. The right and left contact angle were measured as shown in Figure 4.1. The average of both contact angles was used for the results and calculation of the surface energy. The specimens had a UD lay-up and were milled with a scarfing ratio of 1:20. The drop shape

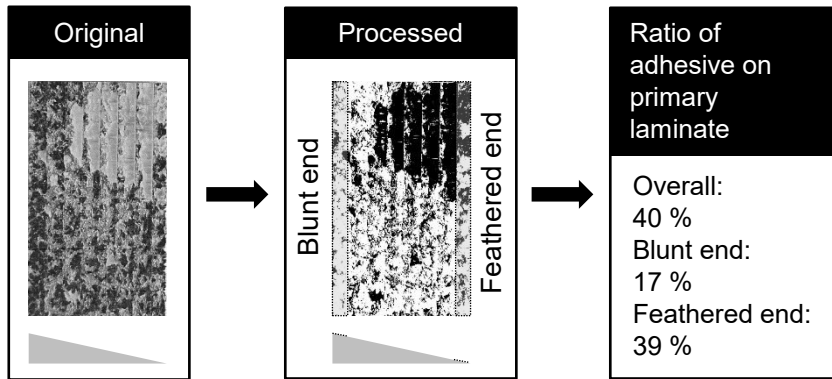
Figure 4.2: Processing of the fracture surface images by the evaluation procedure.

The fracture surfaces were photographed with a digital camera (E-330 from Olympus, Tokyo, Japan). Qualitative assessment of the fracture surface was done by comparing the brightness on the primary and repair laminate. If the bright adhesive could be found on both surfaces, it was assigned to a cohesive failure (CF). Adhesive failure (AF) was assigned in the case that adhesive could be found on only one of the surfaces. In the case of adherend material on both surfaces, cohesive substrate failure (CSF) was assigned. For the quantitative assessment, images of the fracture surfaces were analysed by an image evaluation procedure in Matlab from The Mathworks (Natick, USA). For the first step, the fracture surface of the primary laminate was isolated. Then the adhesive on the primary laminate side was selected. This was possible by a brightness selection as the bright adhesive stood out against the dark CFRP. The selection of the adhesive and primary laminate is solely based on the brightness. Therefore, fibres from the repair laminate cannot be separated from the primary laminate. This poses a limitation to the image evaluation procedure. Overall, only a small amount of failed repair laminate is visible on the fracture surfaces, so that the error should be negligible. The number of pixels was calculated and divided by the total number of pixels. Additionally, the scarf endings were evaluated separately as these represent regions with stress concentrations for UD lay-ups. The mentioned regions reached from the scarf ending up to 10 % of the overlap length into the middle of the scarf. Figure 4.2 shows the process of data acquisition and the regions of interest according to the location on the scarf. With this method, it was possible to quantify the amount of adhesive on the fractured surface as a measure of the surface treatment quality for the UD lay-up specimens.

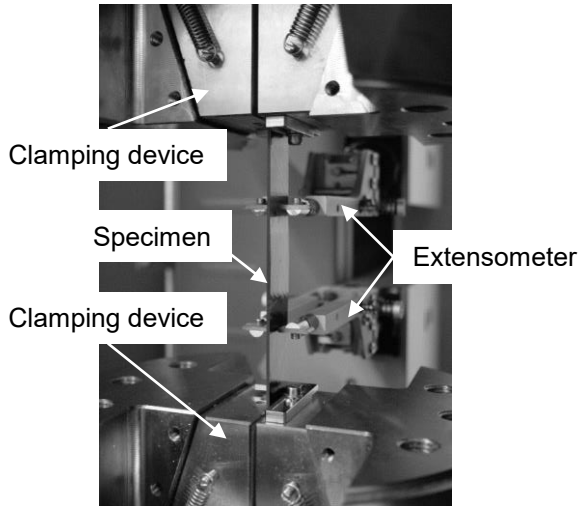
The static strength of the scarf bonded joint was evaluated by tensile tests. A Z100 universal testing machine from Zwick Roell (Ulm, Germany) was used for testing. The specimens were clamped at a length of 50 mm with a distance of 50 mm to the respective scarf ending. The extensometer multiXtens from Zwick Roell measured the displacement in a distance of 20 mm from the respective scarf ending. The experimental setup is shown in Figure 4.3. As recommended by the standard DIN EN 6066, a displacement rate of 2 mm/min was applied [136]. All tests were executed at an ambient temperature of 21 ± 1 °C and a humidity of 50 ± 10 %. For the evaluation of the strength for the specimen with a UD lay-up, the actual bonded area was measured from the fracture surfaces. The bond strength σ_A was therefore calculated by

Figure 4.3: Experimental setup for the evaluation of the static scarf bond strength.

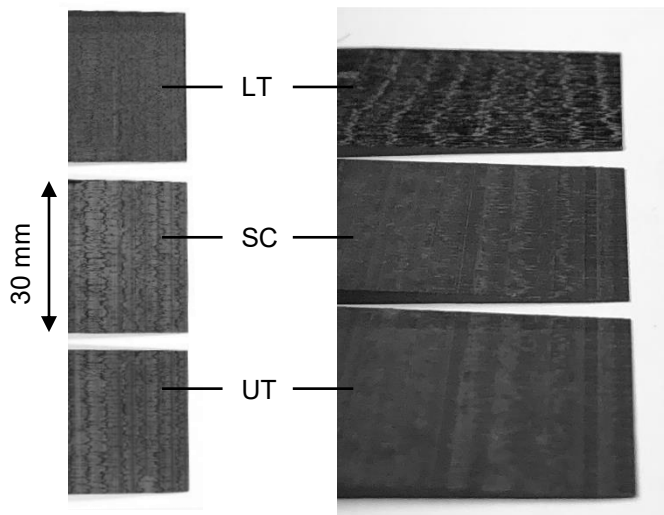
Figure 5.1 shows images of the UT, SC and LT surfaces in comparison side by side. While the UT and SC surfaces appear very similar and no difference can be pointed out, the LT surface shows distinctive characteristics. The LT surface is significantly darker than the other two configurations. As a result, the resin-rich areas are more clearly visible in the form of wavy lines for the LT configuration. The resin-rich areas are present in the SC as well as LT surface, which means that neither of the surface treatments is able to remove these layers. The LT surface appears to be smooth without fuzzy fibres protruding from the surface as reported by some authors [97,99]. This is a result of the low power laser used in this work which also should reduce the HAZ. The changed appearance of the LT configuration compared to the UT and SC configurations could be used as an indicator for surface treatment, thus simplifying a visual quality control of surface treatment.

Figure 5.1: Comparison of the untreated (UT), solvent cleaned (SC) and laser-treated (LT) surface by photography. Left column: Top view. Right column: Side view with perspective.

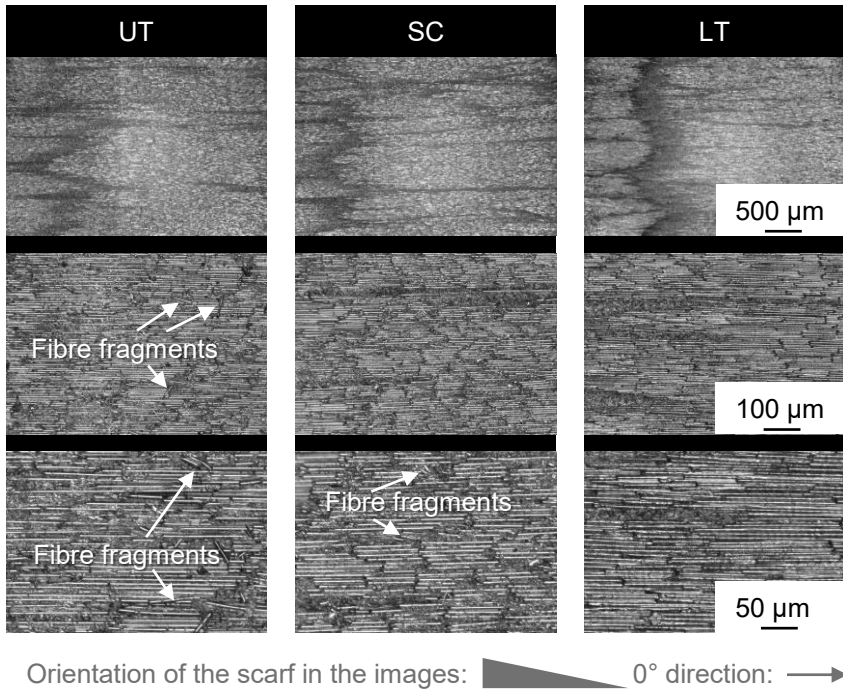
LM images in Figure 5.2 only show slight differences between the three different surfaces. On the lowest magnification only in the area of the resin-rich areas, a difference is visible. Here, the UT and SC configurations show a smoother transition of the epoxy resin. For the LT configuration, this is not the case, as part of the epoxy resin could be removed. Looking at the higher magnifications, carbon fibre fragments can be seen on the UT and SC configuration. Fibre fragments are recognizable by the deviation from the 0° direction. Comparing the UT and SC configuration, a difference in the length of the fibre fragments can be observed. While the UT configuration shows a significant amount of fibre fragments that can reach lengths of up to $50\text{ }\mu\text{m}$, the SC configuration shows only few fibre fragments which have lengths of less than $10\text{ }\mu\text{m}$. This clearly shows the ability of the SC surface treatment to remove larger fibre fragments from the surface.

Figure 5.2: Images of the untreated (UT), solvent cleaned (SC) and laser-treated (LT) surface taken with a light microscope. Each column represents the same configuration, while each line represents the same magnification.

Figure 5.14 shows the elemental composition of the bulk matrix, the SC and LT configuration. From Chapter 5.1.2 and 5.1.3, a significant fibre stripping effect was identified after the laser treatment. As a result, matrix and fibre-rich regions could be identified. Therefore, for the point scan results, the laser-treated surface has been investigated separately in terms of matrix and fibre-rich. Still, the point scan has to be seen as a composition of both constituents. This is especially true for the matrix-rich region, as the spot diameter is significantly larger than at least one dimension of the matrix-rich region (compare Figure 5.2).

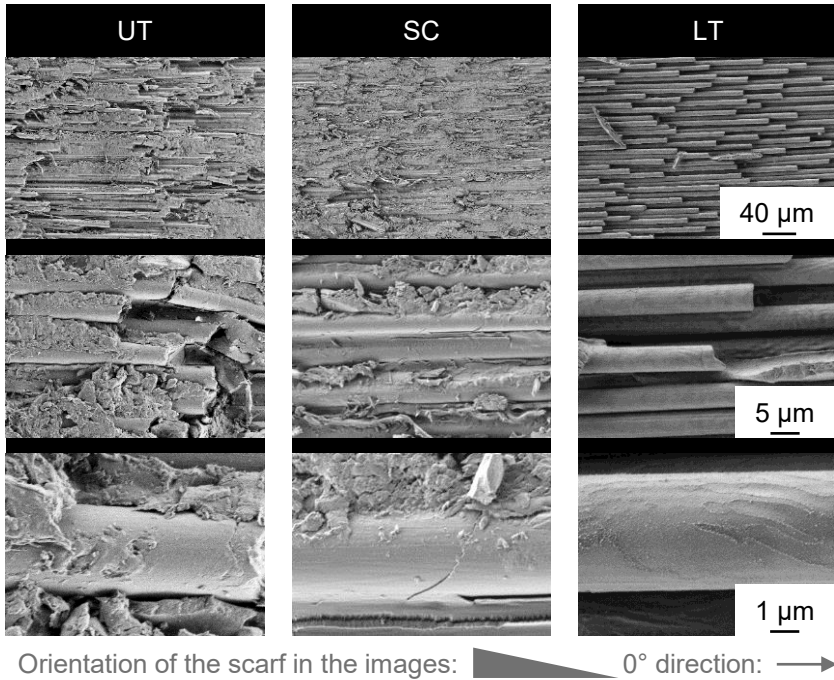
The three configurations also show clear distinctions in the SEM images in Figure 5.3. As in the LM images, fibre fragments can be seen on the UT as well as the SC surface. Exposed fibres of the UT configuration indicate fibre-matrix debonding during the milling process. Furthermore, on the UT surface, a layer of milling debris is visible. While the SC is able to remove the debris layer, smaller particles are still visible. The surface of the LT configuration shows higher contrast with stripped fibres reaching deep into the surface. The stripping of the fibres is a result of the heating and subsequent sublimation of the epoxy resin of the surrounding matrix as previously reported [54]. Though the exact temperature on the surface is not known, it can be estimated from the stripping behaviour: The M21 epoxy resin is known to decompose between 400 °C and 500 °C in air [148]. A T700 carbon fibre, which is similar to the T800S fibre in terms of thermal properties, decomposes between 700 °C and 1000 °C [149]. Therefore, in the proximity of the fibre temperatures of at least 700 °C are reached, while between fibres temperatures of at least 400 °C are possible.

Smaller epoxy resin particles are also visible on the LT surface. Furthermore, partially debonded epoxy resin strips can be observed on the LT surface. Here, the power was apparently too low to remove the epoxy resin. As these strips are still partially embedded into the surface, the suction was not able

to remove the debonded parts. Adding to the fibre stripping, an increased roughness of the fibres for the LT surface can be observed. The fibres show wavy indentations that in part resemble a flame. These indentations could be the result of the combustion process that was hypothesised by several authors [49,54].

Figure 5.3: Images of the untreated (UT), solvent cleaned (SC) and laser-treated (LT) surface taken with an SEM. Each column represents the same configuration, while each line represents the same magnification.

Figure 5.4 shows the adhesive disc and the peeled off debris for the UT and SC configuration. For the LT configuration, it was not possible to remove the adhesive disc without significant damage. This indicates that the amount of loose debris on the LT surface must be very low and therefore supports the observations from Figure 5.3.

The LT configuration shows the highest roughness for both parameters and even after correction for outliers. The removal of the outliers more than halves the values of R_z from 29.7 μm to 14.1 μm and significantly reduces the standard deviation. The surface roughness parameter R_a is by definition less influenced by outliers and therefore only reduced by less than 10 %. This emphasises that the surface is most likely roughened beyond the detached fibres. As already seen from Figure 5.3, laser treatment is able to strip the fibres, which increases the roughness values.

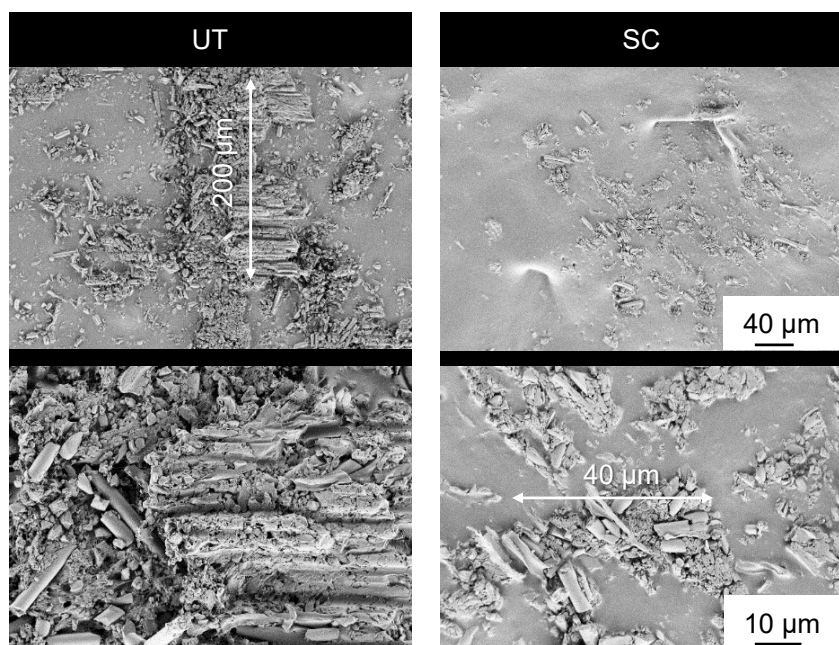
Figure 5.4: Debris removed from the untreated (UT) and solvent cleaned (SC) surface by an adhesive disc. The laser-treated (LT) configuration is not shown, as the adhesive disc could not be removed from the surface.

For the UT and SC configurations, the focus was on the largest observed agglomeration. From Figure 5.4, the difference between both configurations

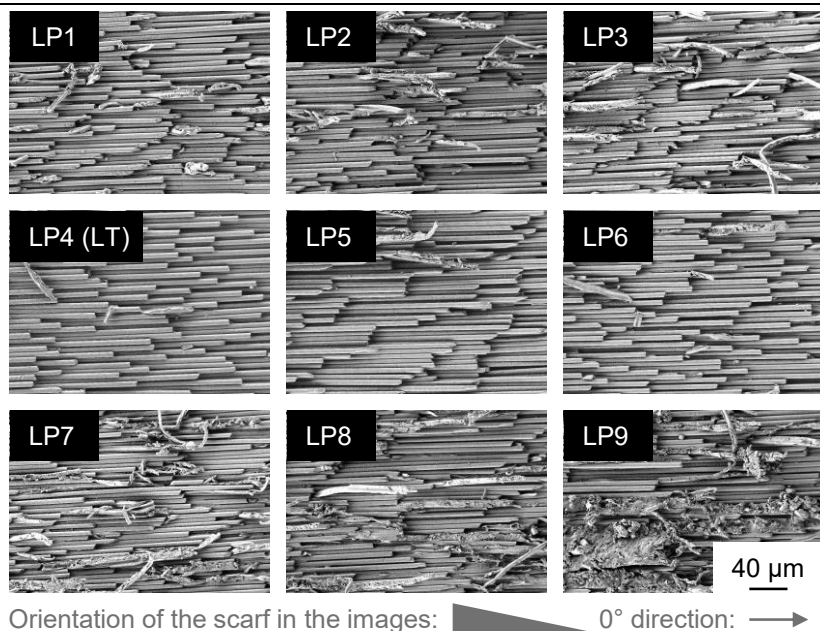
Differences between the investigated laser parameters were only visible in the SEM. Figure 5.5 shows that all tested laser parameters are able to strip the fibres, though the degree of stripping varies. The highest degree of stripping and the cleanest surface can be observed for LP4, LP5 and LP6. These three laser parameters were treated at a pulse frequency of 200 kHz. The adjustment of the scan speed and hatch distance appears to work better for this pulse frequency. As for the stripping, all laser parameters show a roughening of the fibre and removal of milling residues. Remaining epoxy resin appears to be embedded into the surface, though a clear distinction is not always possible for laser parameter with a high percentage of remaining epoxy resin (e.g. LP9). Nevertheless, in the case of embedded epoxy resin, no negative effect on the adhesive strength can be expected since the bonding between epoxy resins is known to be sufficiently good even without surface treatment [25].

From the comparison of the different laser parameter, LP4 showed good stripping without significant damage to the fibres. Furthermore, from the parameters with a pulse frequency of 200 kHz, it had the lowest pulse energy. Hence, a low thermal impact on the surface with effective stripping could be expected. As a consequence, LP4 was chosen for further detailed assessment.

Figure 5.5: Comparison of different laser parameters in the SEM. All images were taken at the same magnification.

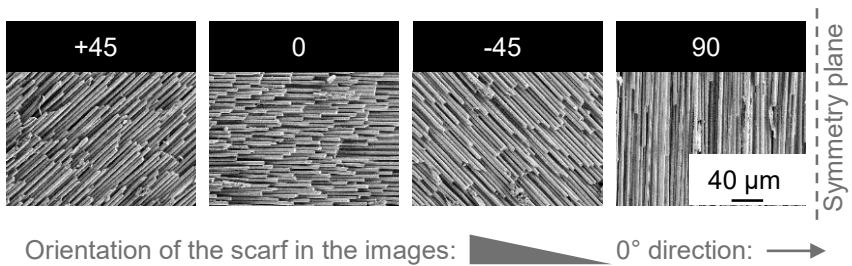
Figure 5.6 shows the different ply orientations of a laser-treated scarf with a QI lay-up. No apparent difference in the morphology can be identified when comparing the different ply orientations. The effect of the laser treatment appears to be very similar for all ply orientations. Presumably, this is a result of the low pulse energy and duration of the laser system used for this investigation. As an effect, the material is only heated in the vicinity of the laser pulse. Furthermore, all parameters involve an overlap of at least 46 % related to the pulse distance and at least 17 % related to the hatch distance. That means that for all laser parameters, the whole surface is covered by the laser pulses, which leads to a homogenous treatment independent from the ply orientation.

Figure 5.6: SEM images of the different ply orientations of the laser-treated (LT) scarf with a QI lay-up.

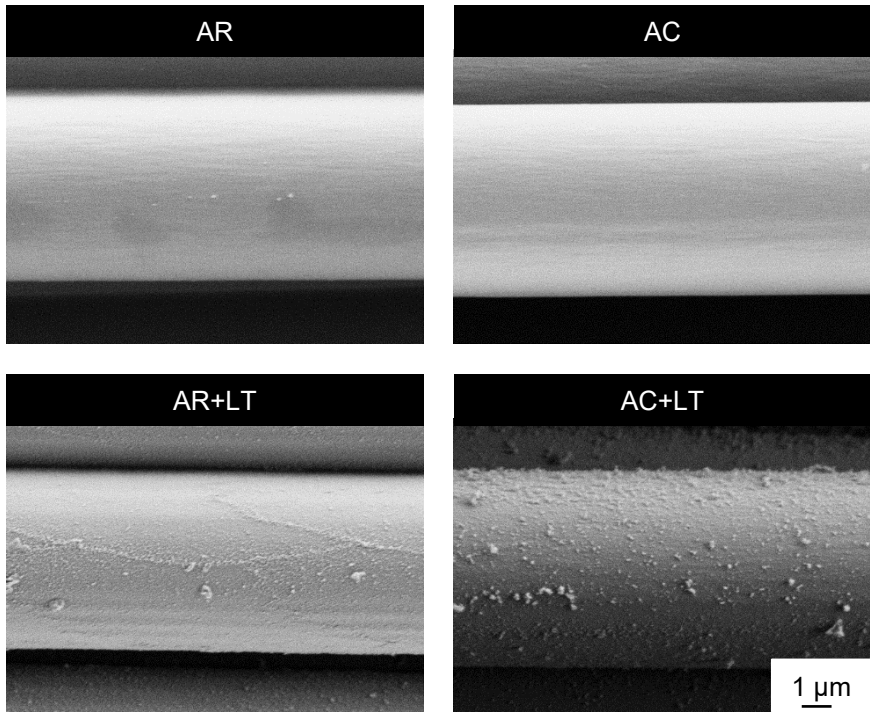
Figure 5.7 shows a comparison between the acetone treated (AR) and as-received (AC) as well as the laser-treated (AR+LT, AC+LT) combinations of both. Comparing the AR and AC configuration, no clear difference can be observed. Both configurations show a smooth surface with slight striations in the fibre direction. Similar results have been reported previously for T700S fibres [116]. The T800S fibres from the UT and SC configurations of the CFRP as shown in Figure 5.3 have slightly deeper striations, which is also in accordance with the literature [114]. Whether the sizing could be successfully removed by the acetone treatment is not identifiable from the SEM images. As the thickness of the sizing tends to be around $0.03\text{ }\mu\text{m}$, removal would not necessarily be recognizable in the SEM for the given magnifications [103].

After laser treatment, both configurations show an increase of roughness. For the AR+LT configuration combustion marks are visible. Furthermore, a roughening and particles of a few nanometres size can be observed. Overall the fibre appears very similar to the laser-treated fibres in the CFRP from Figure 5.3. The same holds true for the AC+LT configuration, though no combustion marks are visible. One reason for that could be the increased energy of the combustion in case of the as-received fibre because of the sizing. For CFRP the combustion effect is even intensified because the fibre is additionally surrounded by epoxy resin.

The particles that are visible after the laser treatment are likely a byproduct of the combustion process, similar to so called “low molecular weight oxidized material” (LMWOM) that results from intense plasma treatment of polymers. These particles appear not to be bonded to the surface. In case of LMWOM, particles can be washed off with, e.g. ethanol. Some studies found a strength decreasing effect, while others showed no influence from LMWOM and argued that particles could be successfully integrated into the load bearing surface [151]. Thus the effect of such particles cannot be clearly stated.

Figure 5.7: Comparison of the as-received (AR), acetone rinsed (AC) and afterwards laser treated (AR+LT, AC+LT) configuration of carbon fibres.

As for the LT fibre-rich configuration, the result of the fibre bundle laser treatment is a chemical state that is similar to the electrochemical surface treatment. Therefore it can be concluded that the presence of the embedding matrix is negligible for the reaction of the fibres. The results of the fibre bundle further support the finding that a laser treatment with such low pulse energies removes the sizing as well as a layer of the fibre. The freshly exposed surface is most likely a result of the electrochemical surface treatment during manufacturing. Given the information depth of the XPS measurement, at least 10 nm of material has to be removed from the surface. Given the thickness of a conventional sizing ($\sim 0.03\text{ }\mu\text{m}$ up to $0.5\text{ }\mu\text{m}$ [104]) and the morphological changes observed (see Figure 5.7) it is reasonable to assume that at least 10 nm have been removed from the surface of the fibre.

Given the observed roughness of the carbon fibres in Figure 5.7, the measured values appear to be surprising. The results show that the laser-treated fibre (AR+LT) shows the lowest surface area despite the observed roughening in the SEM images. The particles that were observed on the carbon fibre after the laser treatment also appear not to increase the surface area. The measured value for the AR+LT configuration is even lower than the theoretical value. The AR fibre, on the other hand, shows the largest surface area.

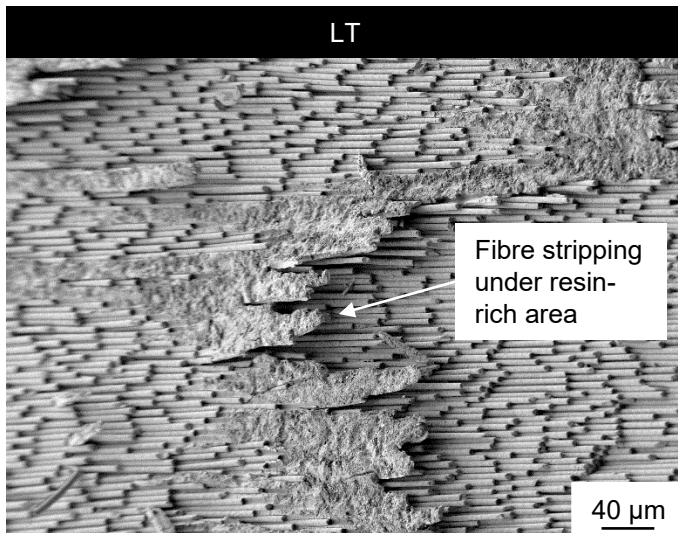
Figure 5.9: SEM image of a laser-treated (LT) surface showing the stripping under resin-rich area.

Figure 5.9 shows a laser-treated surface that focuses on a resin-rich area. Additionally, the surface was tilted by 45° to see the effect in depth and in the surface plane. In the proximity to the resin-rich area, the laser stripping is identical to that of a fibre-rich area. From the shadow under the resin, it can be concluded that resin of a significant thickness has been removed, which is in accordance to the findings from Figure 5.8. This leaves access to the stripped fibres and cavities under resin-rich areas. The effect of cavities depends on whether they can be infiltrated by an adhesive. Consequently, a bonded surface was investigated in the next step.

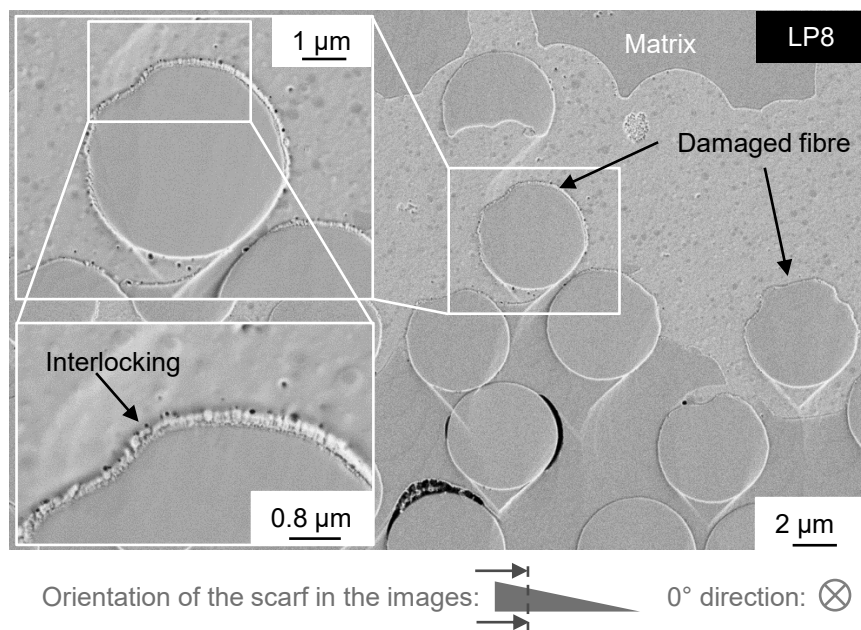
Figure 5.11: SEM image of a laser-treated and bonded surface prepared by ion beam milling. Detailed view of the fibre roughening effect.

In the last step, the interaction between laser-treated fibres and the adhesive was investigated. Figure 5.11 shows fibres in the proximity of the macroscopic surface that are surrounded by the adhesive. The indentations on the fibre surface are clearly visible in the cross-section view indicating that the fibre has been damaged. These indentations are only visible on the upper part of the fibre. Here the effect of the laser beam is more pronounced.

Increasing the magnification, an interlocking between the fibre interface and the adhesive can be observed. It is not possible to state whether the interlocking happens between the particles or the fibre and the adhesive, though it appears as the rough section is part of the fibre. This would support the theory that the particles can be incorporated into the load bearing interface. The roughening is likewise only visible on the upper part of the top most fibre layer. As for the fibre stripping and filling of cavities, an increase of the adhesion with regards to the mechanical interlocking can be assumed through the roughening of the fibre on a nanoscale. On the other hand, the effect on the fibre roughening is only limited to the upper half of the first fibre layer. Furthermore, the fibre is weakened by the reduction of the diameter.

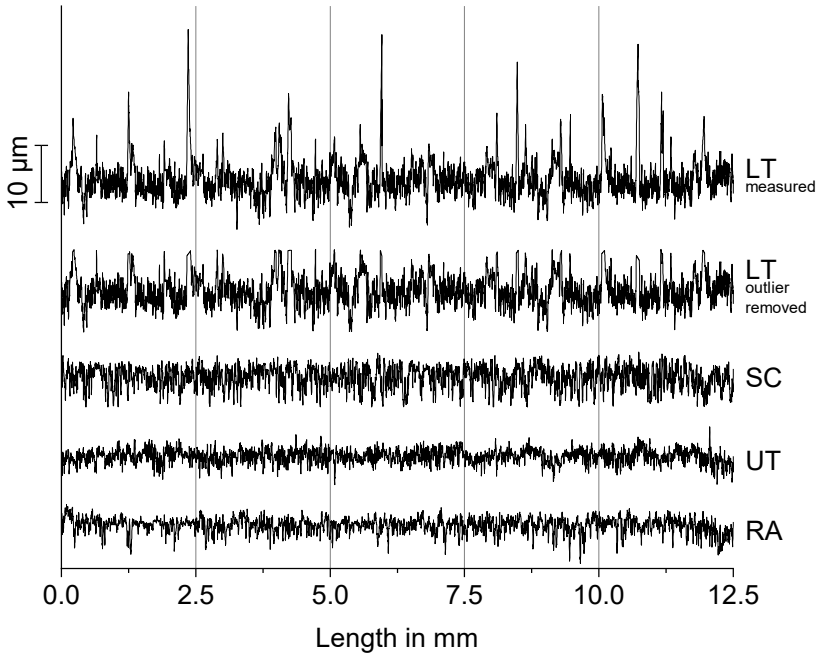
Figure 5.12: Surface profiles for the release agent applied (RA), untreated (UT), solvent cleaned (SC) and laser-treated (LT) configurations. Scales for length and profile depth vary.

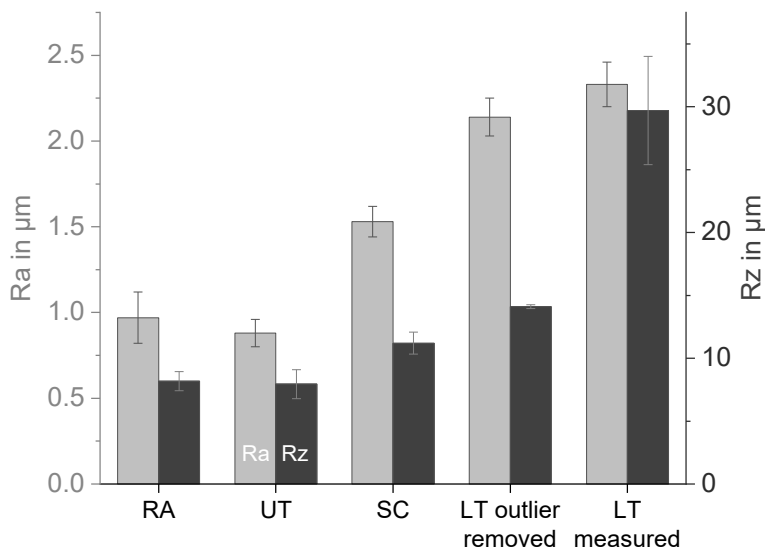
Figure 5.13 shows the evaluation of the roughness profiles with the arithmetical mean deviation of the profile R_a and the maximum peak to valley height R_z . The determined roughness values confirm the observations made from the profiles.

Figure 5.13: Comparison of the surface roughness parameter R_a and R_z for the release agent applied (RA), untreated (UT), solvent cleaned (SC) and laser-treated (LT) configuration.

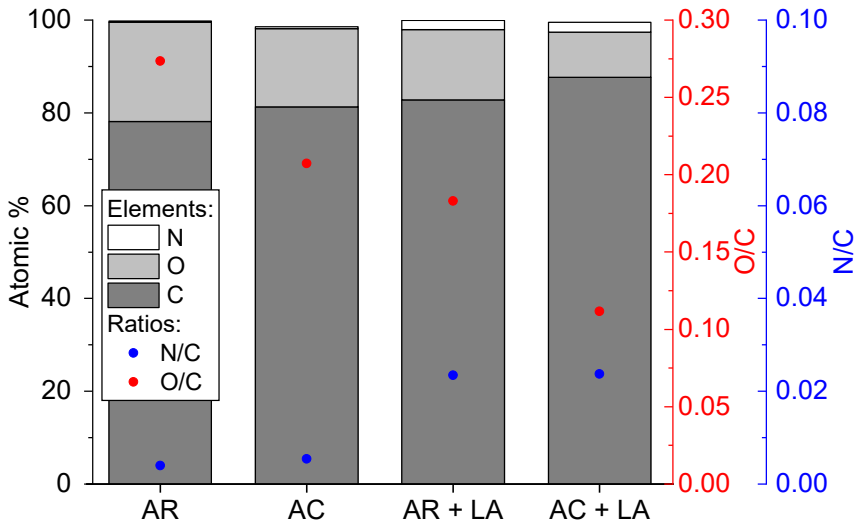
Figure 5.14: Surface elemental composition of the bulk matrix and milled CFRP after solvent cleaning (SC) and laser treatment (LT).

Carbon and oxygen account for at least 90 % for all configurations and are therefore by far the most present elements in epoxy resin and CFRP. Furthermore, smaller amounts of nitrogen and sulphur were detected. The results show no indication of a functionalisation on the surface, but rather a decrease of the O/C ratio after the laser treatment, especially for the fibre-rich region. Though an increase of the N/C ratio is observed for the matrix-rich region, the increase is significantly lower than the decrease of the O/C ratio. The bulk matrix shows the highest O/C ratio and sulphur content of all configurations. Epoxy resin is known to have a relatively high oxygen ratio of around 20 % [153]. Furthermore, sulphur most likely cannot be found on the carbon fibre surface. A significant decrease of sulphur can be identified for the LT (fibre- and matrix-rich) as well as SC configuration compared to the bulk matrix. Both configurations show stripped fibres to a varying degree on the surface. Therefore, a decrease of the O/C ratio of the LT configurations can be attributed to the decrease of epoxy resin on the surface to some extent.

The elemental composition on the surface of the carbon fibre bundles can be seen in Figure 5.18. Compared to the elemental composition of the CFRP, no sulphur was found on the surface. This further emphasizes that the sulphur content in Figure 5.14 and Figure 5.17 is a good indicator for the amount of epoxy resin on the surface.

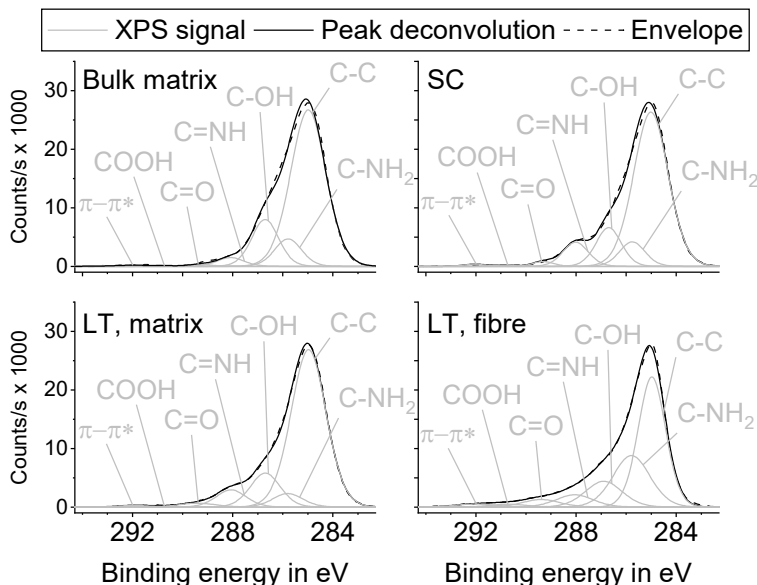
To get a better understanding of the processes that could lead to the changes of the elemental composition on the surface, the C1s spectra of the respective configurations were compared as seen in Figure 5.15. Generally, a very good agreement between the XPS signal and the fitting (envelope) was achieved for all configurations. All configurations have a significant amount of carbon-carbon bonds. Given the high carbon ratio on the surface, this is a reasonable result and in accordance with the literature [104]. Except for the fibre-rich LT configuration, the hydroxyl group has the highest ratio of all functional groups. Hydroxyl groups are present in cured epoxy resin systems that involve an amine curing agent, which is generally the case for prepreg type epoxy resins [154]. Adding to the change in the elemental composition, the comparably low hydroxyl content of the LT, fibre-rich configuration is another indicator for the removal of epoxy resin, but cannot be correlated to removal of functional groups on the fibre.

Figure 5.15: C1s spectra of the bulk matrix and milled CFRP after solvent cleaning (SC) and laser treatment (LT).

after acetone treatment seems unlikely. The C1s spectrum of the AC+LT configuration shows a close resemblance with the LT fibre-rich configuration of the CFRP (see Figure 5.15), which means that similar processes must have taken place.

the laser treated configurations, the C1s spectra in Figure 5.22 also show similar shapes. Overall, the shapes very much resemble the fibre-rich regions of the laser treated configuration in Figure 5.15. As matrix-rich regions were significantly smaller, the C1s spectra are dominated by the fibre chemistry, which would explain the similarity to the LT fibre-rich configuration. Therefore, as already mentioned in Chapter 5.3.1 good adhesive properties can be expected. An increase in the C-OH peak can be observed. This could be a result of the aforementioned shift of the measurement spot or an oxidation process. Nevertheless, the shape is largely uninfluenced by the time after laser treatment. As from the C1s spectra, the increase of the C-OH functional group ratio is also visible in Figure 5.23.

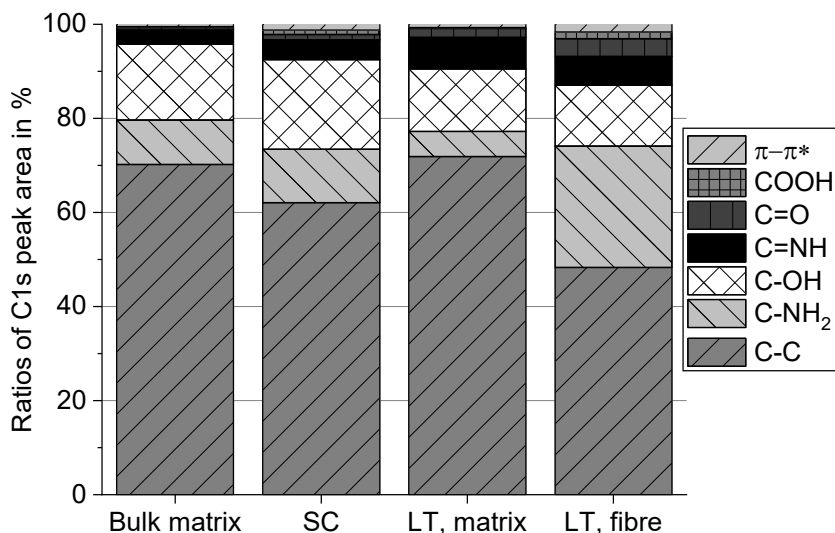
An evaluation of the functional groups present on the surface is given in Figure 5.16. The fibre-rich region of the LT configuration stands out in terms of the C-NH₂ ratio, which is significantly higher than for the other regions. A high amount of C-NH₂ functional groups is characteristic for electrochemically treated carbon fibres [140]. Electrochemical oxidation is the preferred surface treatment method for industrially produced carbon fibres and has most probably been used for the manufacturing of the T800S carbon fibres. Additionally, the LT fibre-rich configuration shows the highest ratio for the COOH functional group, which is known to be an indicator for good bonding to epoxy resin [112]. All of the configurations show a high ratio of functional groups on the surface with at least 28 % of the C1s peak being composed of functional groups. As a functionalisation from the solvent cleaning can be ruled out, the underlying surface is already suitable for adhesive bonding after the milling process, from a chemical point of view.

Figure 5.16: Functional composition of the C1s peak for the bulk matrix and milled CFRP after solvent cleaning (SC) and laser treatment (LT).

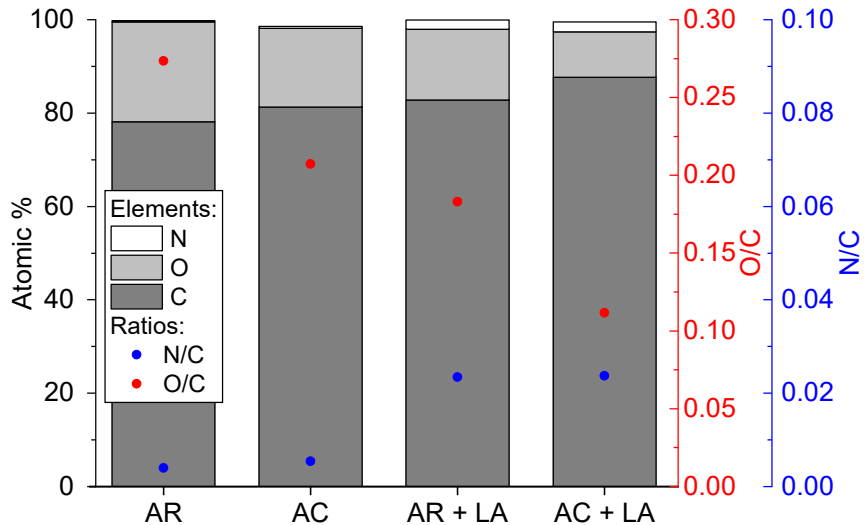
from the fibre. Therefore, the elemental composition has to be evaluated with regards to that. A sized fibre is associated with higher oxygen and lower nitrogen content compared to an unsized fibre [124,155]. The acetone treatment causes a decrease of the oxygen and a slight increase in the nitrogen content on the surface. Accordingly, it can be concluded that the acetone treatment was able to remove the sizing at least partially. Further decreasing oxygen and increasing nitrogen content can be observed for the AR+LT and AC+LT configuration. Some authors argued that high temperatures are necessary in order to completely decompose the sizing and acetone treatment alone is not sufficient [156].

Figure 5.18: Surface elemental composition of the T700S carbon fibre for the as-received (AR), acetone rinsed (AC) and afterwards laser treated (AR+LT, AC+LT) configuration.

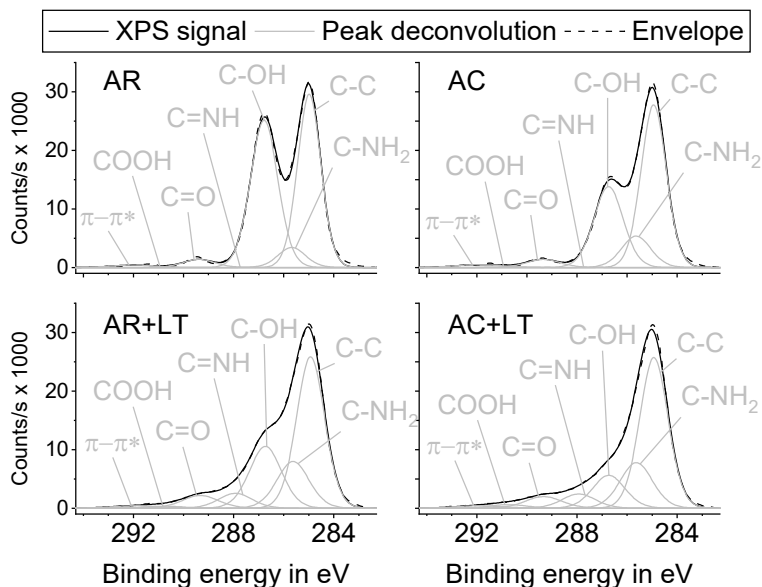
The C1s spectra of the different configurations in Figure 5.19 show significant differences.

Figure 5.19: C1s spectra of the T700S carbon fibre for the as-received (AR), acetone rinsed (AC) and afterwards laser treated (AR+LT, AC+LT) configuration.

The AR configuration shows a distinctive peak for the C-C bond and the C-OH functional group. For the other configurations, the C-OH peaks seem to diminish in the same order as the decrease of oxygen in the elemental composition. Furthermore, the C-NH₂ peak increases. The AR and AC configurations show a close resemblance with the results of a study by Dai et al. [155]. In the study, a desizing of the T700S fibre was assumed. Given the fact that the C-OH functional group, which is an indicator for the presence of epoxy resin, further decreases after laser treatment, a complete desizing
