Near-infrared laser surface treatment of milled CFRP aircraft structures for bonded repair applications

genehmigte Dissertation

von
Sergej Harder

2020

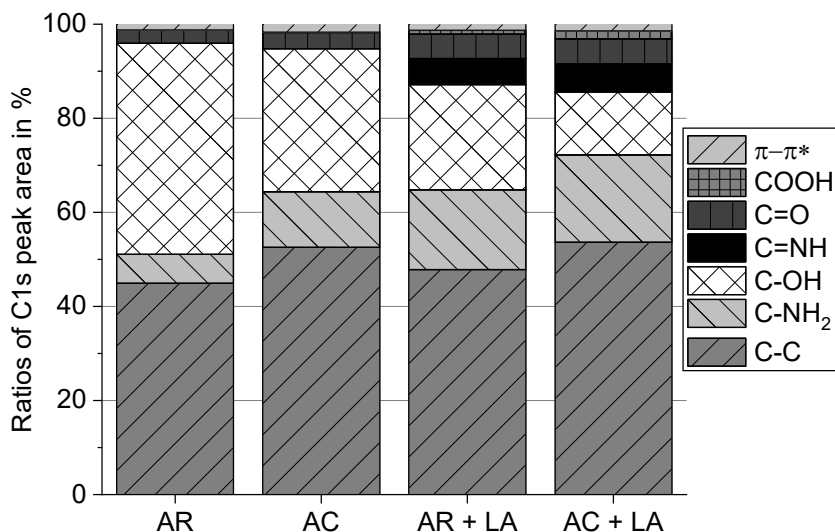
The quantification of the C1s spectra in Figure 5.20 shows that the gradual removal of the sizing also increases the ratio of C=NH, C=O and COOH functional groups. Especially the increase of COOH functional groups should benefit the adhesion with an epoxy based adhesive, though it is small.

Figure 5.20: Functional composition of the T700S carbon fibre for the as-received (AR), acetone rinsed (AC) and afterwards laser treated (AR+LT, AC+LT) configuration.

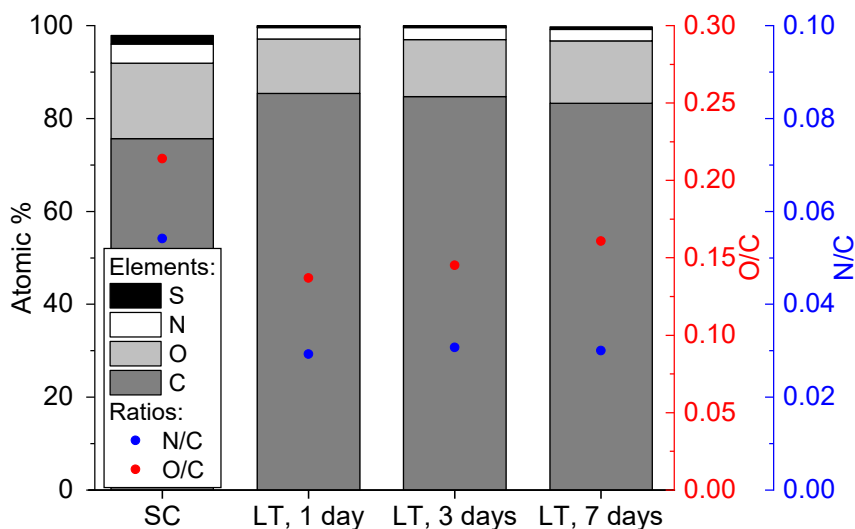
The ageing of the laser surface treatment was investigated by separate measurements of the same specimen at the same position. The first measurement was taken after one day. This was the normal procedure for all previously mentioned XPS measurements. The second measurement was taken three days, and the third was taken seven days after the laser surface treatment. Specimens were stored under ambient conditions. Figure 5.21 shows the elemental composition of the aforementioned configurations and the SC configuration for reference. Elemental compositions for the different measurement dates are similar, though a slight increase in O/C ratio is

visible. On the other side, this increase is also accompanied by an increase in sulphur, which could be the result of a slight deviation of the measurement point. Though the point of measurement was marked for reference, it cannot be recovered completely. Therefore, the increased sulphur content could indicate that an area with slightly more matrix was investigated. This is also accompanied by an increase of oxygen, as known from the previous investigation of the fibre- and matrix-rich region of the laser treated surface in Chapter 5.3.3.

Figure 5.21: Surface elemental composition for a defined time after the laser treatment (LT) and the solvent cleaned (SC) configuration for reference.

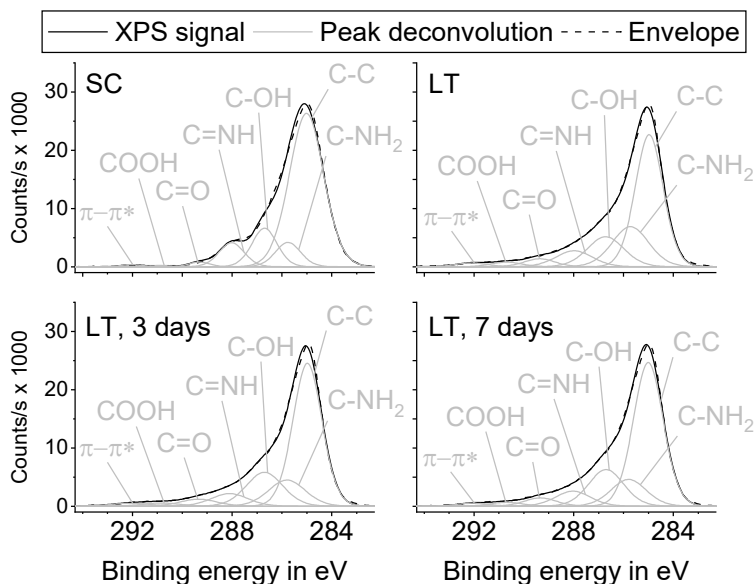
the laser treated configurations, the C1s spectra in Figure 5.22 also show similar shapes. Overall, the shapes very much resemble the fibre-rich regions of the laser treated configuration in Figure 5.15. As matrix-rich regions were significantly smaller, the C1s spectra are dominated by the fibre chemistry, which would explain the similarity to the LT fibre-rich configuration. Therefore, as already mentioned in Chapter 5.3.1 good adhesive properties can be expected. An increase in the C-OH peak can be observed. This could be a result of the aforementioned shift of the measurement spot or an oxidation process. Nevertheless, the shape is largely uninfluenced by the time after laser treatment. As from the C1s spectra, the increase of the C-OH functional group ratio is also visible in Figure 5.23.

Figure 5.22: C1s spectra for a defined time after the laser treatment (LT) and the solvent cleaned (SC) configuration for reference.

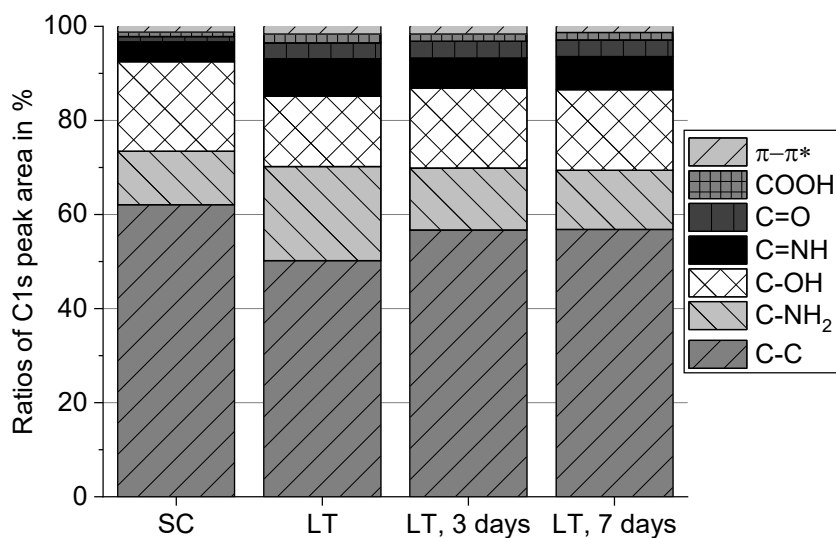
All of the configurations show a high ratio of functional groups of at least 49 %. Furthermore, the ratio for the COOH functional group remains constant during the period of seven days. Overall, the investigated surfaces

show a high functionality. The ageing of the laser treated surface is negligible for the evaluated time. The variation of the elements is in the range of the measurement scatter and therefore no ageing can be expected for the given time. It is thus reasonable to assume that the adhesive properties of the surface should not change and the bonding process can be postponed up to seven days after the laser treatment.

Figure 5.23: Functional composition of the C1s spectra for a defined time after the laser treatment (LT) and the solvent cleaned (SC) configuration for reference.

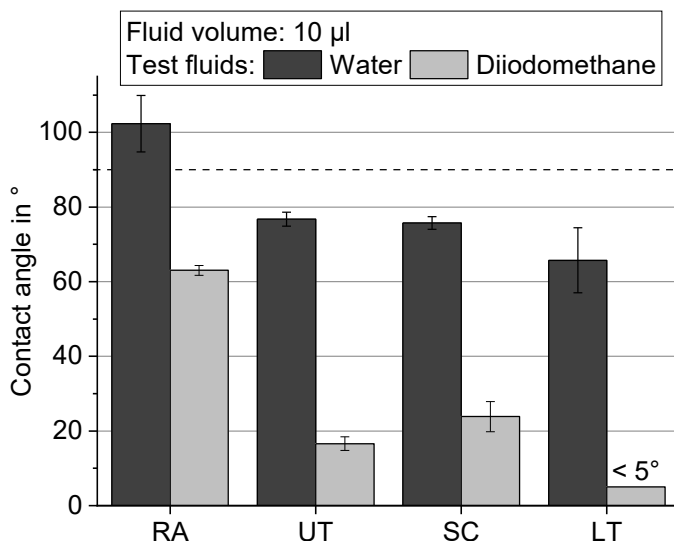
Figure 5.24 shows the static contact angle of the RA, UT, SC and LT configuration.

Figure 5.24: Static contact angle for the release agent applied (RA), untreated (UT), solvent cleaned (SC) and laser-treated (LT) configuration of a milled surface.

An angle of 90° is considered to be the threshold for good wetting. Despite the RA configuration, all other configurations show good wetting with water as a test fluid. Since the aim of the RA configuration was to have a reference where poor adhesive properties could be expected, this result shows good agreement. For diiodomethane, even the RA configuration shows good

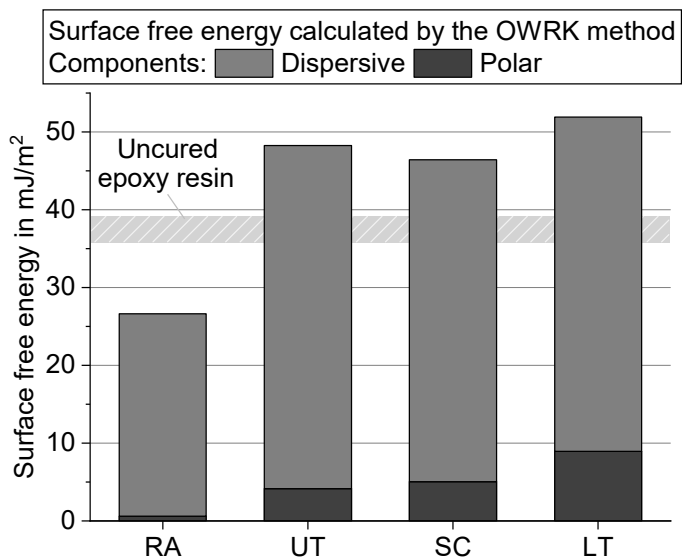
The resulting surface free energies for the average contact angles calculated by the OWRK method are shown in Figure 5.26. The RA configuration has a significantly lower surface free energy than the other configurations. The other three surface free energies are in the range between 46 mJ/m^2 and 52 mJ/m^2 . Studies reported a surface free energy between 36.3 mJ/m^2 up to 39.0 mJ/m^2 for uncured epoxy resin [66,158]. Therefore, except for the RA configuration, a spreading of the epoxy based adhesive can be expected. Since the surface free energy of a surface is influenced by the chemistry and the surface roughness, both could contribute to the improved wetting of the LT configuration. The LT configuration showed the highest roughness of all. In the case of good wetting, an increase of the roughness will further increase the surface free energy [159]. Therefore, the increased roughness could be an explanation for the higher surface free energy. On the other side, the

The higher surface free energy of the UT compared to the SC configuration is somewhat surprising, given that for the SC configuration a higher surface roughness was measured. Since the chemical composition should be similar on both surfaces, a higher surface free energy would be expected for the SC configuration. A reason for the higher surface free energy of the UT configuration could be the porous surface. While the milling residues do not contribute to the surface roughness, this layer can be penetrated by the test liquids and therefore improves the wetting.

Figure 5.26: Surface free energy calculated with the OWRK method considering the determined average contact angles for the release agent applied (RA), untreated (UT), solvent cleaned (SC) and laser-treated (LT) configuration.

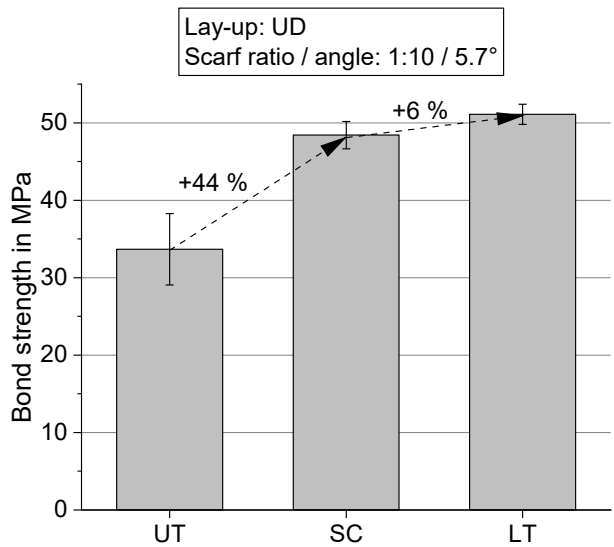
Figure 5.27 shows the effect of the solvent cleaning and laser treatment on the scarf bond strength for a scarfing ratio of 1:10 and a UD lay-up. The assessment of the bond strength shows that surface treatment improves the bond strength significantly.

Figure 5.27: Comparison of the effect of surface treatment after milling for the untreated (UT), solvent cleaned (SC) and laser-treated (LT) configuration.

A solvent cleaning already improves the bond strength by 44 % compared to a milled and untreated surface. For laser treatment, a further improvement of 6 % can be observed. An analysis of variance (ANOVA) showed that the improvement of the LT configuration compared to the SC configuration is statistically significant ($p\text{-value} < 0.05$). Furthermore, the SC configuration was tested with 18 specimens from two different panels to account for the complex specimen manufacturing. The bond strengths of both panels

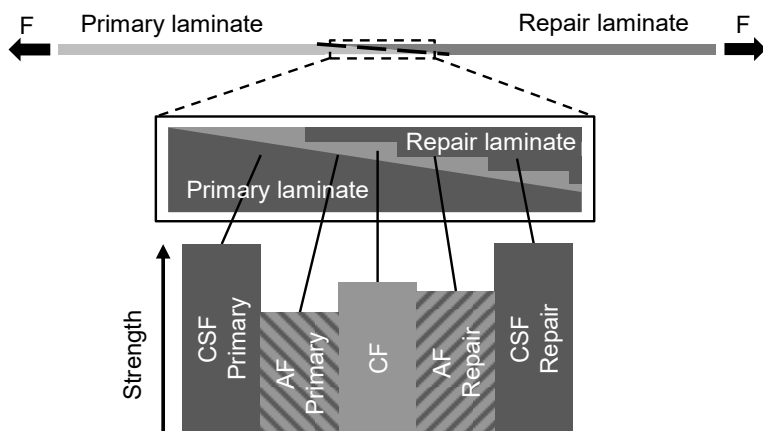
The assessment of the fracture surfaces is a fundamental part of the mechanical testing of bonded joints as the specimen can fail at different locations. Therefore, a chain model that was proposed by Reitz et al. [73] was adjusted by adding the repair laminate and implemented for the assessment. Figure 5.28 shows the bond line and the corresponding model with the five elements, each representing a failure location. Though this model is a simplification of the conditions in the bond, since the failure is an aggregate of the stress distribution and the respective strengths at the different locations, it helps to visualize the effect of the surface treatment.

1. Adhesive failure at the primary laminate interface (AF Primary in Figure 5.28). This result returns a value for the strength of the interface.
2. A change of the fracture location for different surface treatment methods. The change of the fracture surface includes a shift from adhesive to cohesive failure or adhesive failure at the repair laminate in case of an improvement of the bond strength. In case of a weakening, a cohesive substrate failure of the primary laminate would be visible. This result returns a qualitative statement about the effect of surface treatment.

Figure 5.28: Schematic representation of the bond line and the model for the assessment of the fracture surface with the assumed strengths for an arbitrary configuration. CSF: cohesive substrate failure, AF: adhesion failure, CF: cohesion failure.

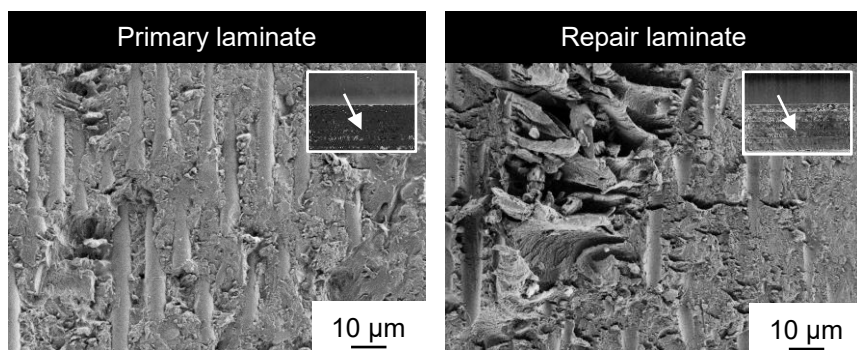
Figure 5.30 shows a section of the primary and repair laminate adherend of a UT configuration specimen. The primary laminate side of the fracture surface appears very smooth without any significant amounts of milling residues visible. On the repair laminate side, a rough and smooth section is visible. The rough part could indicate a cohesive failure but also removed milling residues. A definitive distinction is not possible, though it could be argued that similar to the adhesive disc in Figure 5.4, the adhesive peels of remaining milling residues on the primary laminate. This would also explain the comparably low strength as the adhesive is only partially able to bond with the primary laminate.

Figure 5.30: SEM images of the fracture surfaces of an untreated (UT) configuration.

The smooth section on the repair laminate shows fibre indentations. The fibre indentations indicate a weak bonding of the adhesive with the fibre. The darker spots on the fracture surface of the repair laminate side were found to be relatively smooth, while brighter parts were rougher. No significant areas with peeled of fibres were found on neither side.

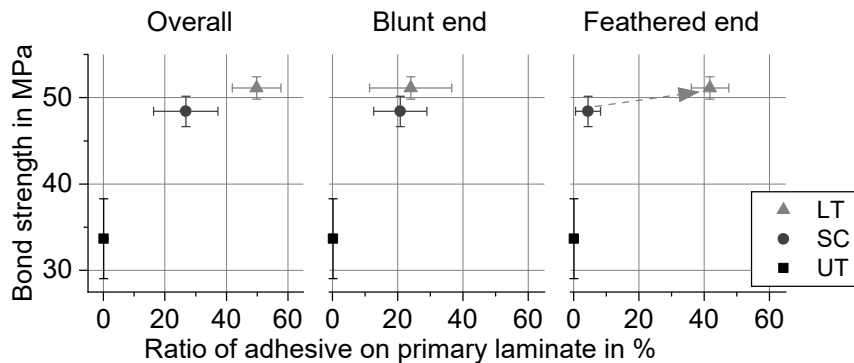
As part of the fracture surface assessment, a quantitative method was developed to evaluate the amount of adhesive on the primary laminate after a fracture. The adhesive on the primary laminate can either be related to cohesive or adhesive failure on the repair laminate. Since the interface between the adhesive and repair laminate is not modified, it is a suitable indicator for the surface treatment effect. Figure 5.31 shows the ratio of adhesive on the primary laminate in correlation with the achieved bond strength.

Figure 5.31: Correlation between the bond strength and ratio of adhesive on the primary laminate for the untreated (UT), solvent cleaned (SC) and laser-treated (LT) configuration.

The bond strength and adhesive ratio seem to correlate quite well for the overall bonded surface. The results, therefore, confirm the qualitative observations from the fracture surfaces. Furthermore, the effect can be separated between the blunt ending and feathered ending of the scarf for the SC and LT configuration. While the adhesive ratio is similar for both surface treatments at the blunt end, a significant difference can be observed for the feathered end. The scarf ends are subject to stress peaks. Consequently, the failure may start at the feathered end. As the increase of the bond strength is low compared to the increase of the adhesive ratio, the LT configuration could establish the transition to the preferred cohesive dominated failure.

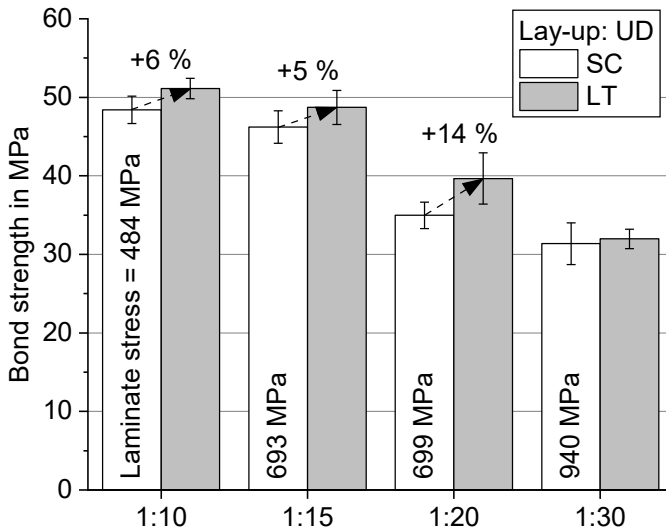
The influence of the scarf ratio on the effect of the bond strength is shown in Figure 5.32. For this study, only the SC and LT configuration were compared since the goal was to evaluate if the laser treatment could achieve similar results as the established reference process.

Figure 5.32: Comparison of the bond strength for the solvent cleaned (SC) and laser-treated (LT) configuration for different scarf ratios.

As for the previously shown scarf ratio of 1:10, the LT configuration performs similar or better than the SC configuration in terms of the bond strength. The result shows that the potential increase of cavities does not affect the bond strength negatively. Generally, decreasing bond strength can be observed for an increasing bond area. This is a result of the previously mentioned correlation between the size of the stress peaks and the bond area. Nevertheless, the strength is increased in terms of the laminate stress as shown by the values inside the bars. The laminate stress was estimated by the average maximum force of the SC configuration and the cross-section of the laminate given by the thickness (1.5 mm) and width (25 mm) of the adherend.

For a scarf ratio of 1:30, the difference between the SC and LT configuration was not significant. Additionally, the laminate stress is significantly higher

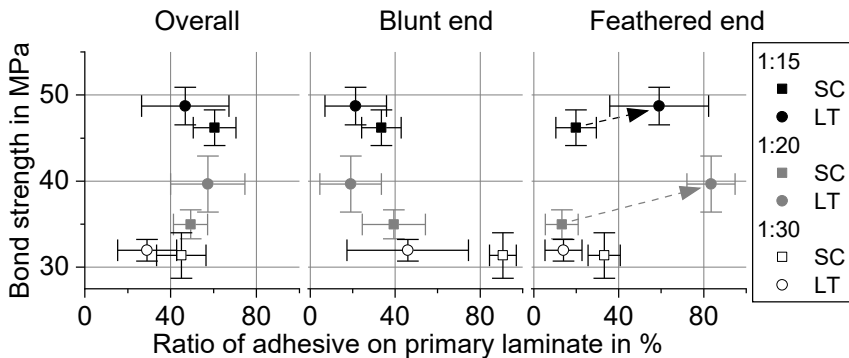
Figure 5.34: Correlation between the bond strength and ratio of adhesive on the primary laminate for the solvent cleaned (SC) and laser-treated (LT) configuration.

configuration is not evident as for the 1:10 scarf ratio, the feathered end shows a significant difference for the 1:15 and 1:20 scarf ratio. The quantitative analysis in Figure 5.34 also confirms the increasing adhesive ratio on the feathered end for the LT configuration. Together with the increased bond strength, this observation further strengthens the assumption that the failure starts at the feathered end of the primary laminate.

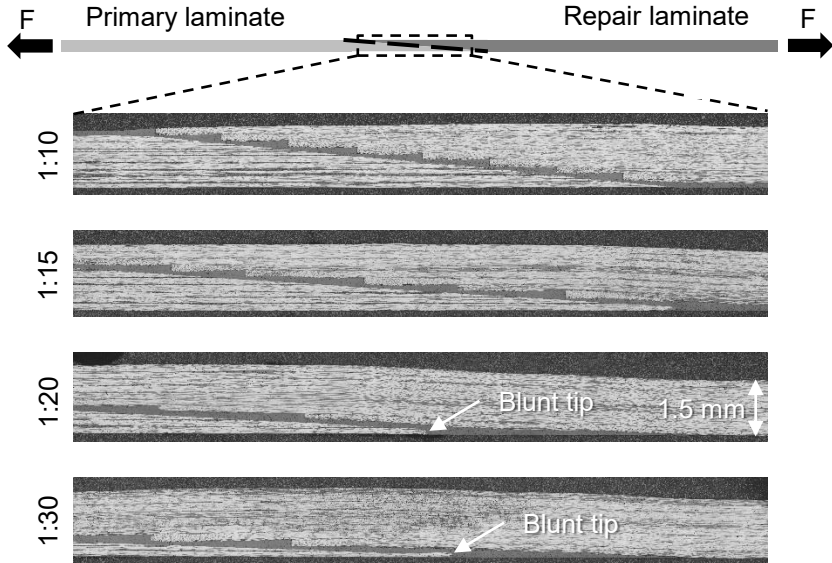
As the geometry plays a critical role in the bond performance, cross-sections of the bonded areas have been prepared for every panel. Figure 5.35 shows the representative cross-sections for all four investigated scarf ratios that were prepared from the edges of the panels. Generally, the bond lines show regularly spaced repair laminate plies. This shows that the use of moulds is suitable for the manufacturing of high-quality bond lines for soft-patch repairs. Furthermore, the varying bond line thickness that is a result of the combination of the tapered scarf of the primary laminate and the stepped repair laminate is well visible.

Noticeably, the shallower scarf ratios of 1:20 and 1:30 show a blunt tip and to a lesser degree also the 1:15 scarf ratio. For shallower scarf ratios the thickness and therefore the geometrical stiffness transitions slower than for steeper scarf ratios. As a result, more extended tips with lower thicknesses are produced. The thin tips increase the flexibility and make the manufacturing of sharp tips more difficult. On the other hand, blunt tips cause an increase in the stress concentrations at the scarf endings. This effect increases for shallower scarf ratios [18]. As a consequence, higher bond strengths could be expected for sharper tips. Furthermore, a superimposed effect of the tip bluntness and surface treatment method can be expected. While for the SC and LT configuration, comparable tips were produced, comparability between scarf ratios is aggravated. As the influence of tip bluntness increases for shallower scarf ratios, the significance of the surface treatment decreases. Therefore, adding to the increased adherend failure, the tip bluntness could be a further explanation for the similarity of the bond strength for all three surface configurations of the 1:30 scarf ratio.

Figure 5.35: Cross-section images of the bond area in the region of the primary laminate feathered tip.

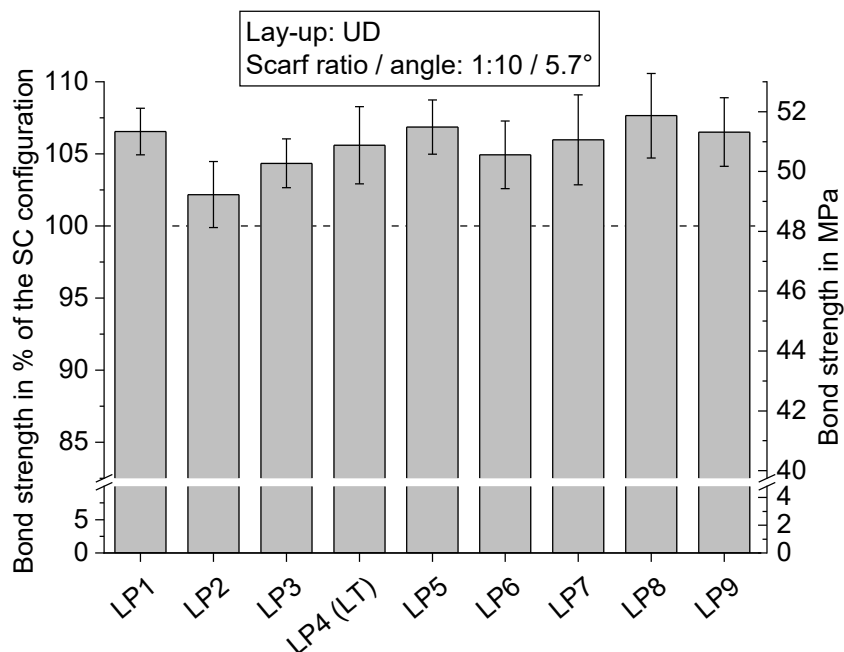
The bond strength of the different laser parameter referenced to the SC configuration can be seen in Figure 5.36. The mean bond strength for all laser-treated configurations is higher than that of the SC configuration. The improvement based on the mean values ranges from 2.2 % to 7.6 %. The results indicate that the laser surface treatment improves the strength of the scarf joint, though the improvement is lower than 6 % for most of the laser parameter. No apparent correlation between the laser parameters and the bond strength can be made. Since laser parameter sets modify four process parameters (pulse frequency, pulse energy, hatch distance and scan velocity), a correlation is not straightforward. Modification of all four process parameters, on the other hand, was necessary to prevent process

Figure 5.36: Comparison of the effect of different laser parameter on the bond strength in reference to the solvent cleaned (SC) configuration.

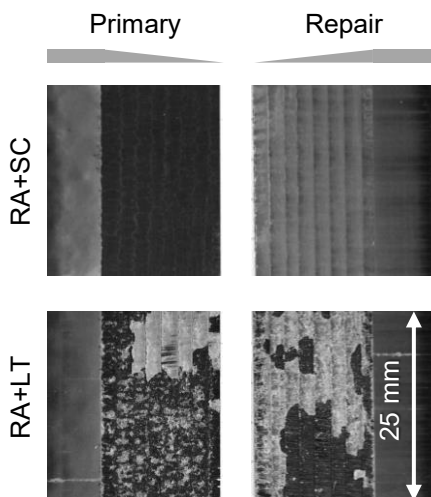
Figure 5.38: Representative fracture surfaces for a solvent cleaned (RA+SC) and laser-treated (RA+LT) after contamination with a release agent.

As previously stated, a blunt tip decreases the bond strength for scarf bonded joints. Therefore, the strength values should only be compared for similar scarf endings. Additionally, the evaluation of the fracture surfaces is essential for the interpretation of the surface treatment effect. The comparison of the fracture surfaces is shown in Figure 5.38. A significant difference between the configurations can be observed. After solvent cleaning the primary laminate is very smooth, revealing the effect of the release agent. For laser treatment, a notable amount of adhesive is visible, though a difference between the previously tested LT configuration without prior release agent

application can be observed. The fracture surface suggests that the release agent was potentially not fully removed. On the other hand, the fracture surface is significantly rougher after the laser treatment and the difference compared to the previously tested LT configuration (see Chapter 5.6.1) could also be attributed to the blunt tip. Nevertheless, laser treatment shows a significantly superior ability to remove the release agent compared to isopropanol. Given that release agent is the worst possible type of contamination, because of the effect on the bond strength and the fact that it is not detectable by conventional non-destructive testing methods like ultrasonic scanning, this result is even more impressive. A release agent layer of a few nanometres can be expected [82]. During the stripping of the fibres, this release agent layer or at least the majority is removed.

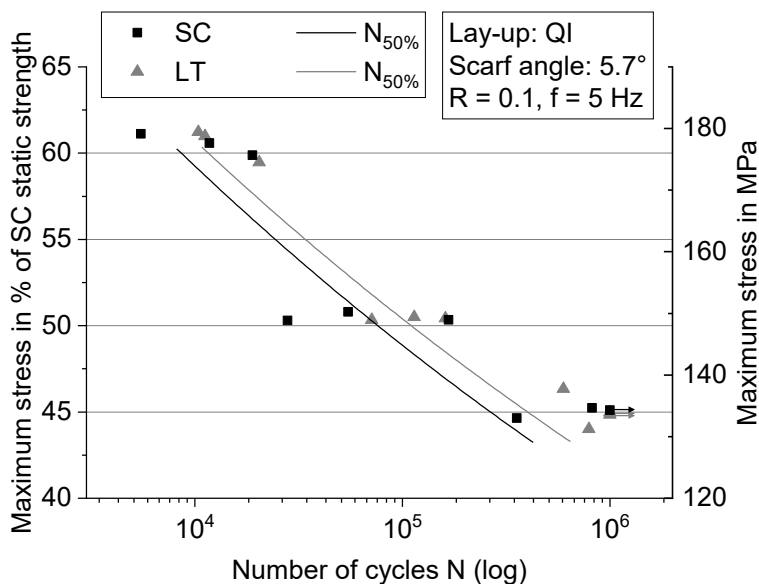
The fatigue strength with respect to the maximum stress during cyclic loading is given in Figure 5.39.

Figure 5.39: Fatigue strength comparison of the solvent cleaned (SC) and laser-treated (LT) configuration.

The maximum stress is in the range of around 50 % of the static strength for 10^5 cycles. For 10^6 cycles or more, the maximum stress is in the range of 45 % of the static strength. These values are significantly better than previously determined values by Yoo et al. [22] (40 % for 10^5 cycles and a scarfing ratio of 1:20), which highlights the quality of the bonding. Three specimens, two for the LT and one for the SC configuration, reached the limit of 10^6 cycles. These specimens are marked by an arrow and not considered for the calculation of the Wöhler line. The determined strengths and Wöhler lines

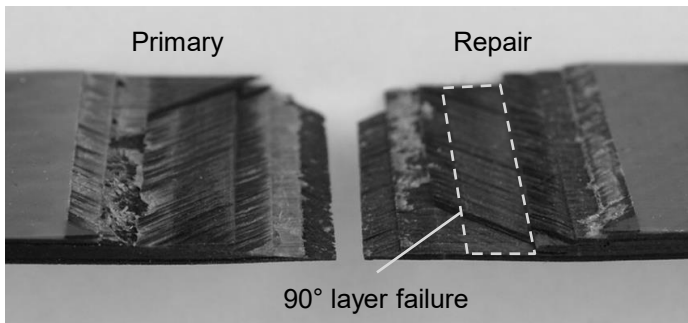
The fracture patterns showed a higher complexity compared to the UD lay-up adherends. Especially the failure of the 90° layer of the repair laminate, as shown in Figure 5.40 needs to be highlighted. Here, the completely detached 90° layer of the repair laminate is visible because of the step in the scarf. The 90° layer has the lowest strength in the loading direction. Furthermore, the ILSS of the repair laminate is around 10 % lower than that of the primary laminate (see Chapter 3.1.1). Therefore, this failure mode appears to be reasonable, though it is not clear whether the failure initiates in that region. Since failure initiation and propagation is a result of the local stress and strength, it is not clear whether the 90° layer is responsible for the resulting bond strength. Given that the strengths between both configurations differ and that the strength of the 90° layer is comparable, this assumption seems unlikely. In order to investigate potential patterns between different configurations despite the failure of the 90° layer, the fracture surfaces were compared for both configurations and load types.

Figure 5.40: Failure of the 90° layer for QI lay-ups.

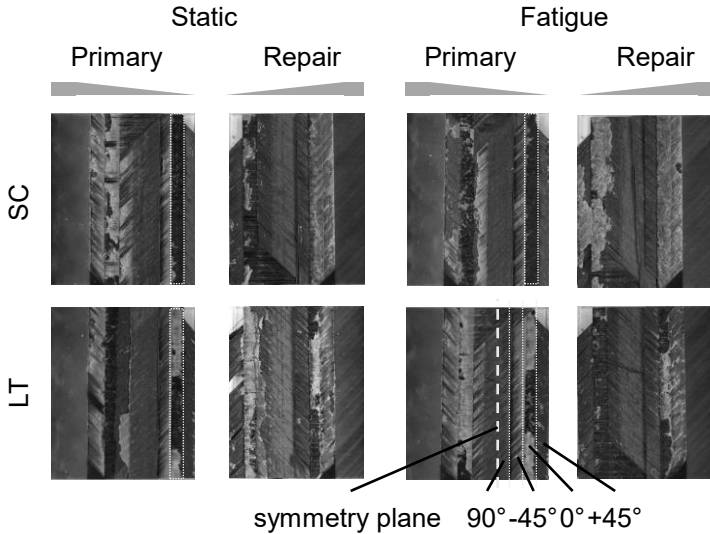
Representative fracture surfaces are shown in Figure 5.41. At first, no apparent pattern can be derived. It was known from the literature that stress peaks in scarf bonded joints with a QI lay-up are found near the 0° plies. Moreover, from previous mechanical testing of adherends with a UD lay-up,

it was concluded that failure likely initiates near the feathered end of the primary laminate. Therefore special interest was taken into these plies (outlined in Figure 5.41).

Figure 5.41: Representative fracture surfaces solvent cleaned (SC) and laser-treated (LT) configuration with a QI lay-up.

Here, a difference between both configurations could be spotted. The 0° ply of the SC configuration shows a smooth fracture surface, without any adhesive residues. In contrast, for the LT configuration, a mixed failure can be observed. The difference in the fracture surfaces could, therefore, indicate the improvement of the bond strength of the LT configuration. A difference in the fracture surface patterns near the regions where stress peaks can be expected was already observed for the UD lay-up. Furthermore, the results show that the presence of cavities does not influence the bond strength negatively for static or even cyclic tension-tension loading. It can instead be concluded that the strength improving mechanisms are also valid for cyclic loading and QI lay-ups.

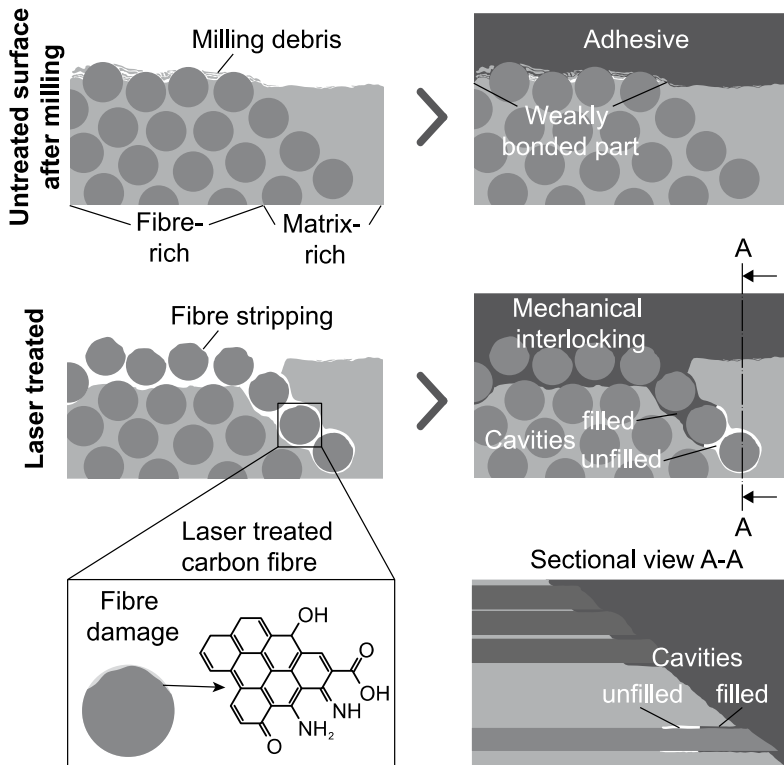
Given the comprehensive information of the surface and the resulting bond strength, this section aims to develop a model view of the laser treatment-induced changes and the subsequent effect on the adhesion. Figure 6.1 shows a schematic representation of the major effects of laser treatment, which are explained in more detail in the following part.

Figure 6.1: Schematic representation of the major effects after laser treatment and the influences on the adhesive properties.

The laser treatment causes a notable change on the surface. As the solvent cleaning, the laser treatment is able to remove the layer of milling debris efficiently. Large agglomerates of milling debris cause a disruption of the interlocking of the adhesive with the load transmitting part of the surface. The milling debris, on the other side, is only poorly attached to the surface and can be easily removed as the adhesive disc experiments showed. Compared to solvent cleaning, the surface is further roughened, and smaller milling particles can be removed. The change is accompanied by a complete circumferential stripping of the fibres. The stripping is evident in the LM, SEM and even roughness measurement. As a result, fibre stripping increases the effective surface area. Therefore, the removal of milling debris and fibre stripping should benefit bond strength. Moreover, as the investigation with contaminated surfaces confirmed, the laser treatment is also able to remove contaminations.
