## Marine Structures

# Ultra-low cycle fatigue of ship hull structure – an alternately-cyclically loaded four-point bending test of a large box girder

Large complex structure  
Ship structure  
Steel structure  
4-point bending  
Ultra-low cycle fatigue  
Large scale test

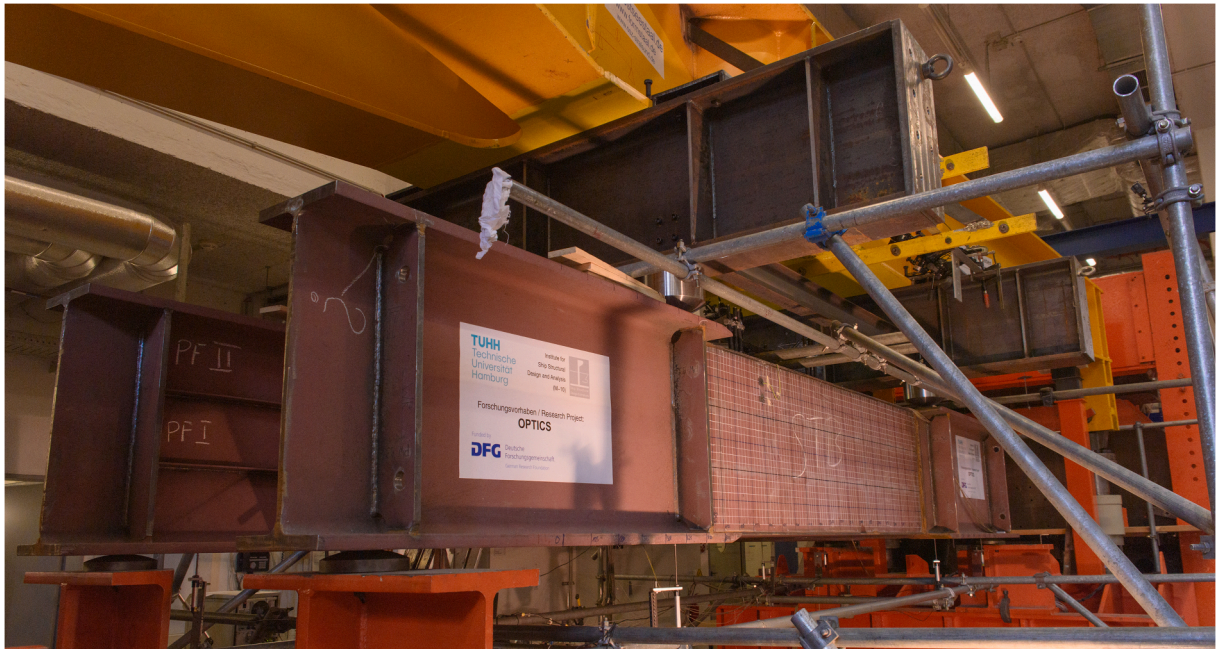
Fig. 2. Outside view of the specimen, taken from the stern and starboard side of the specimen.

girder is shown in Fig. 1 and Fig. 35, while the list of the components is shown in Table 1. Outside and inside views of the specimen before test are shown in Figs. 2 and 3.

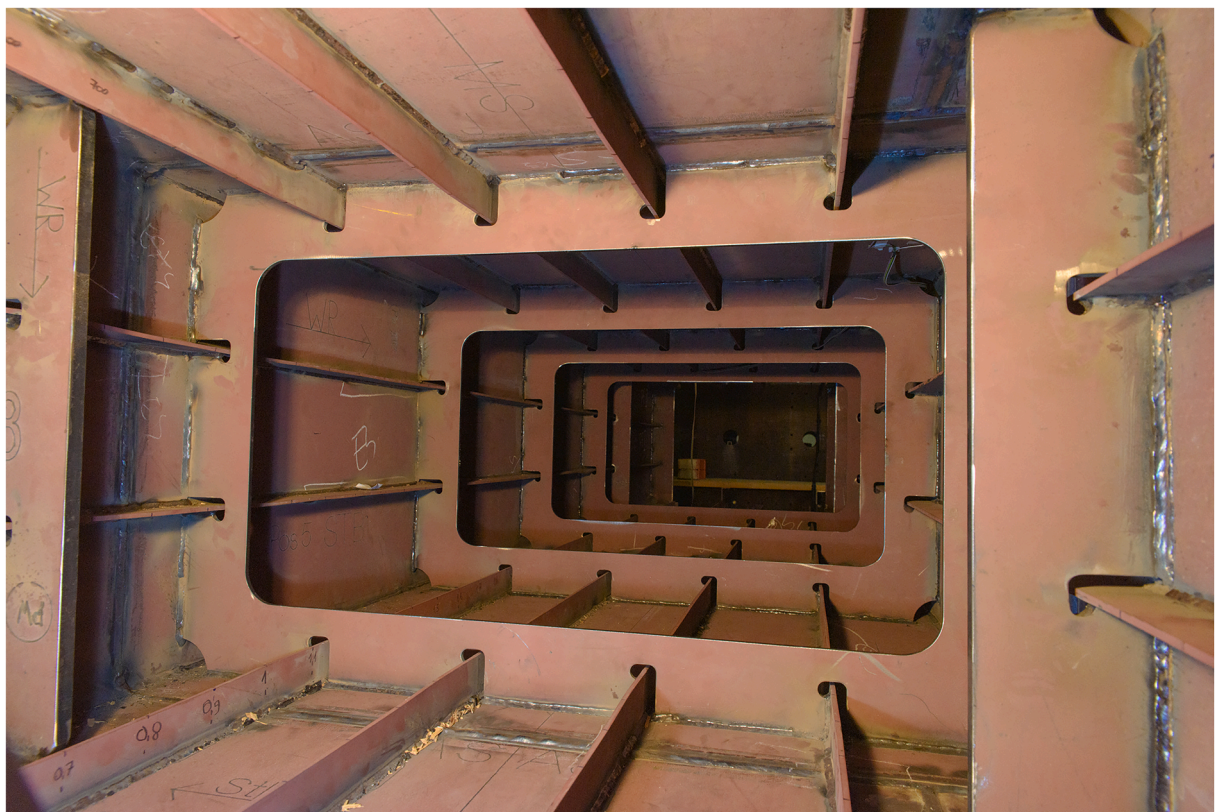
Fig. 3. Inside view of the specimen.

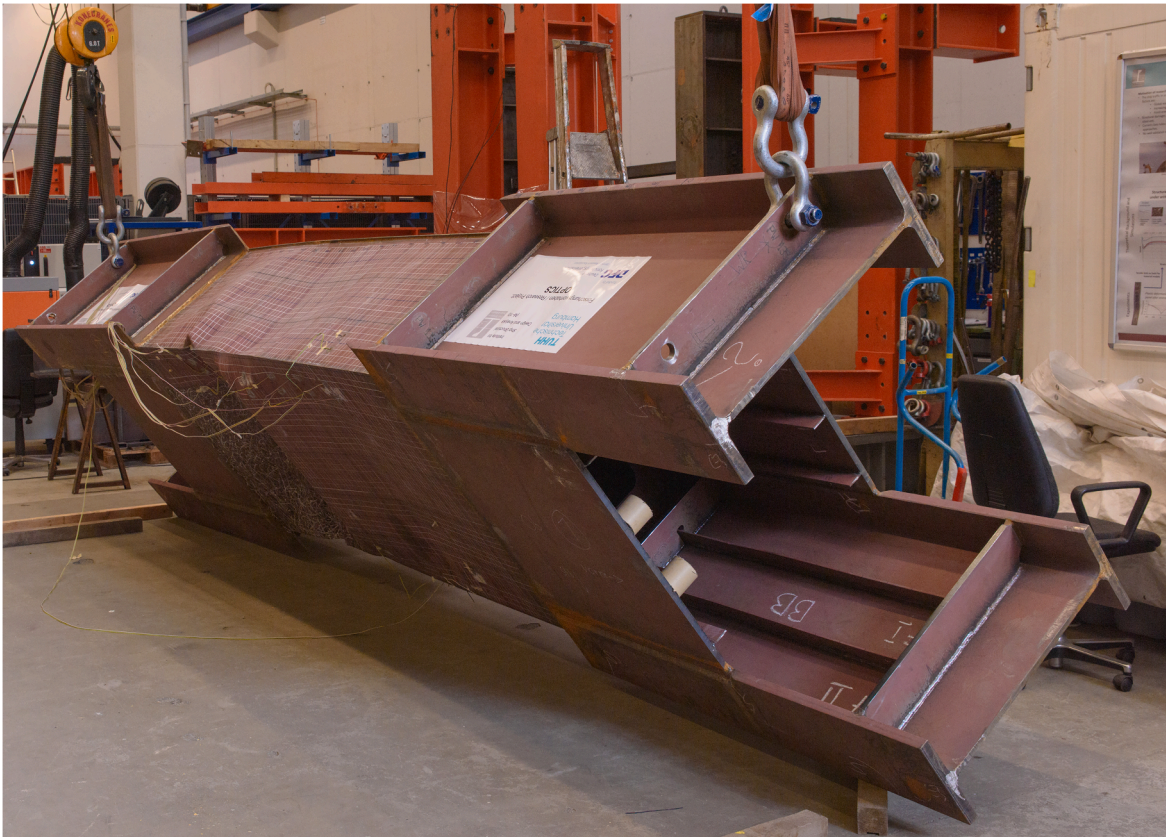
Fig. 10. Turning of the specimen.

For an ultra-low cycle fatigue test, cyclic loading is essential. In this test, each cycle consists of two half-cycles. In each half-cycle, the specimen is loaded monotonically. Before the next half-cycle, the specimen is turned for 180° about its x-axis, see Fig. 10. After the turning, the specimen is placed back on the test rig and load in the same manner, see Fig. 11. Therefore, it is possible to apply the load in the opposite direction from the last half-cycle. In this test, the specimen is loaded with one and half load cycles (three half-cycles). The load is displacement controlled. In the first half-cycle, the displacement introduced in each hydraulic cylinder is about 70 mm. In the second half-cycle, the displacement introduced in each hydraulic cylinder is about 120 mm, while calibrations are applied considering the different deformation at the forward and aft of the specimen. Combining with the unloaded displacement by elastic deformation (about 20 mm) in the first half-cycle (see Fig. 28), this loading control keeps the same load amplitude in both directions for the first cycle (including the first and second half-cycle), see Figs. 11 and 20. Such extent of load can ensure the occurrence of obvious damage, like plastic deformation and even local fracture, while avoid total collapse of the whole specimen in only one loading

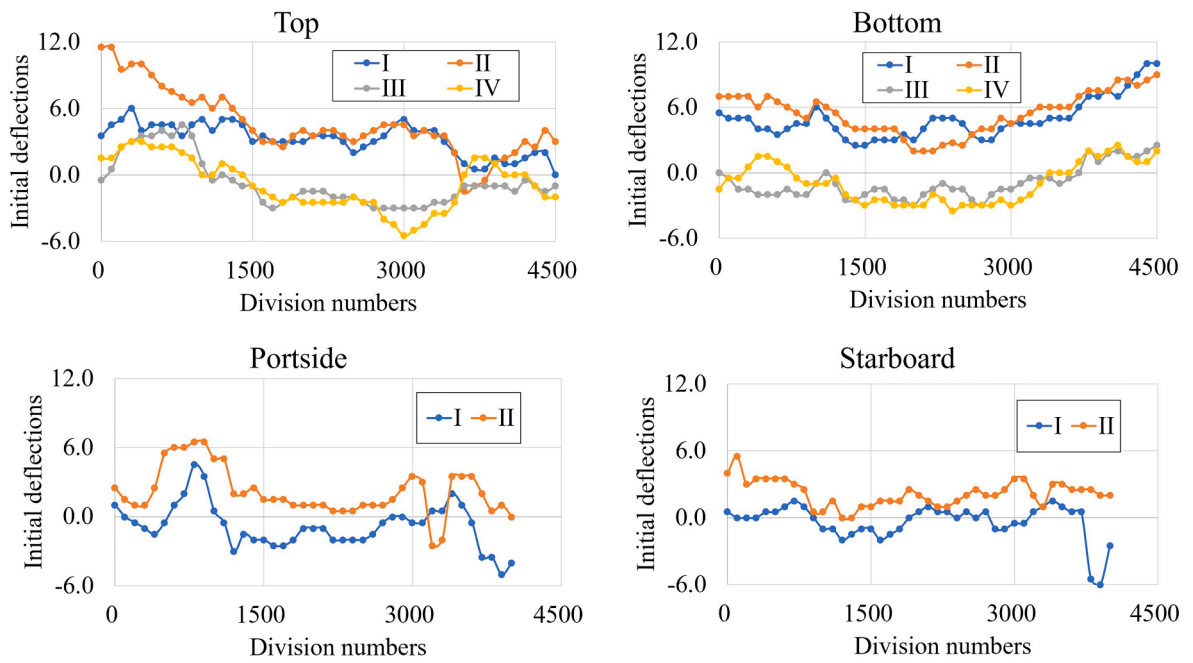
Fig. 13. Initial deflections of the stiffeners.

Before the test and after each half-cycle, the outer hull of the specimen is measured along the divisions by laser scanner or laser rangefinder. Moreover, positions of the stiffeners are measured inside the specimen to indicate the initial imperfections before each half-cycle. The stiffeners are marked in Fig. 12, with the same coordinate system shown in Fig. 4. The initial deflections of the top of the stiffeners are shown in Fig. 13. It can be seen that the initial deflections of the stiffeners are mostly less than their thickness (6.16 mm) within the midsection area. However, large deflection still exists, like the stiffener II between division 3200 and 3300 on portside, see Figs. 13 and 14.

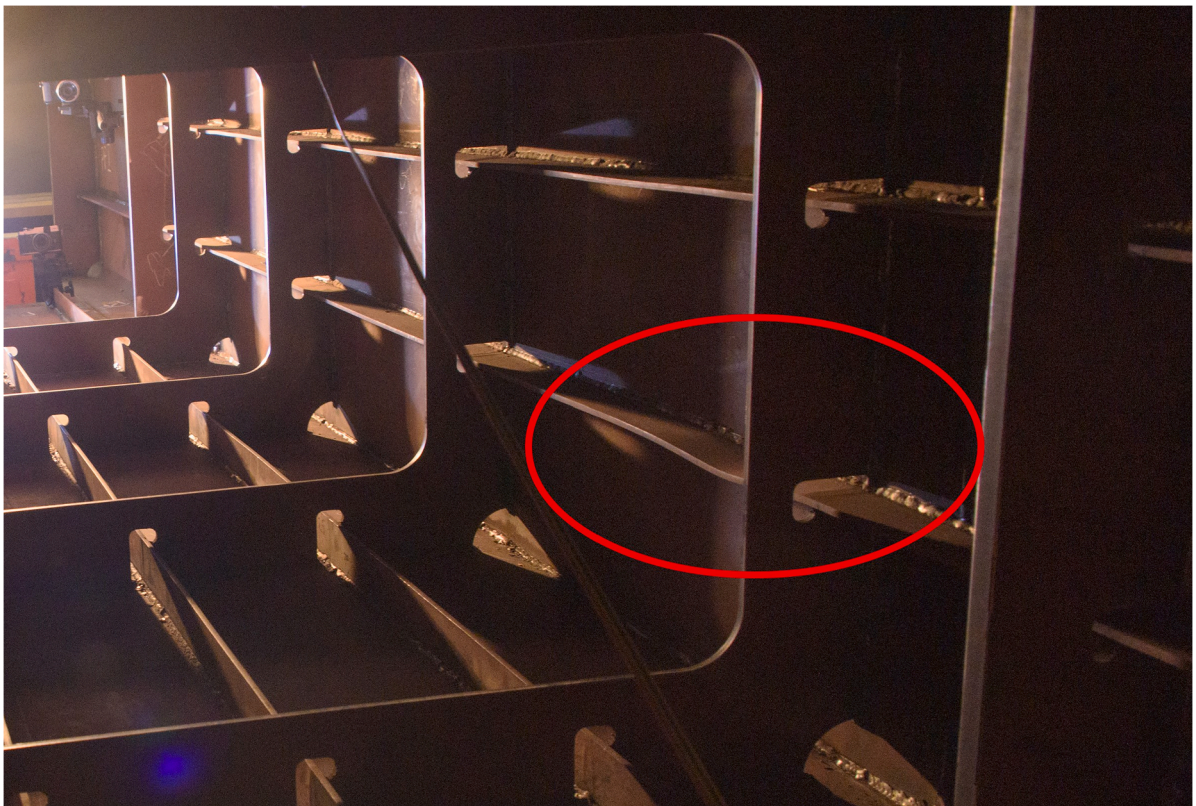
Fig. 14. Large initial deflections of the stiffener before test.

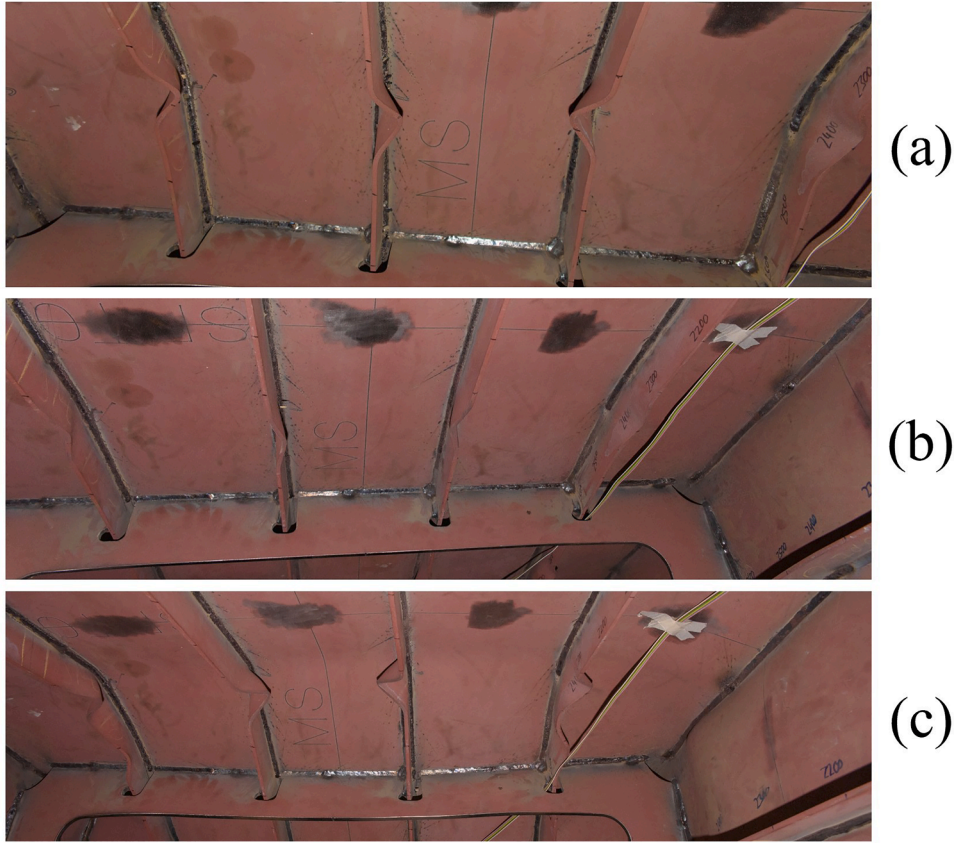
**Fig. 17.** Deformation of the stiffeners on top hull in S2, (a) - (c) refer to the results after 1st, 2nd and 3rd half-cycle respectively. In the picture, the right side is closer to starboard.

After the first half-cycle, buckling of hull plates, stiffeners and frames were observed, as well as large plastic deformation, see Fig. 15, Fig. 16, and Fig. 17. The largest deformation induced by buckling happens in sub-section S2 and S3. Comparably, the S1 is not very heavily damaged. The extent of damage in these sub-sections are illustrated by the laser scan results of the outer hull surface along division 1375, 2250 and 2875, see Fig. 18. The coordinate system here is based on that shown in Fig. 4.

did not fully “recover” back to what they were before the first half-cycle, see Figs. 17 and 19, whose extent is even higher for the third half-cycle. The remaining damage can cause additional imperfection to the specimen, such as increased initial imperfection of stiffeners, see Fig. 27. This will increase the extent of damage, such as buckling and fracture, in the next half-cycle. Moreover, the endurance of the specimen, such as the UHGS, is also reduced compared to the first half-cycle, see Fig. 34. This will be further presented and discussed in the following sections.

damage accumulation, it can be inferred that, existing damage will influence more on the loading with same direction. For example, referring to Fig. 17, the deformation of the stiffeners occurred in first half-cycle are not “recovered” during the second half-cycle. The plastic strain cannot be removed as well. Therefore, the specimen is easier to deform during the third half-cycle. This also explains why the UHGS reduces significantly in the third half-cycle, compared with the reduction in the second half-cycle.

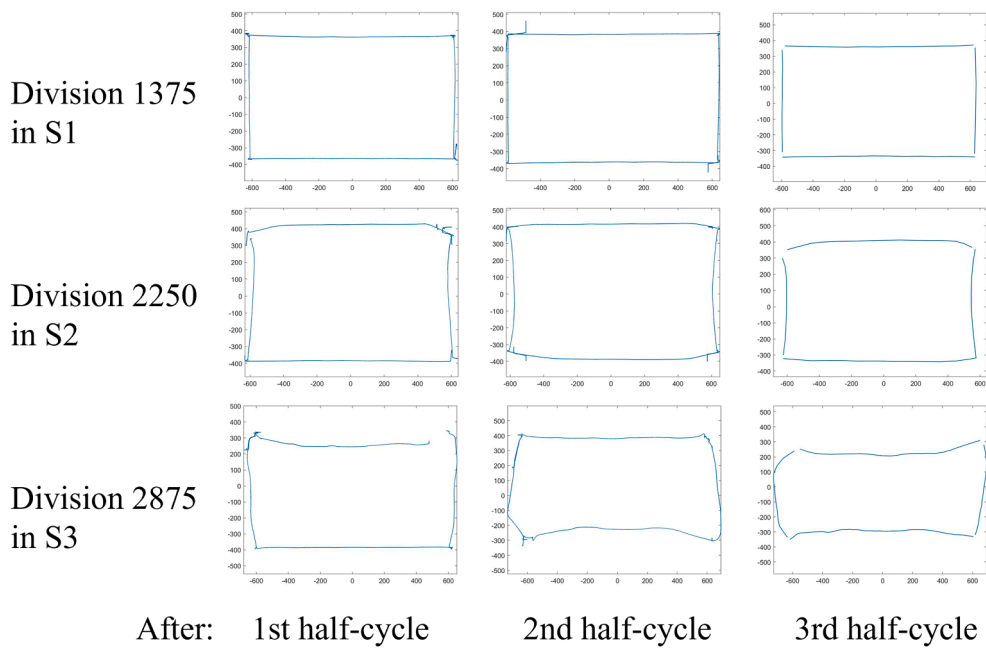
**Fig. 18.** Laser scan result for the outer surface of the specimen at division 1375 in S1, 2250 in S2, and 2875 in S3 after each half-cycle. Due to the limit of range from laser scanners, the surface is not always fully scanned. In all the plots, the upper side refers to the top of specimen, while left side refers to the starboard of the specimen.

Compared with the second half-cycle, due to higher initial imperfection, including the occurred fracture, the deformation and fracture become more severe after the third half-cycle, see Figs. 18 and 23 to Fig. 26. Considering the Bauschinger effect [30], the existing plastic strain also contributes to easier follow-up plastic deformation and fracture at the position with large deformation [18].

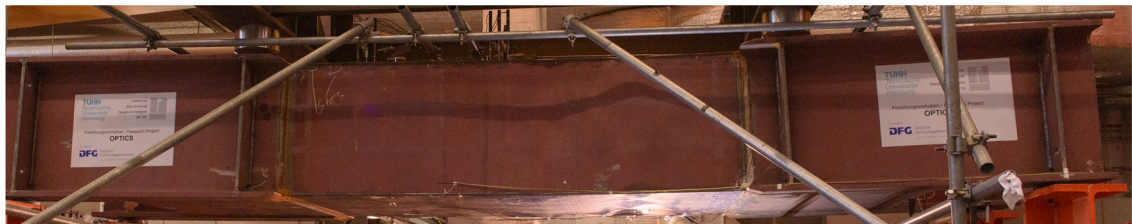
**Fig. 19.** During the second half-cycle (a) and third half-cycle (b), the bent specimen once “recovered” back to a “straight” box girder. However, the damage by buckling did not recover.

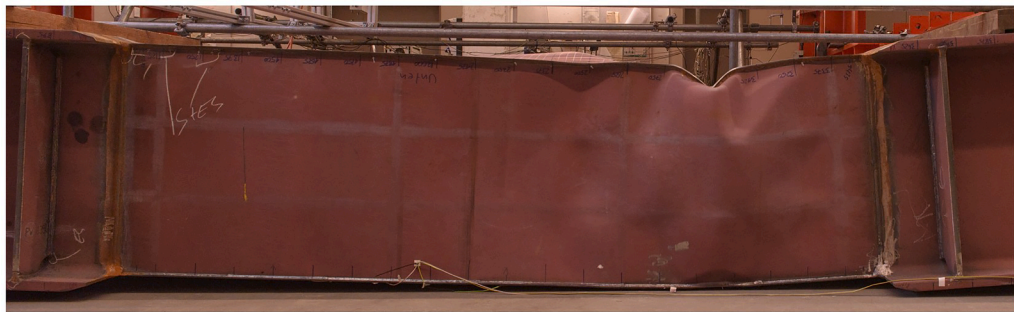
**Fig. 20.** Deformation of the specimen after the second half-cycle. (a) is from the view of portside, and (b) is from starboard. Since the specimen was turned for loading, the upper side of the specimen in the picture is its bottom.

The overall deformation of the specimen after second half-cycle is shown in Fig. 20. Moreover, apart from buckling, fracture was also observed in the second half-cycle, see Fig. 21, Figs. 22 and 23. Since the loading direction of the second half-cycle is opposite to the first half-cycle, the longitudinal deformation of the box girder is reversed, but the plastic deformation occurred in the first half-cycle

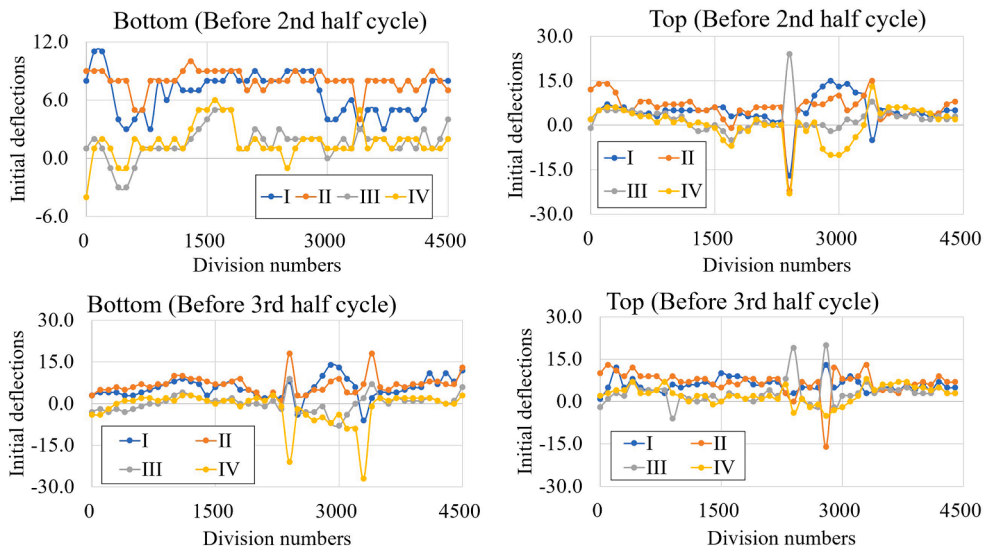
**Fig. 27.** Initial deflection of stiffeners on top and bottom of the specimen before second and third half-cycle.

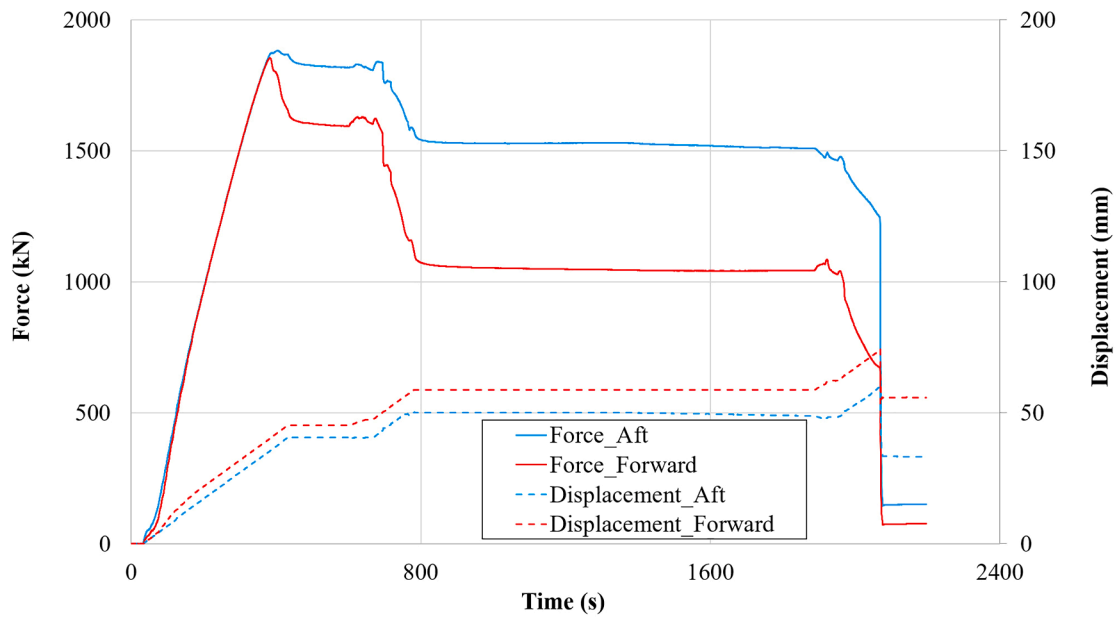
Fig. 28. Force and displacement versus time from the hydraulic cylinders, in the first half-cycle.

The data collected from the hydraulic cylinders are shown in Fig. 28, Figs. 29 and 30. The hydraulic cylinders are called as “HC” here. Referring to the positions of the hydraulic cylinders shown in Fig. 9, the force and displacement of the hydraulic cylinders at forward of the specimen are very similar, which is the same for aft. Therefore, the results are organized into groups for forward and aft. The group for forward includes HC2 and HC4, while the group for aft include HC5 and HC6. The force of each group is the total force induced by the hydraulic cylinders, and the displacement of each group is the average displacement of the hydraulic cylinders. It can be seen from the test results that, the maximum force at the hydraulic cylinders becomes lower after each half-cycle.

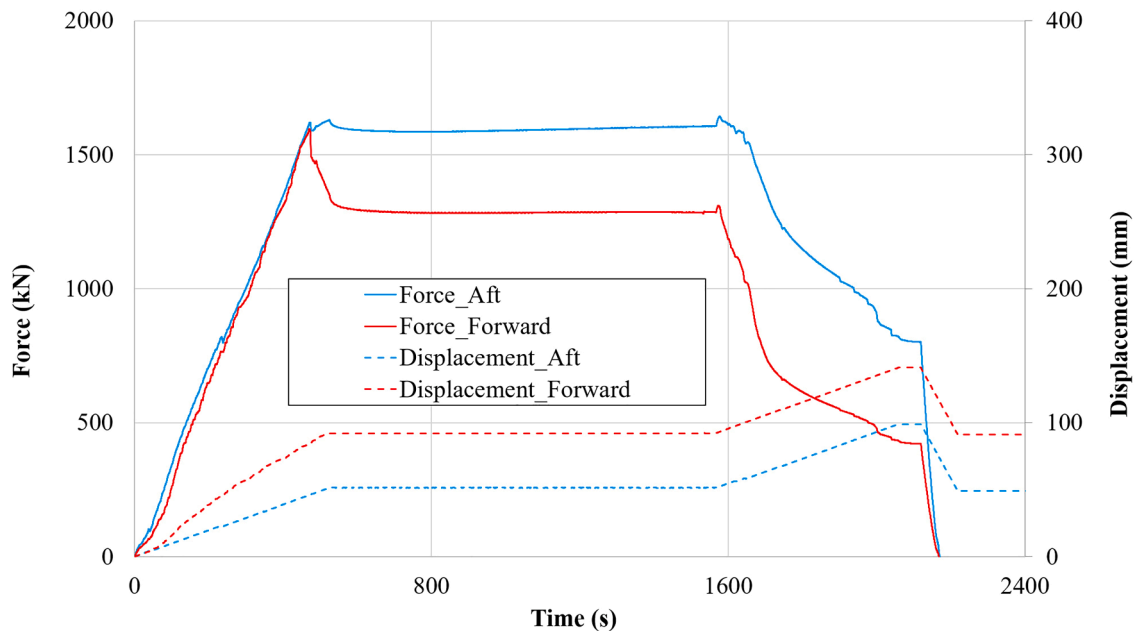
Fig. 29. Force and displacement versus time from the hydraulic cylinders, in the second half-cycle.

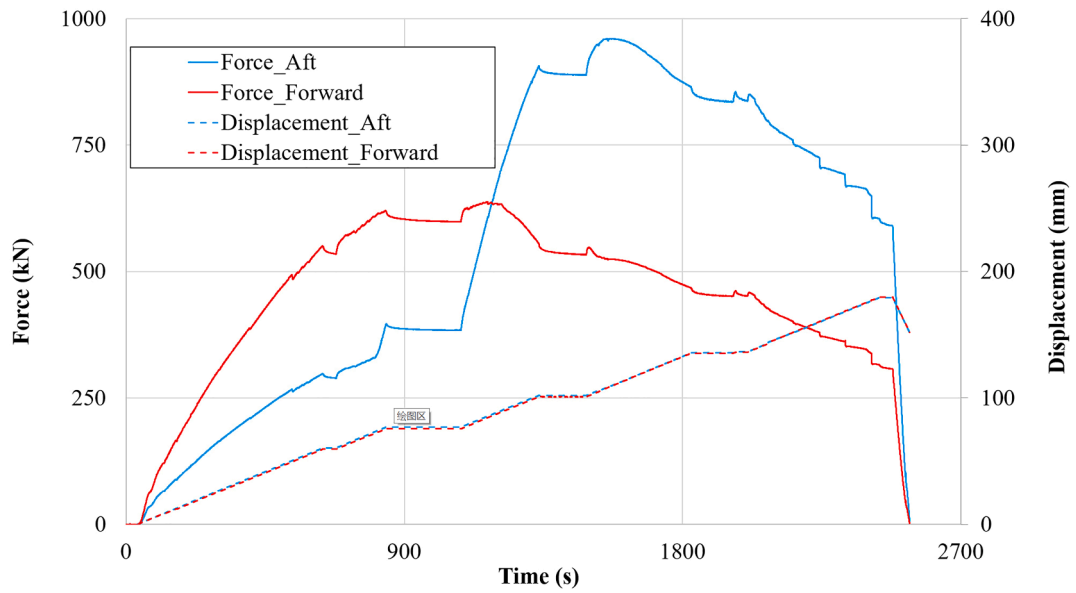
Fig. 30. Force and displacement versus time from the hydraulic cylinders, in the third half-cycle.

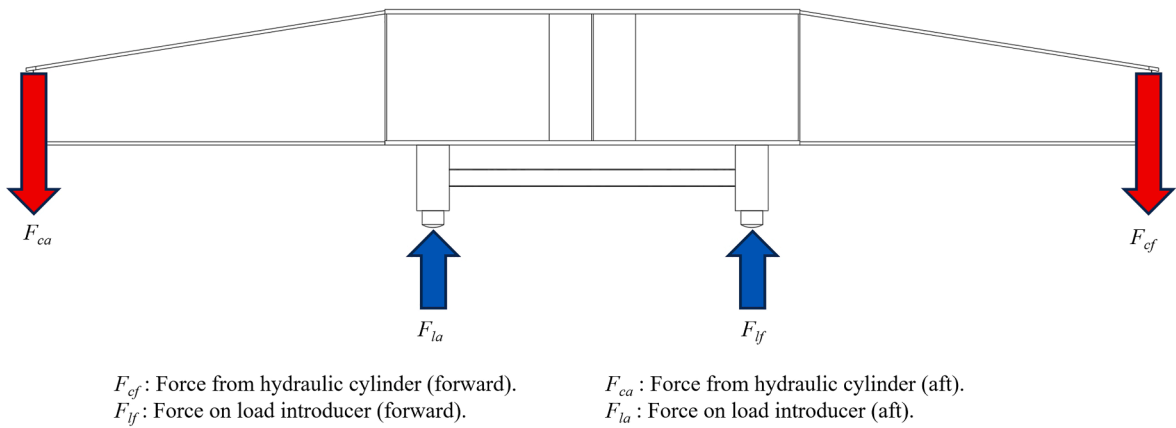
Fig. 31. The designation of forces in the combination of cross beam and load introducer. The relevant dimensions can be found in Figs. 36 and 38.

The force analysis is based on the mechanical equilibrium of the combination of cross beam and load introducer, see Fig. 31. The displacement calibration includes the deformation of test rig and the geometry relationship within it. The deformation of test rig is done by FEM analysis, see Fig. 32, where all components are modelled with elastic material and shell elements. As a result, the calibration of force and displacement are as follows:

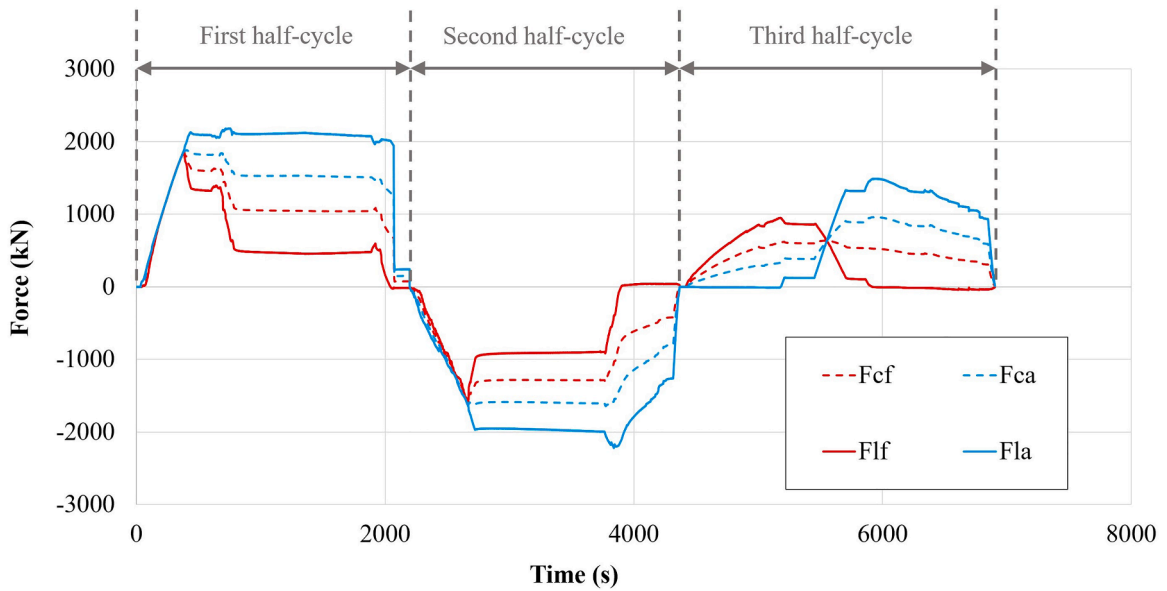
Fig. 33. The calibrated force during the whole test.

As is shown in Fig. 33, during the second and third half-cycles, the load applied by load introducer can be as low as zero. This is due to the unsymmetric deformation of the specimen, which leads to different deformation speed at their contact with each load introducer. As a result, the contact force between the specimen and load introducer is not always the same on each contact point.

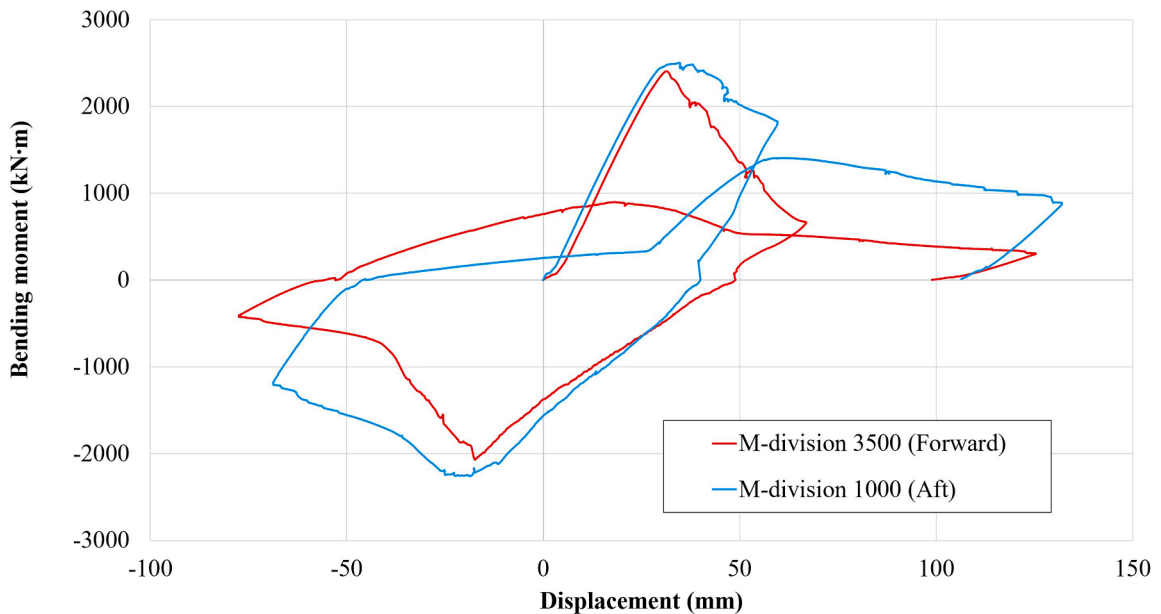
Fig. 34. Bending moment vs. displacement for the two ends of the midsection.

where  $M_{1000}$  and  $M_{3500}$  refer to the bending moment at division 1000 and 3500. The unit for the bending moment is  $kN \cdot m$ . As a result, the bending moment vs. displacement is shown in Fig. 34. Here the displacement refers to that at indenters on forward and aft side accordingly. The positive direction for bending moment corresponds with sagging of the specimen, based on the coordinate system shown in Fig. 4.

Considering the bending moment from two ends of the midsection plotted in Fig. 34, the UHGS of the specimen is reduced after each half-cycle. Considering the large deformations showed in subsection 3.1, such reduction can be caused by multiple factors. In each half-cycle, large deformations including buckling occur in the specimen, which cause plastic deformation locally. These deformations bring additional imperfections for the following half-cycles. Moreover, the existing plastic strain reduces local material strength and leads to fracture, due to the Bauschinger effect. Moreover, taking division 2875 as an example, after each half-cycle, due to buckling
