EXPERIMENTAL STUDY ON THE FATIGUE PERFORMANCE OF CFRP BEAMS WITH STRUCTURED SURFACE LOAD INTRODUCTION UNDER CYCLIC LOADING

Keywords: CFRP, Fatigue testing, 3-point bending, Load introduction, Cyclic loading

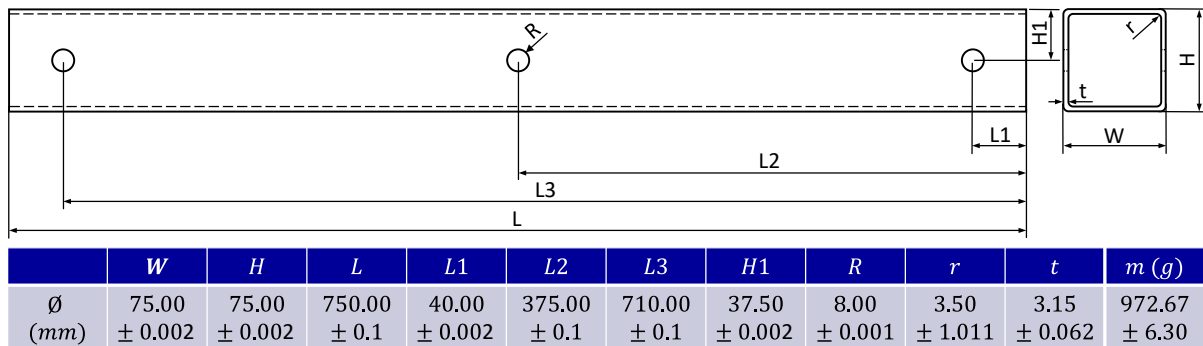
Figure 1: Dimensions of the test specimens.

The fatigue behavior of CFRP structures is investigated using a 3-point bending test setup. The test specimens consist of CFRP square tubes with dimensions of $75 \times 75 \times 750$ mm and a wall thickness of 3 mm. The geometric dimensions of the specimens are shown in Figure 1, including mean values across all beams and their maximum deviations. Dimensions up to 75 mm were measured using a micrometer, while larger values were obtained with a caliper. The corner radius was determined via optical microscopy. Notable deviations are observed in the wall thickness and corner radius, whereas all other dimensions exhibited high dimensional accuracy. For the milled bolt holes, the measured radius deviation is at the limit of the measurement accuracy.

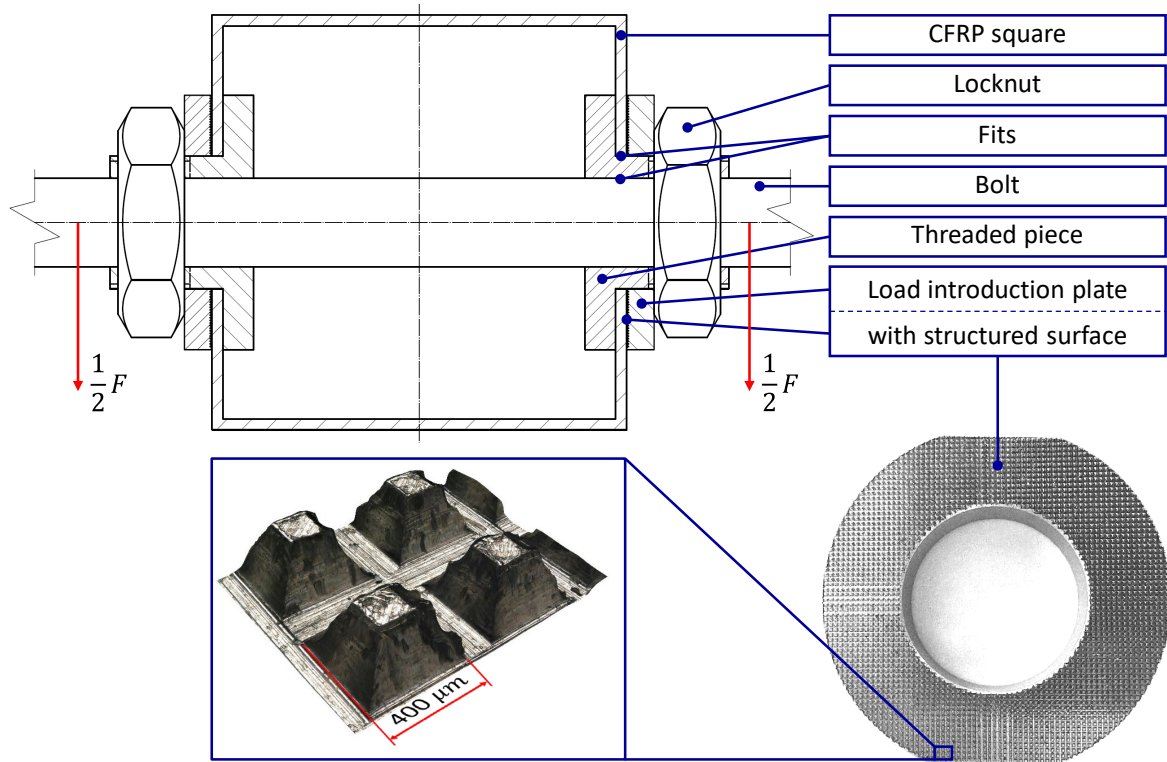
Figure 2: Load introduction design with structured surface and three-dimensional enlargement of the pyramid-shaped surface structure.

The laminate was manufactured using a prepreg process in an aluminum negative mold and featured a 12 layer quasi-isotropic layup, following the stacking sequence $[0^\circ, 60^\circ, -60^\circ, 0^\circ, -60^\circ, 60^\circ]_s$. To introduce the load, a bolted connection with structured surface plates is developed (see Figure 2). The bearing plates with structured contact surfaces are mounted on threaded pieces, which are pressed against the CFRP square profile by a locknut. These threaded elements are then fitted onto bolts through which the load is applied. This design enables both form-fit and clamping effects, aiming to enhance load transfer by increasing contact friction and minimizing stress concentrations. The structured surfaces featured pyramidal elements with a tooth height of 0.3 mm. The tooth geometry was selected based on literature [17] to ensure high friction and allowable surface pressure. The holes in the CFRP profile are manufactured with high dimensional accuracy to ensure a precise fit between bolt and laminate, as literature shows that even small clearance gaps can lead to a significant reduction in load transfer capacity [14].

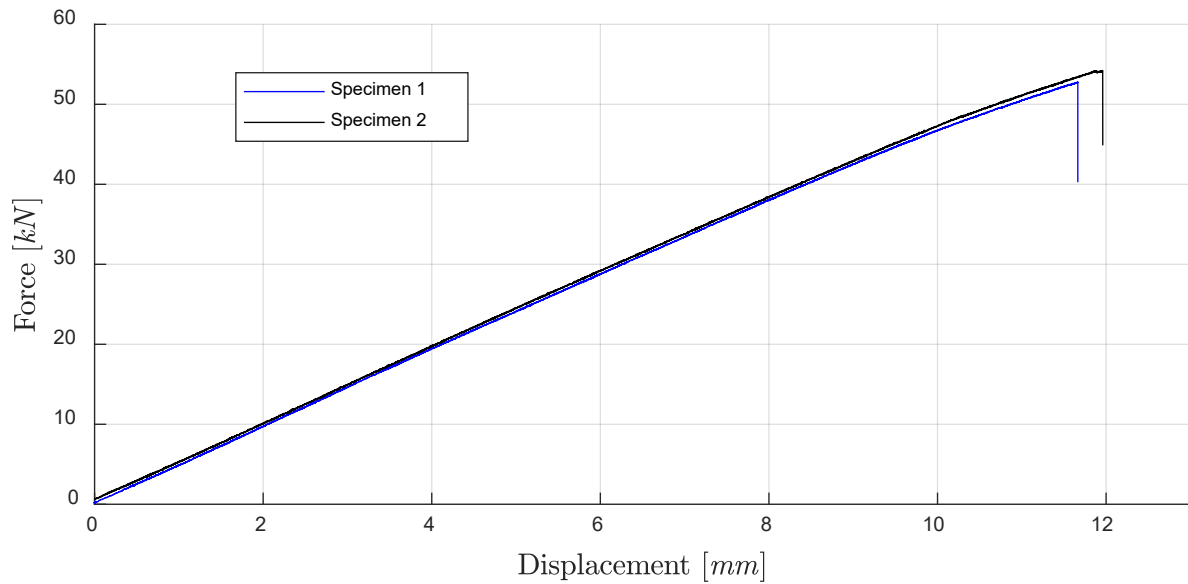
Figure 3: Force-displacement diagram of quasi-static tests.

The quasi-static tests reveal a linear force–displacement behavior up to the point of failure, indicating elastic material response across the tested load range. Maximum load capacity is observed at approximately 53 kN. Figure 3 shows the force–displacement diagram obtained from the quasi-static bending tests. Failure occurs suddenly, suggesting a brittle failure mechanism under bending load. A very good agreement is observed in the linear-elastic range of the force–displacement response.

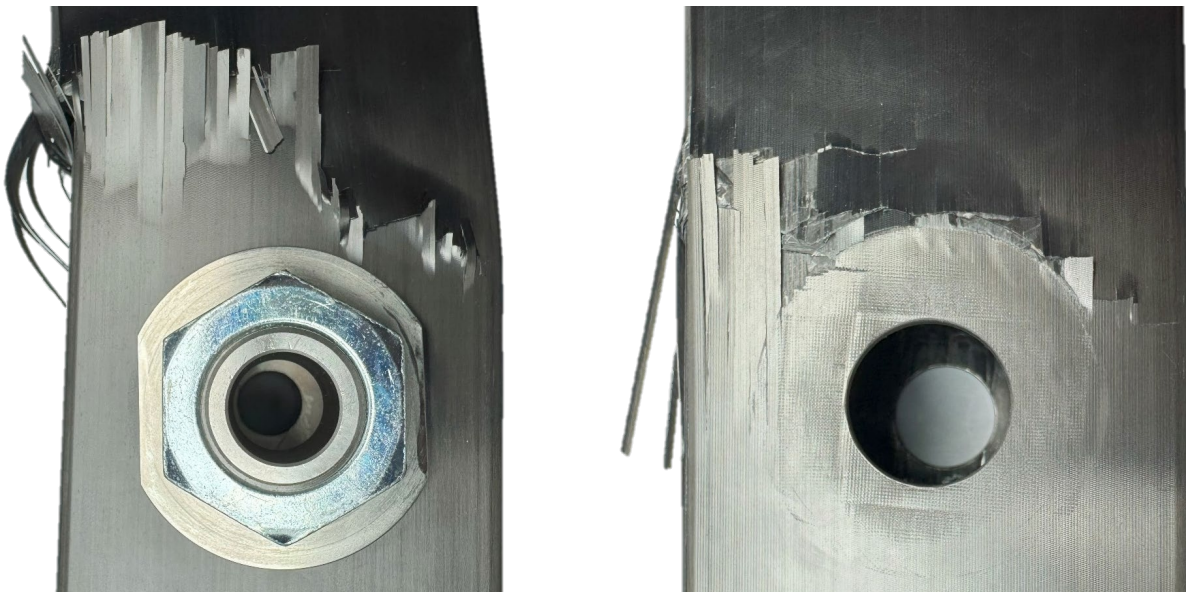
Figure 4: Failure of Specimen 1 with load introduction (left) and Specimen 2 without load introduction (right).

Figure 4 presents the failure patterns of the two quasi-static specimens. The beams exhibit local buckling at the lower flange, combined with matrix detachment and interlaminar delamination, consistent with typical compression-induced failure mechanisms in fiber-reinforced polymer structures under bending. These failures are driven by local instability in matrix-dominated regions, which are especially sensitive to interlaminar shear stresses and separation. Notably, Specimen 1 failed at an off-center position, rather than directly at midspan where the highest bending moment occurs, and thus the failure, would be expected. A possible explanation for this behavior is that the load introduction locally reinforces the beam, especially the vertical webs of the square tube, thereby stabilizing the midsection and shifting the critical failure zone outward.

Specimen 2 exhibited a central failure fracture, as shown in Figure 4 (right). The fracture path runs around the load introduction region. As with Specimen 1, this suggests a stabilizing effect of the load introduction unit, likely due to the local reinforcement.

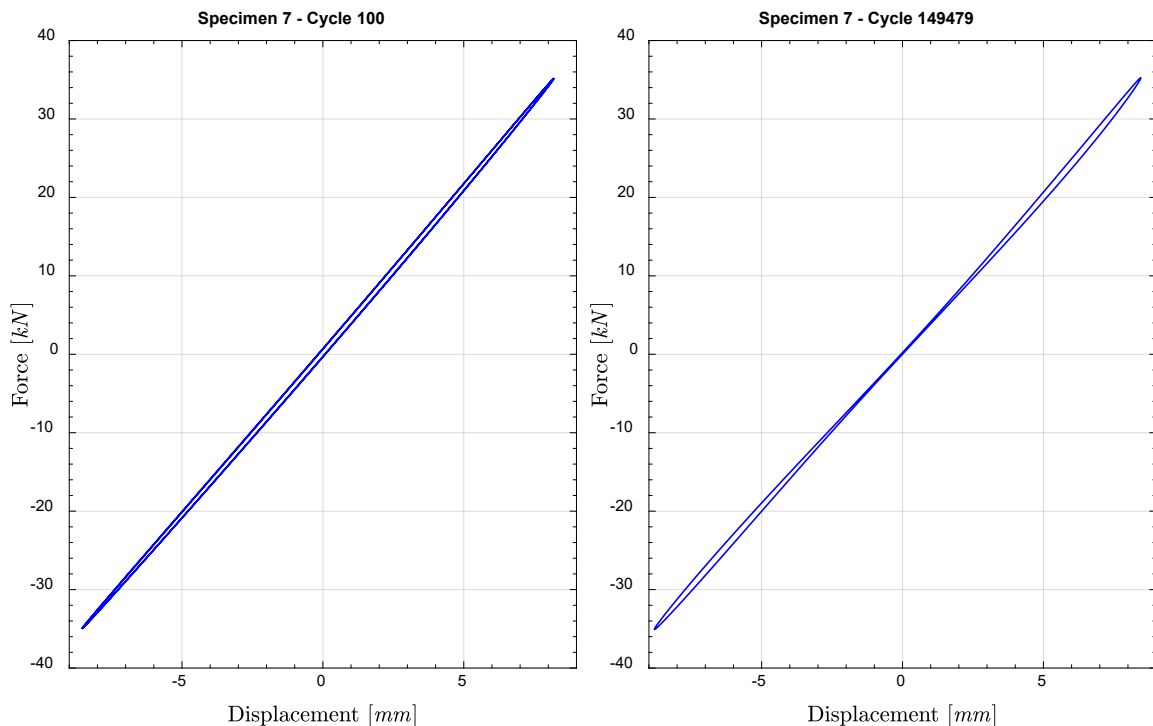
Figure 5: Hysteresis behavior of Specimen 7 at cycle 100 and 149479.

Figure 5 compares the hysteresis behavior of Specimen 7 at cycle 100 and cycle 149,479, the cycle before final failure. A reduction in hysteresis area is observed at the later stage, indicating decreased energy dissipation, which is characteristic of advanced material degradation [18]. The loading and unloading paths converge near the zero-crossing, suggesting a nearly elastic response with no measurable plasticity or damping, a sign of structural exhaustion. While the overall stiffness appears unchanged, internal damage accumulation is likely near critical. A slight asymmetry and narrowing of the curve further points to localized effects such as delamination, matrix cracking, or fiber-matrix debonding. This observation is consistent with findings, where individual fiber bundles delaminated at the sides or corners of the beam, away from the eventual failure location, prior to global failure. This indicates that localized damage initiation can occur independently of the final fracture zone and further supports the interpretation of progressive internal degradation despite externally stable load-displacement behavior.

These features collectively indicate that the material has exhausted its damage tolerance and that failure is imminent. This progression highlights how the collapse of the hysteresis loop at the neutral axis could be precursor of final failure in fatigue-loaded composites. Such behavior could be relevant for structural health monitoring, as it highlights the need to detect early-stage internal damage. Localized delamination or fiber–matrix debonding could serve as early indicators of fatigue degradation. This aspect will be investigated in future tests. To enable a more detailed analysis of local damage progression, strain gauges will be applied at critical locations on the beam surface. This will allow for a broader and more spatially resolved dataset.

The convergence of the loading and unloading paths near the zero-crossing in Specimen 7 developed progressively over the final 40,000 cycles. A similar trend is observable in Specimens 4 and 6, where the hysteresis loops also narrow around the neutral axis as failure approaches. Furthermore, all specimens exhibit increasing asymmetry in their hysteresis behavior toward the end of their fatigue life, though with varying degrees of intensity.

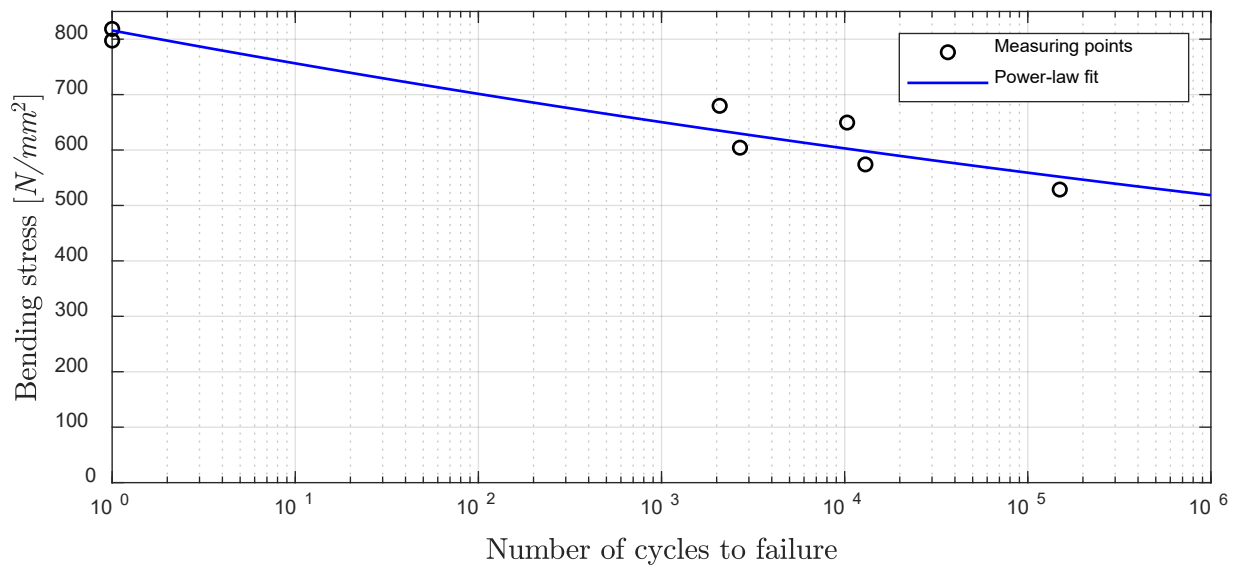
Figure 6: S-N curve with power-law fit trendline.

Figure 6 displays the bending stress versus the number of cycles to failure for all tested specimens. The results from the quasi-static tests are included as reference points with a cycle count of 1. To illustrate the overall trend in fatigue behavior, a power-law fit is applied to the data. This trendline provides a first approximation of the fatigue life curve, highlighting the expected decrease in maximum stress with increasing cycle number.

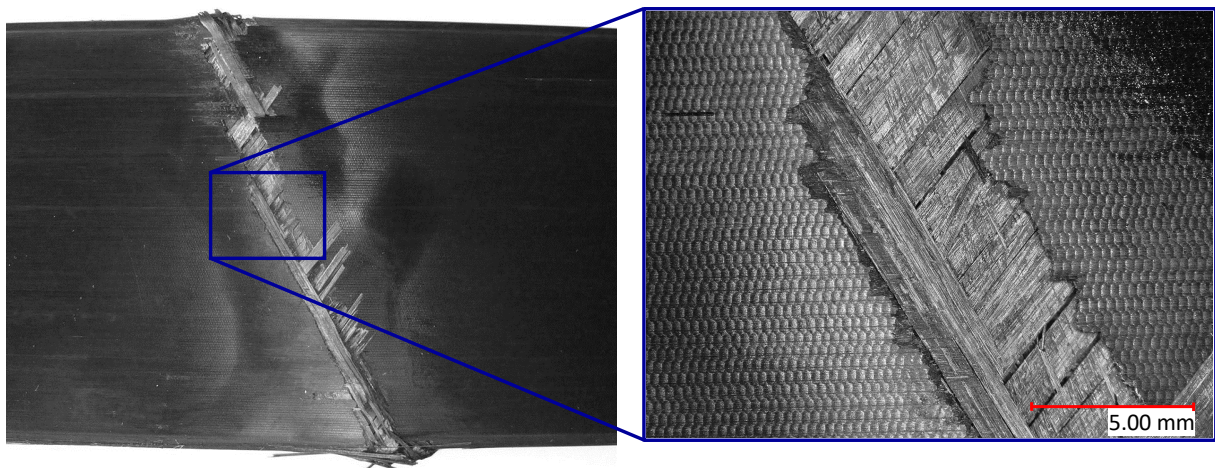
Figure 7: Failure of Specimen 7 with magnified view.

An exception appears in Specimen 7, where a distinct failure mode emerges. Instead of buckling on the compression side, as typically seen, the failure occurred on the tension side of the profile, where a fiber fracture accrued. This result is shown in Figure 7. Such a shift in failure location under fatigue loading is particularly relevant for design practice, as it challenges the assumption that fatigue failure occurs at the same critical location as static failure. In many current design approaches, fatigue is accounted for by applying a global safety factor to the static strength. This strategy may be insufficient when fatigue failure initiates in different regions of the structure. Since only a single specimen was tested in this high-cycle regime, further tests are planned to statistically validate this observation and assess its reproducibility.

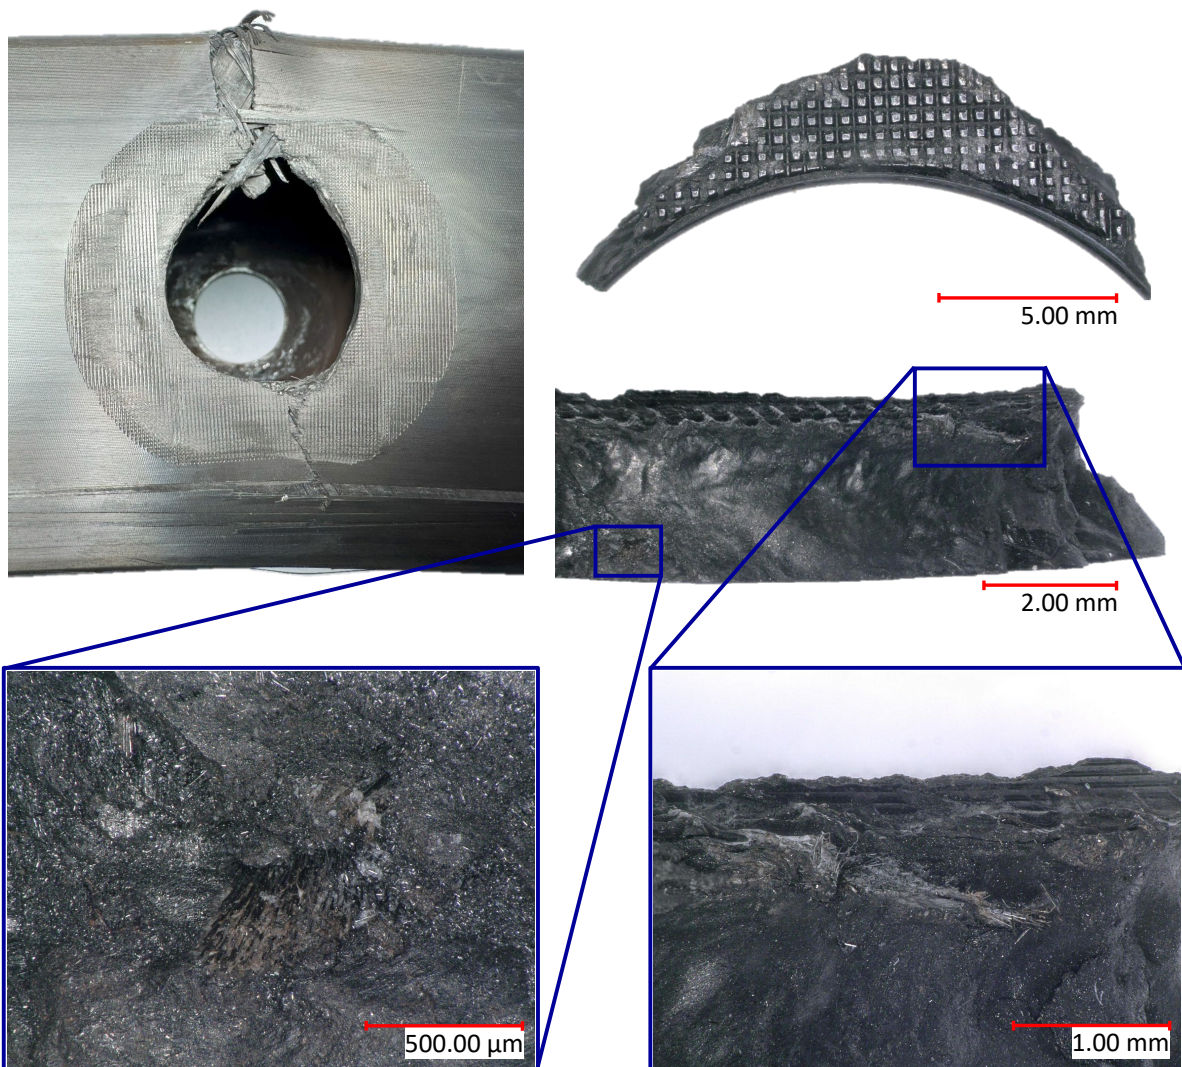
Figure 8: Top view of the damage on Specimen 7 (top left) and the detached fragment (top right). The fracture surface is shown in the middle right image, with magnified views of the fracture edge and exposed fiber bundles (bottom).

None of the tested specimens exhibited catastrophic failure at the load introduction area. However, in two cyclically tested specimens, seizure (galling) occurred between the bolt and the threaded insert. In both cases, localized damage to the CFRP in the load introduction zone is observed (see Figure 8).

The material appears brittle, and during disassembly, a portion of the laminate fractured and detached, shown on the right top in Figure 8. Below that, the fracture surface of the detached laminate fragment is shown. The surface exhibits a dark, discolored appearance, which visually resembles thermal damage or burning. Only two small areas with visible fibers can be identified, which are shown in magnified view in the lower part of the figure.
