## Research paper

# Non-destructive testing of CFRP laminates for aerospace structures: Acoustic emission and ultrasonic longitudinal wave (ULW) evaluation under Mode II loading with destructive validation

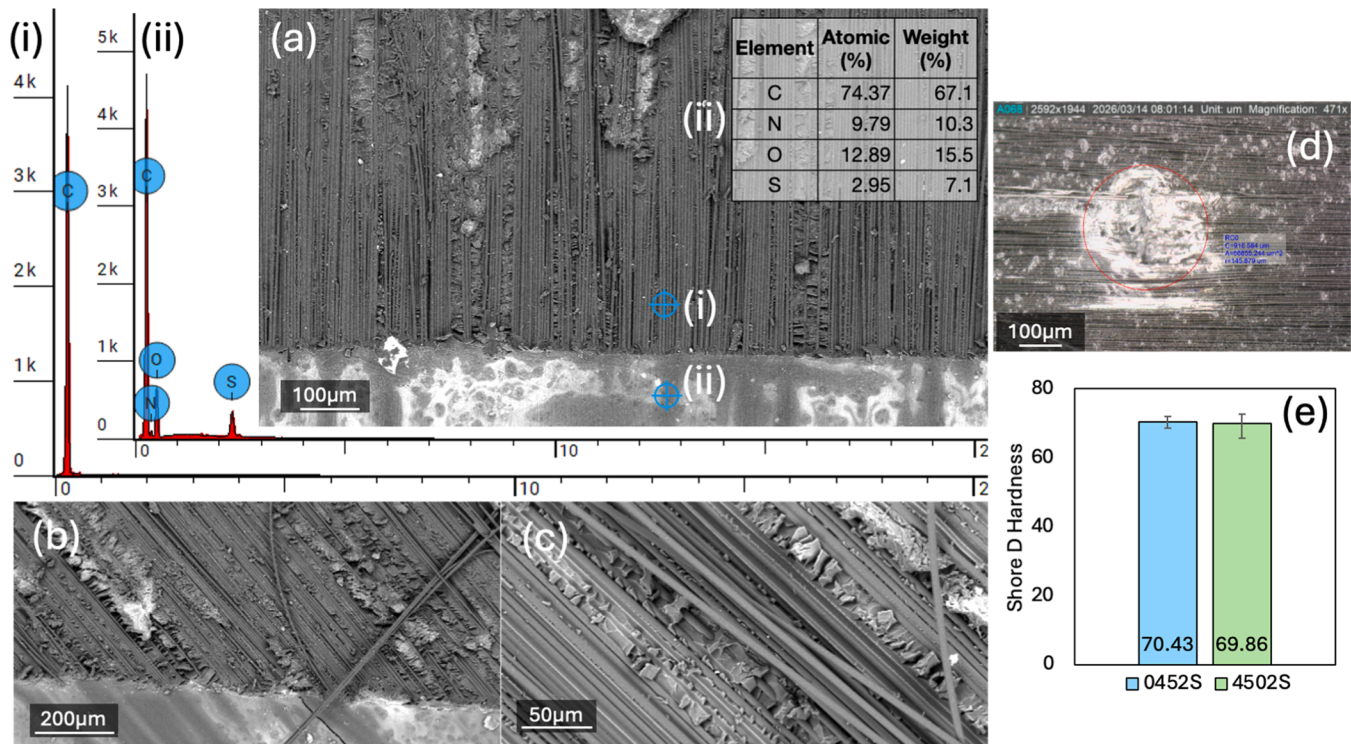
Fig. 15. (a) SEM-EDS of  $[0^\circ/+45^\circ/-45^\circ]_{2S}$  layups with the different elements, (b) SEM image from  $[+45^\circ/-45^\circ/0^\circ]_{2S}$  layups with 420 magnification, (c) with 1500 magnification, (d) Indentation trace from Shore D hardness, (e) Comparison results from Shore D hardness.

Validation of the study was further analyzed using SEM-EDS and Shore D hardness measurements, as presented in Fig. 15. The SEM-EDS analysis of the  $[0^\circ/+45^\circ/-45^\circ]_{2s}$  laminate in Fig. 15(a) reveals the

elemental composition dominated by carbon (C), nitrogen (N) and oxygen (O), indicating the presence of polymer matrix and interfacial regions within the composite structure. The SEM micrographs of the  $[+45^\circ/-45^\circ/0^\circ]_{2S}$  laminate shown in Fig. 15(b) and Fig. 15(c) illustrate the fracture surface morphology at magnifications of 420 $\times$  and 1500 $\times$ , respectively, where aligned fiber traces and matrix deformation along the fiber direction can be clearly observed, suggesting that the crack propagation tends to follow the fiber–matrix interface and local shear paths under loading. In addition, the indentation trace obtained from Shore D hardness testing in Fig. 15(d) indicates the localized deformation behavior of the composite surface during hardness measurement. The quantitative comparison shown in Fig. 15(e) demonstrates that the Shore D hardness values of both stacking configurations are relatively similar, with 70.43 for  $[0^\circ/+45^\circ/-45^\circ]_{2S}$  and 69.86 for  $[+45^\circ/-45^\circ/0^\circ]_{2S}$  laminates, suggesting that the difference in crack propagation behavior observed in the previous sections is primarily influenced by the stacking sequence and stress distribution rather than by significant differences in surface hardness or matrix properties.
